Historic Structure Report

Prepared by: FFA Architecture and Interiors, Inc.
architecture + history, llc

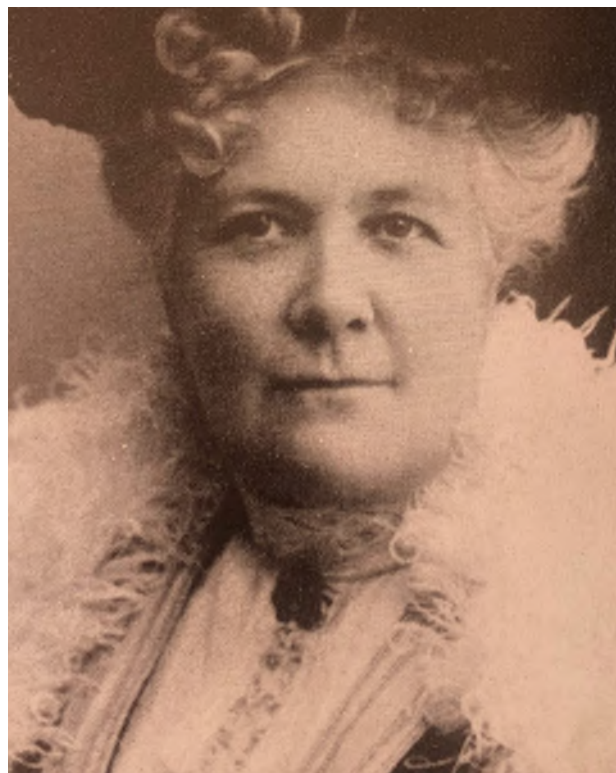
Figure 4.3: Dora Henriette Carry Rowe. Source: *Man of Alaska*.

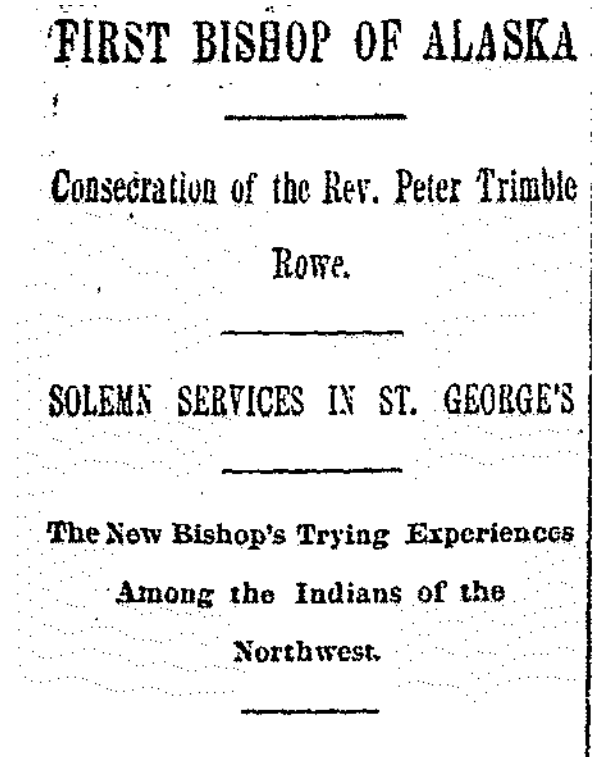
Figure 4.4: *New York Times* article 1895.

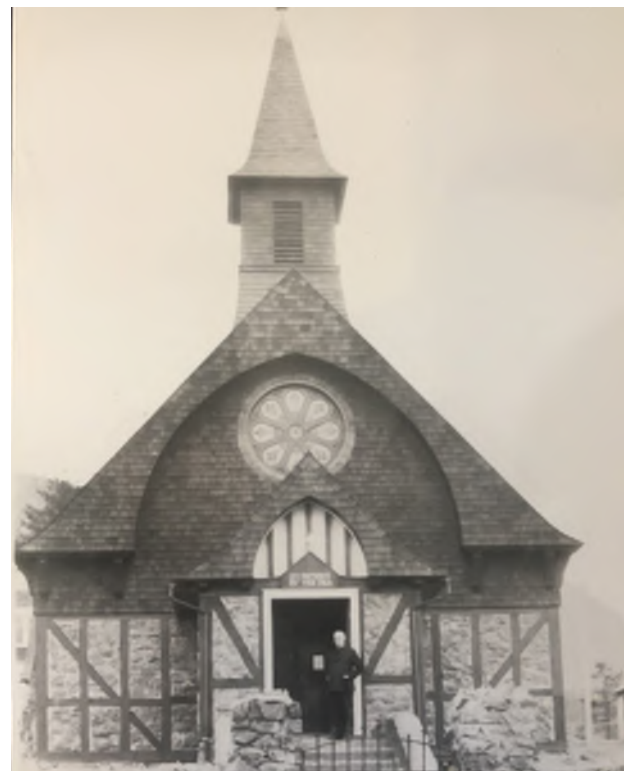
Figure 4.5: Early view of St. Peter's with Bishop Rowe. Source: St. Peter's by-the-Sea Archives.

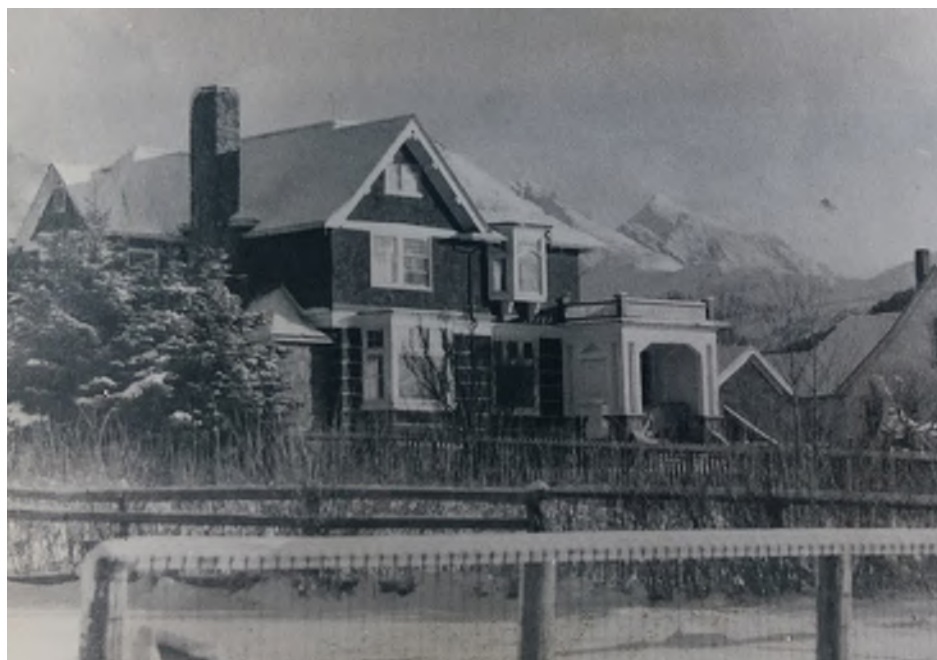
Figure 4.10: An early view of the See House after recent snow fall. Source: St. Peter's by-the-Sea Archives.

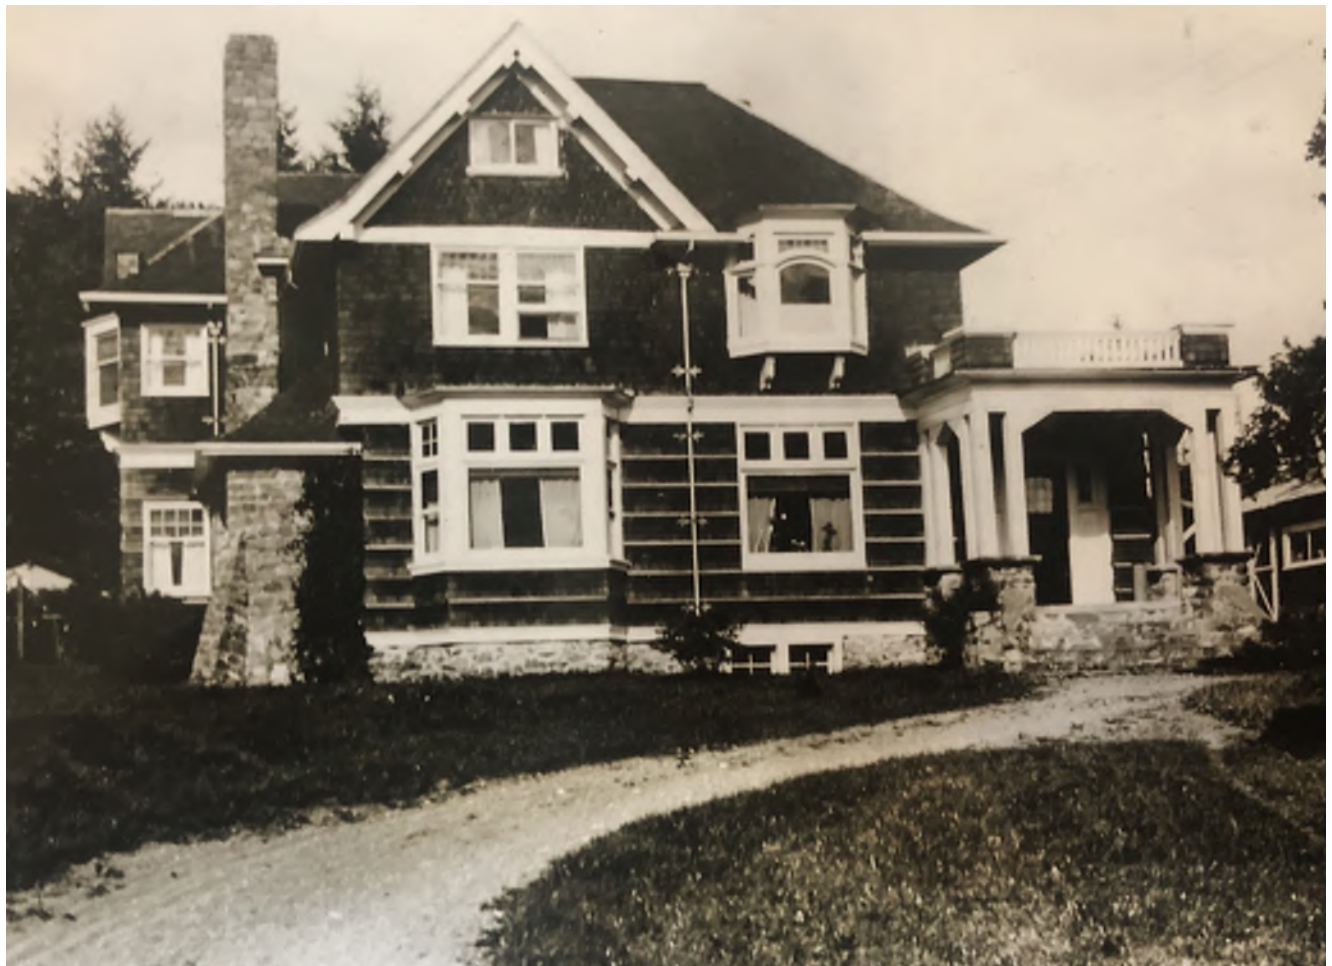
Figure 4.12: An early view of the See House note the driveway, original stair configuration and the chimney rising from the stone base which corresponds to the interior inglenook. Source: St. Peter's by-the-Sea Archives.

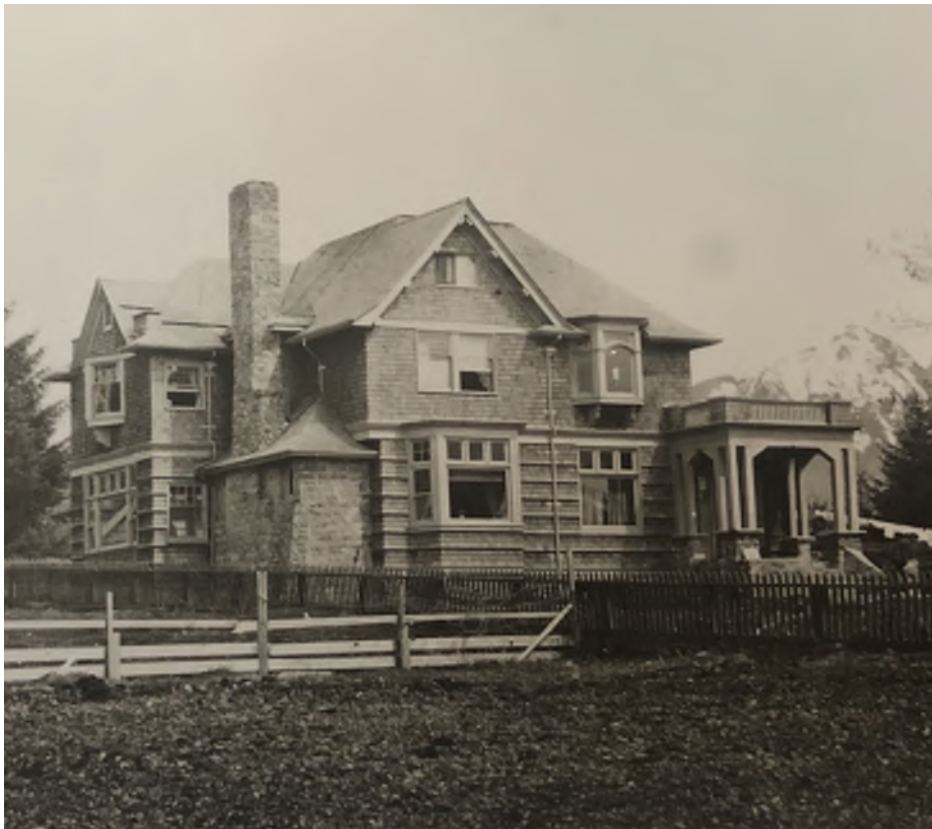
Figure 4.13: An early view of the See House. This may be the earliest view dated c.1905-1910. Note that the shingle siding does not appear to be weathered or stained. Source: St. Peter's by-the-Sea Archives.

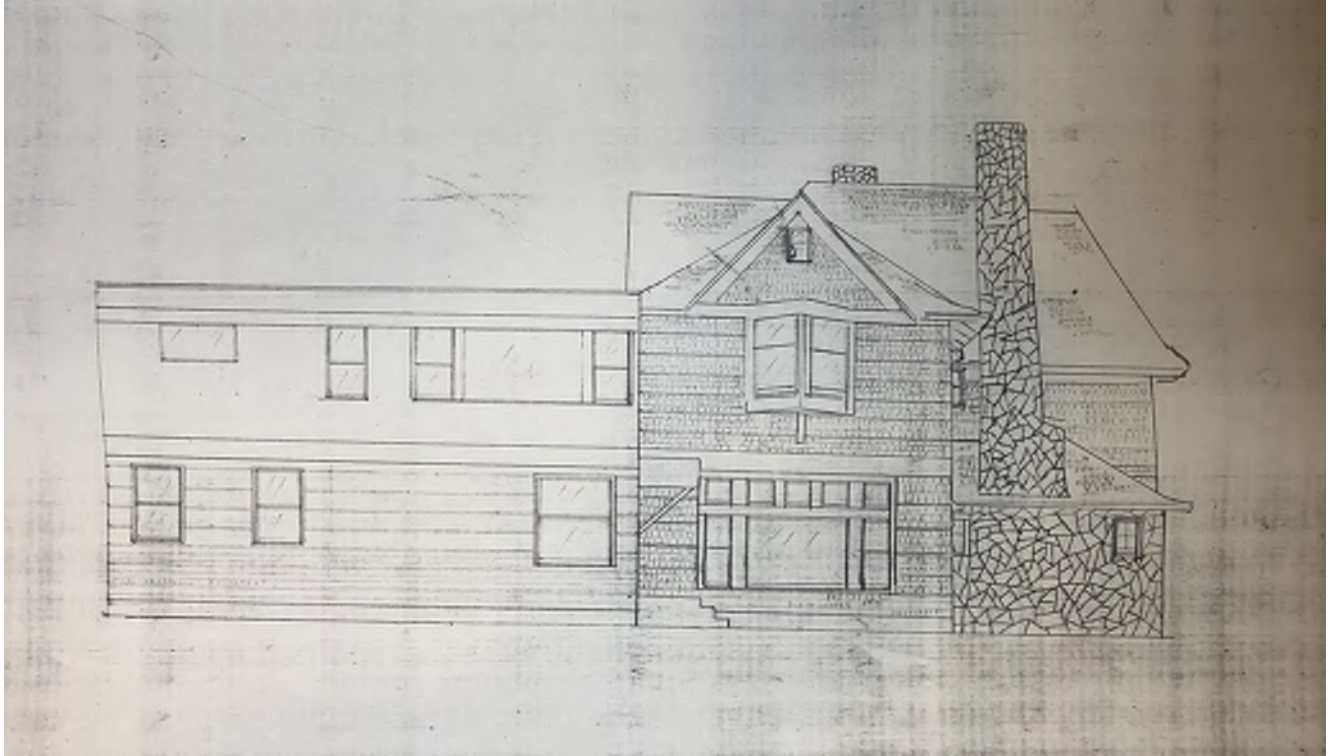
Figure 4.14: Drawing sheet by George Nelson for the 1956 addition to the See House illustrating the west and south elevations, including the entry to the upstairs apartment Source: St. Peter's by-the-Sea Archives.

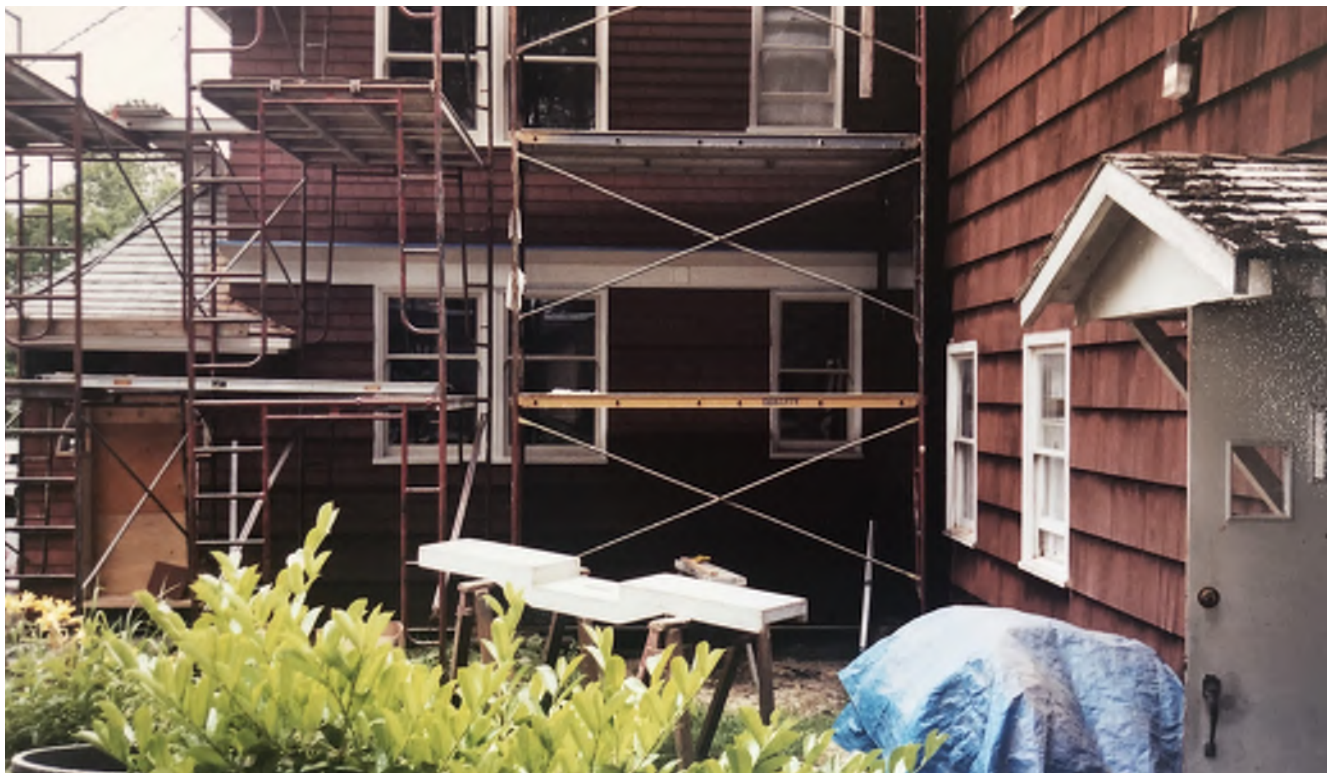
Figure 4.17: Photograph of 2003-2004 restoration of the See House, installation of shingles and repair of doors and windows on the north facade of the See House, looking south. Source: St. Peter's by-the-Sea Archives.

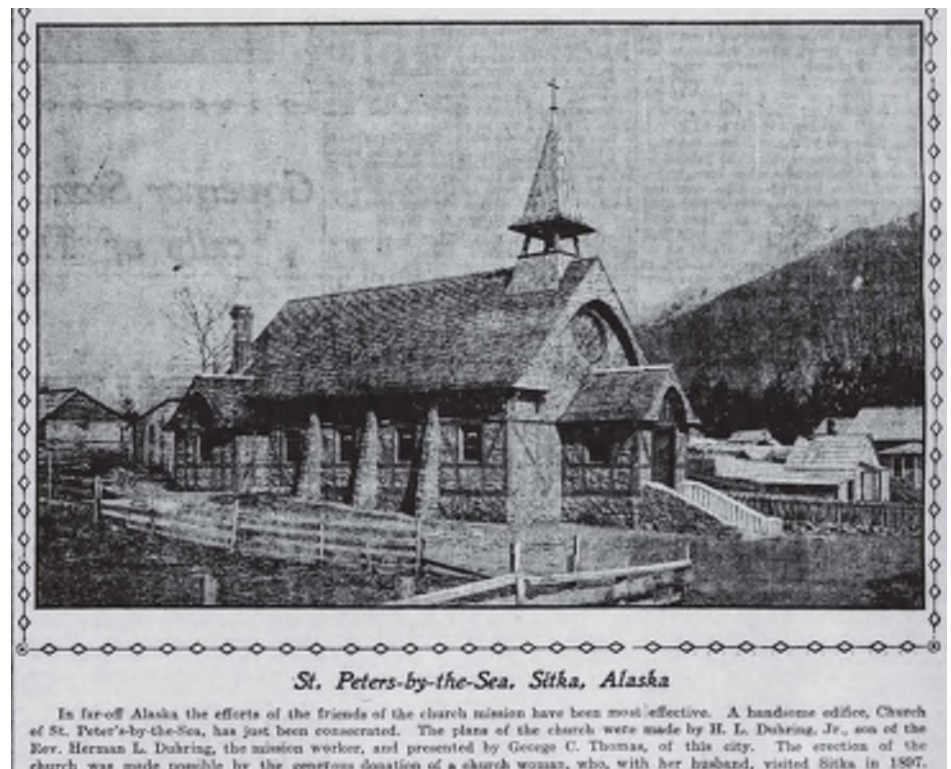
Figure 4.18: From the *Philadelphia Inquirer* August 5, 1900. Source: *Philadelphia Inquirer* as indexed in Newspapers.com.

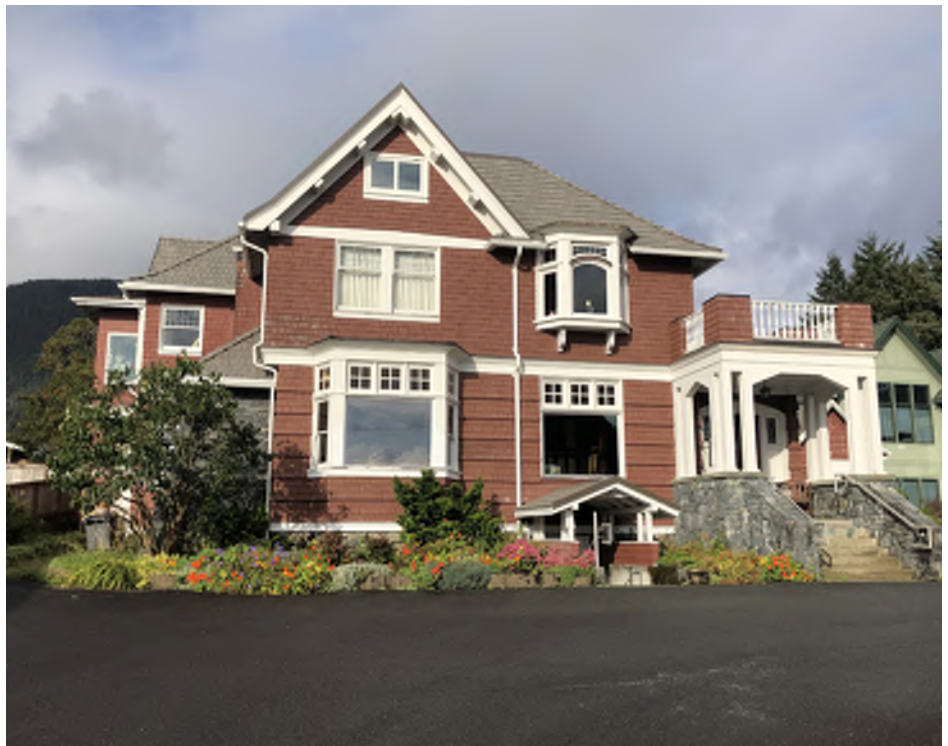
Figure 5.6: Paved parking area and drive that separates the church and See House, looking north.

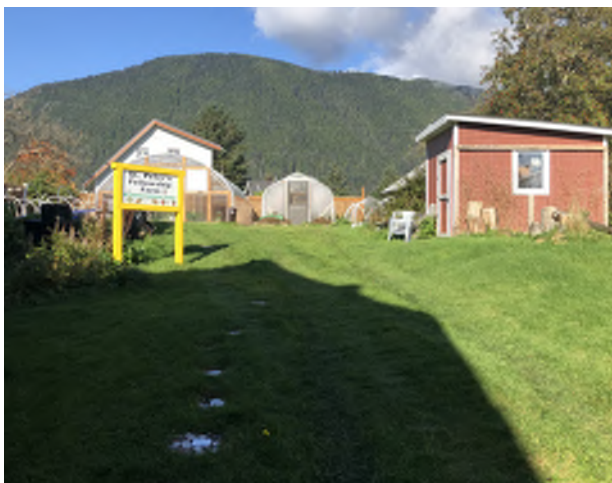
Figure 5.9: Church garden at the north end of the parcel behind the See House, looking north.

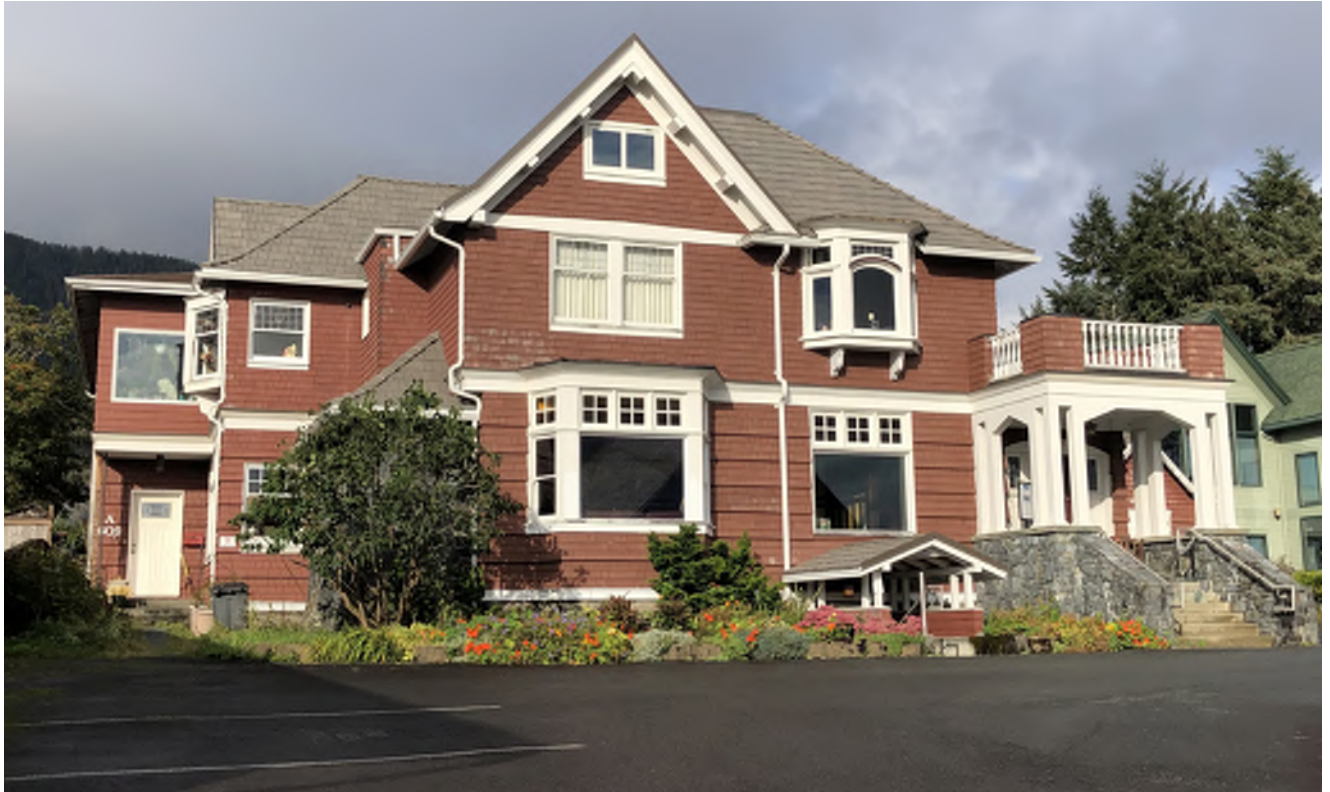
Figure 5.10: Overview of See House, looking north.

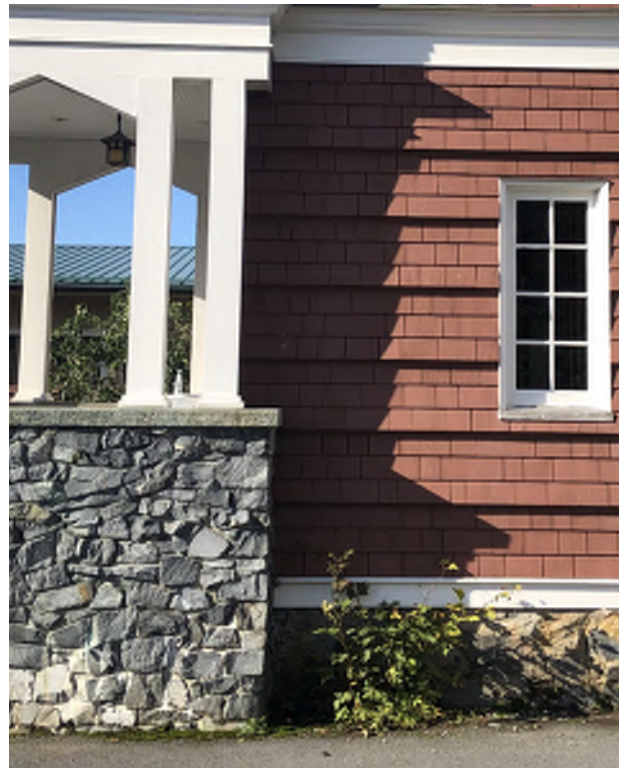
Figure 5.12: Exterior random laid stone at the stair and continuing to the foundation, which is partially obscured by landscaping, looking west.

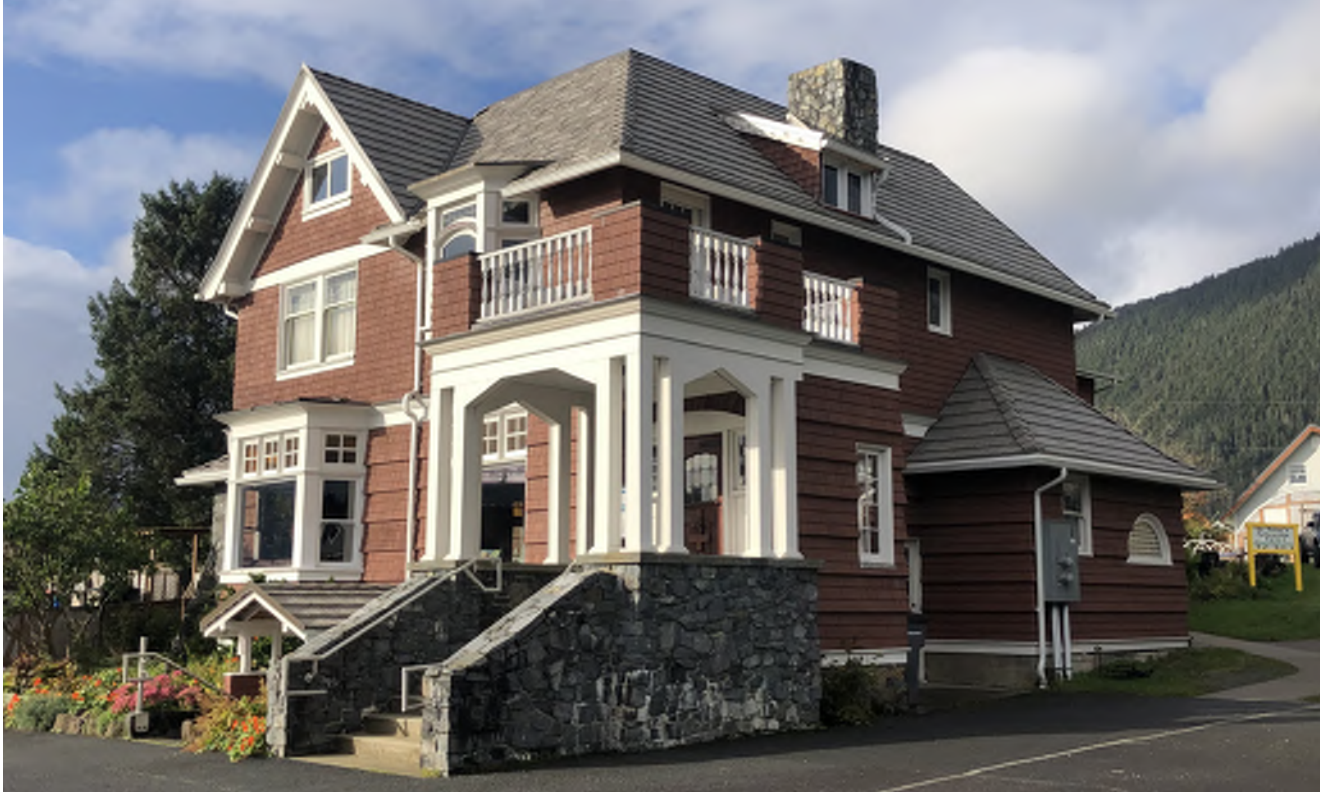
Figure 5.13: View of the roof forms at the See House with the main hip roof, intersecting front gable, dormers and the flat roof of the porch, looking northwest.

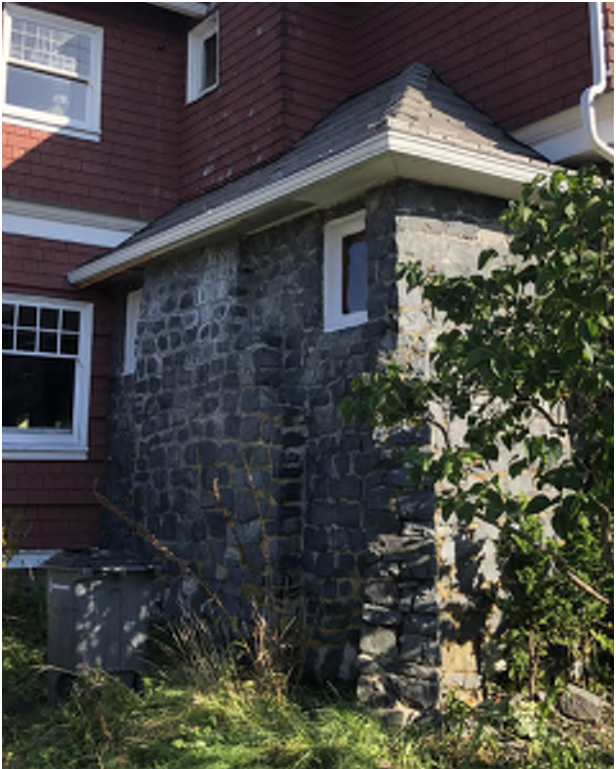
Figure 5.15: Exterior stonework that corresponds with the interior inglenook.

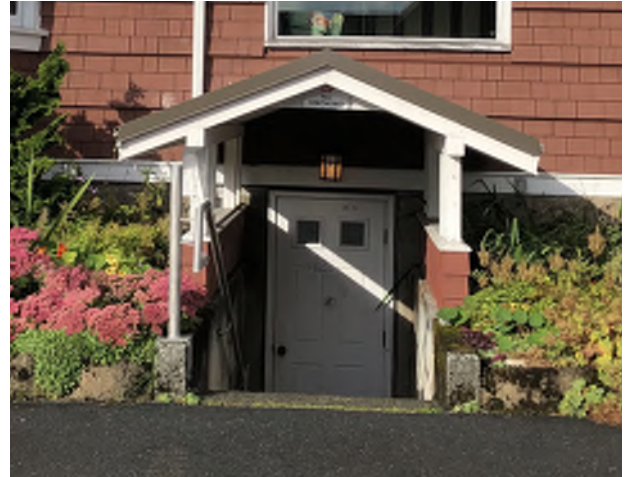
Figure 5.16: The addition of the fixed awning at the basement level entry, looking north.

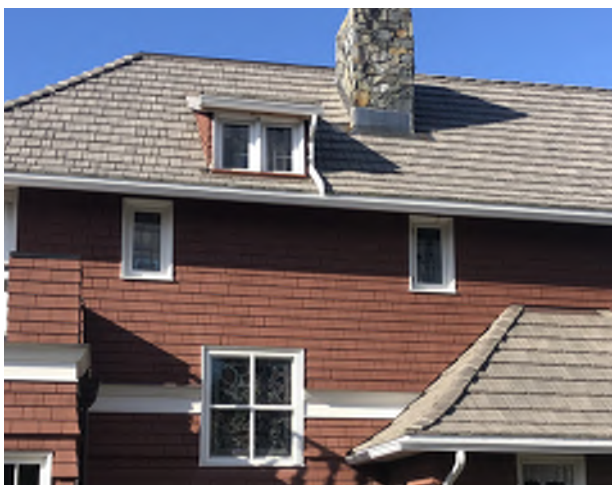
Figure 5.27: The central section of the east façade with the four-lite stained glass window, dormer and chimney.

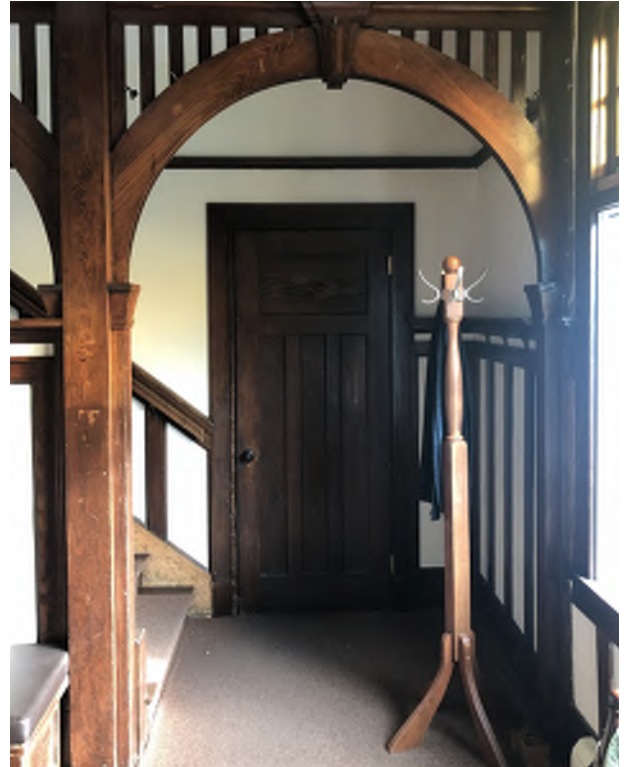
Figure 5.38: Stairway to the second floor accessed from the Entry Vestibule.

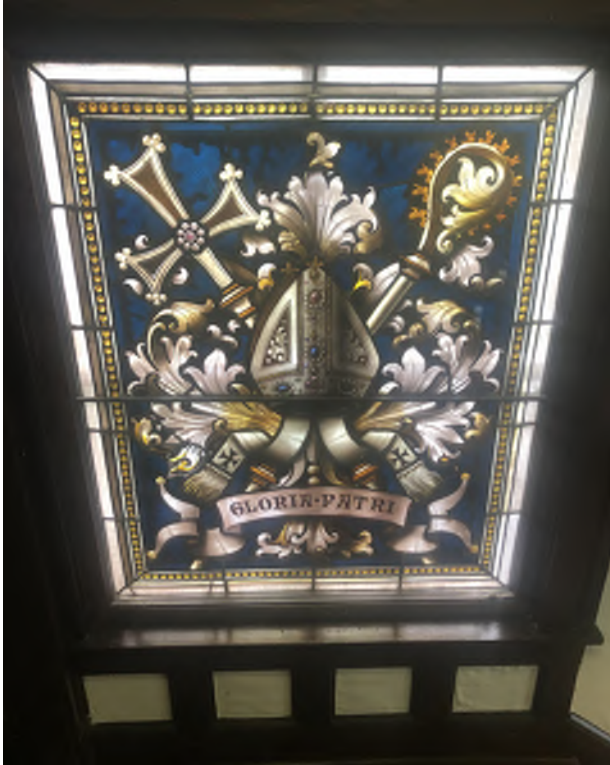
Figure 5.40: Decorative stained glass window at stair landing.

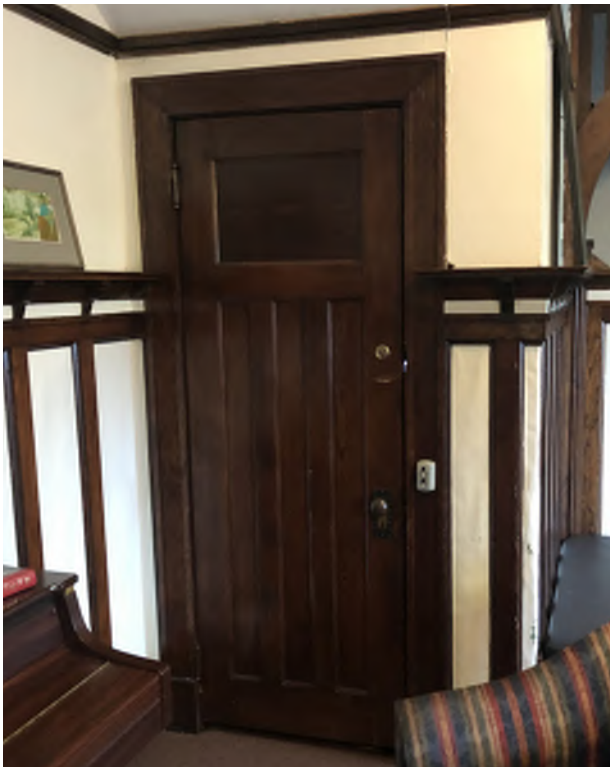
Figure 5.41: Closet with original door, located under the stairwell.

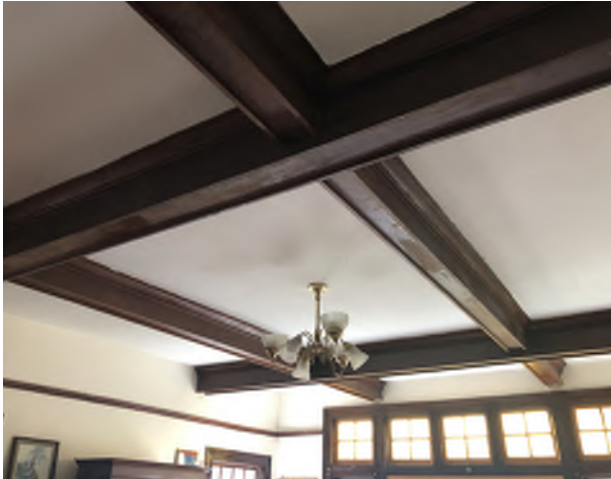
Figure 5.42: Plaster ceilings with dark-stained wood beams in the Living Room.

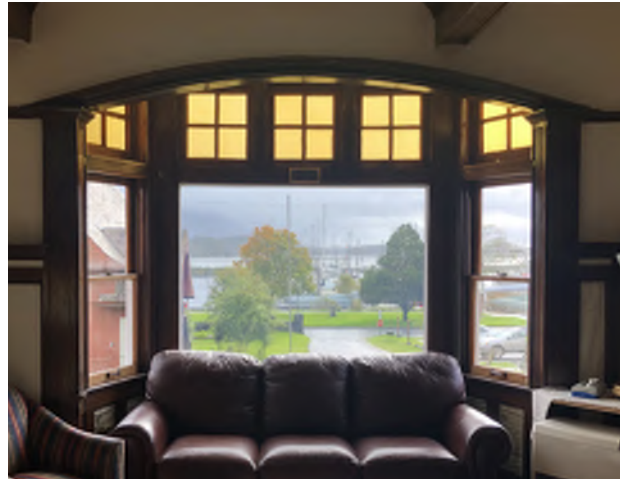
Figure 5.45: Central bay window on first floor, looking south towards bay.

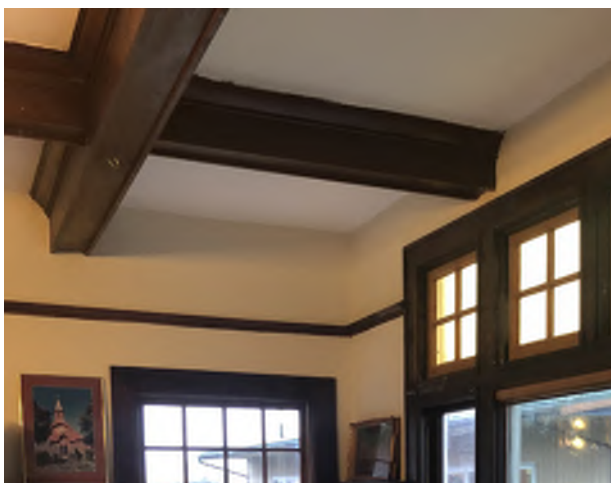
Figure 5.50: Plaster and wood beam ceilings in the Dining Room are the same finishes as those found in the Living Room.

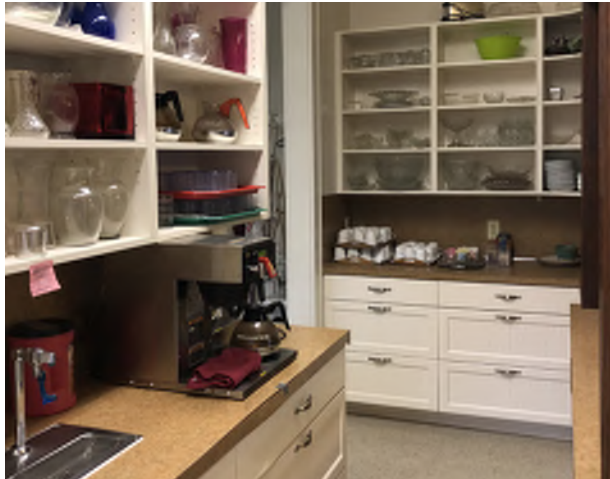
Figure 5.51: Main Kitchen and pantry area.

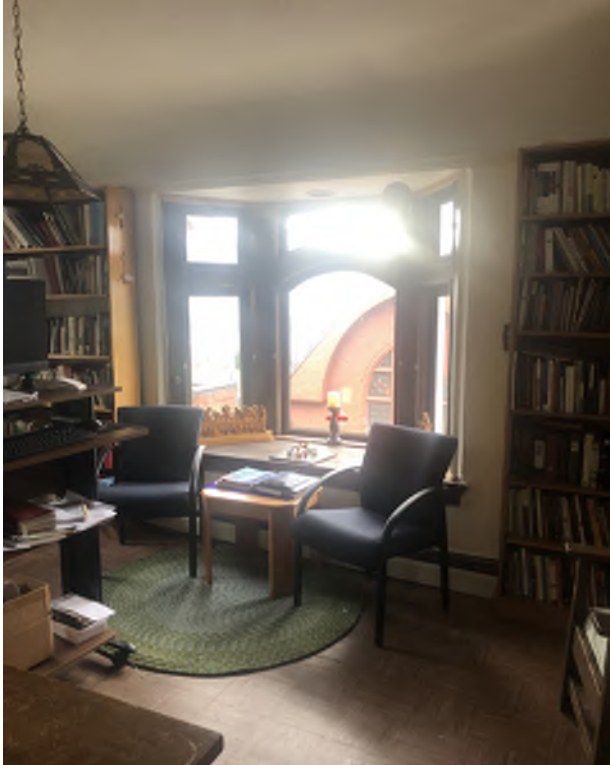
Figure 5.57: Bay window in the southeast bedroom of second floor.

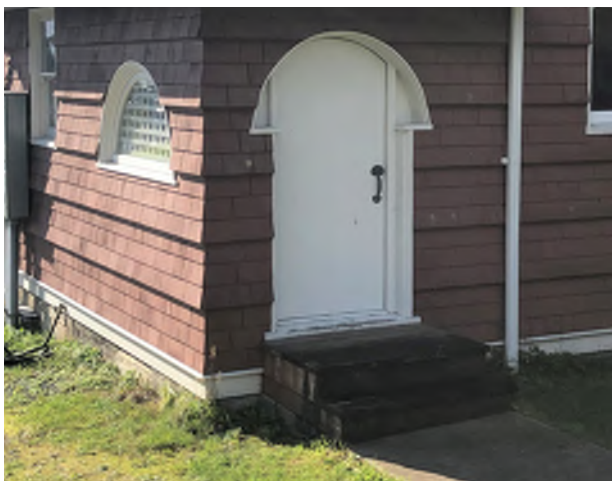
Figure 8.5: The north Kitchen entrance stairs are slippery when wet and pose a safety hazard.

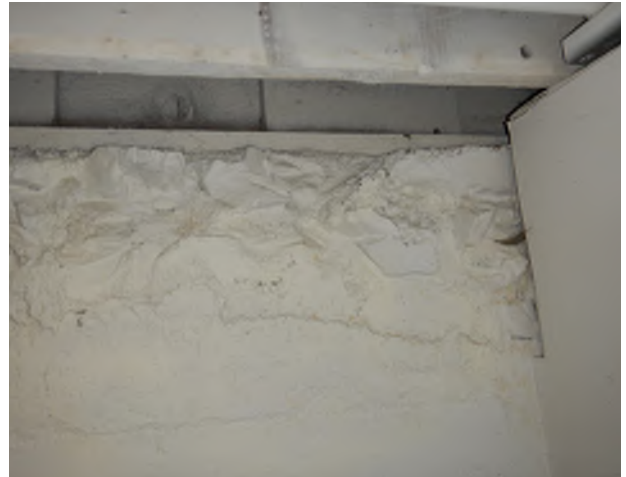
Figure 8.6: The concrete stem wall foundation topped with 1 to 3 feet of rubble masonry.

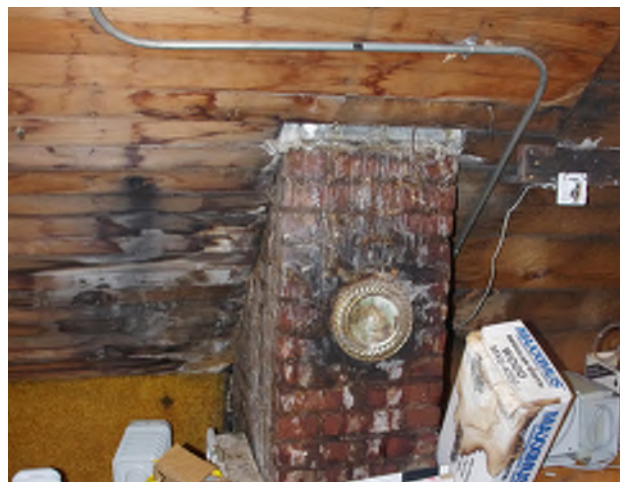
Figure 8.7: Moisture infiltration at the attic level around the Boiler Room chimney.

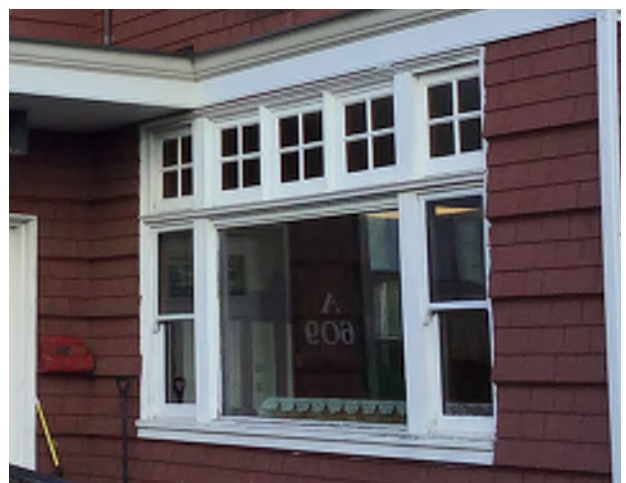
Figure 8.8: Slight sagging of window head on the exterior of the Dining Room window on the west .

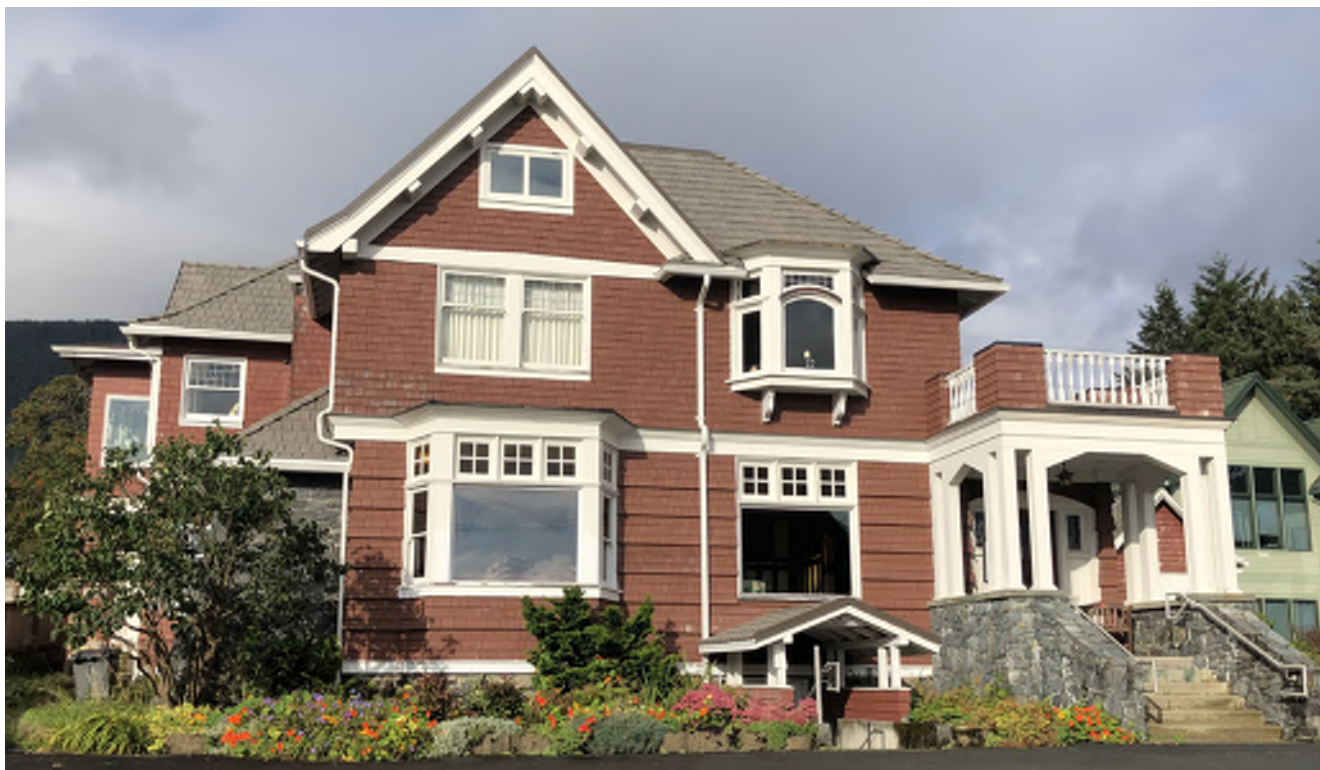
Figure 8.9: Synthetic (plastic) shakes have replaced the original cedar shingle roof.

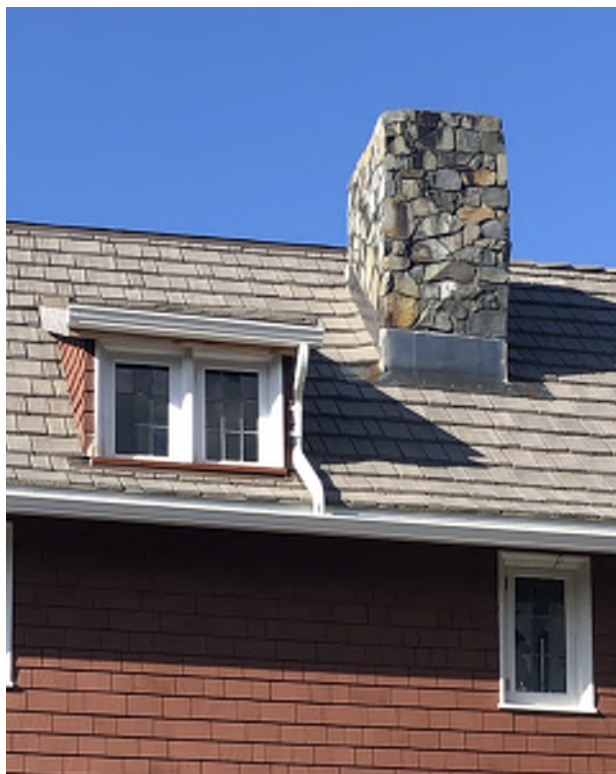
Figure 8.10: Unpainted wood trim at roof dormer on the east facade near the chimney.

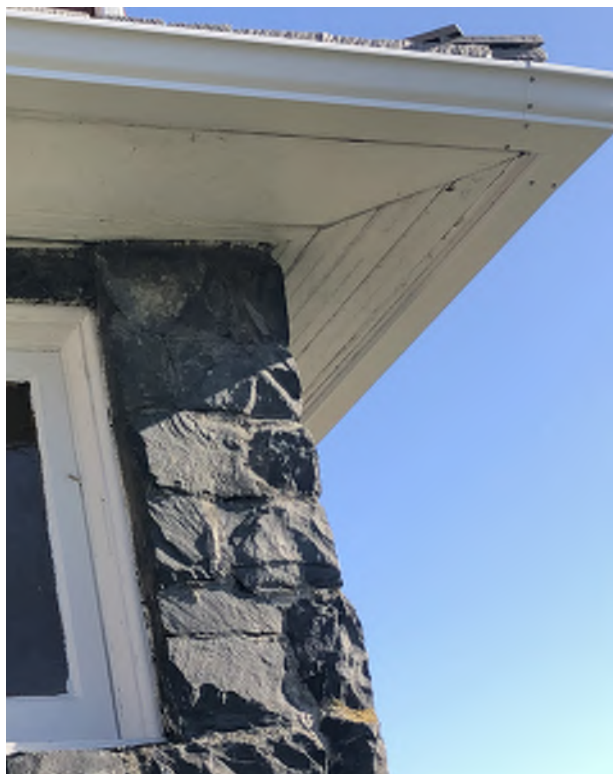
Figure 8.11: A majority of the original tongue-and-groove beadboard paneling on the eaves and soffits has been replaced with plywood.

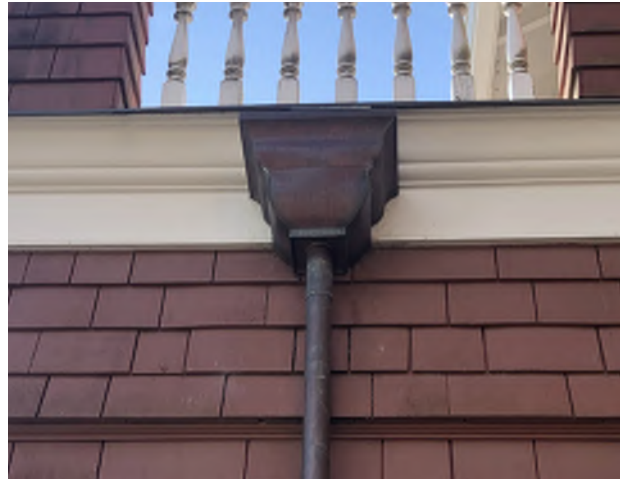
Figure 8.12: Copper leader and round downspout on the east of the entry porch balcony.

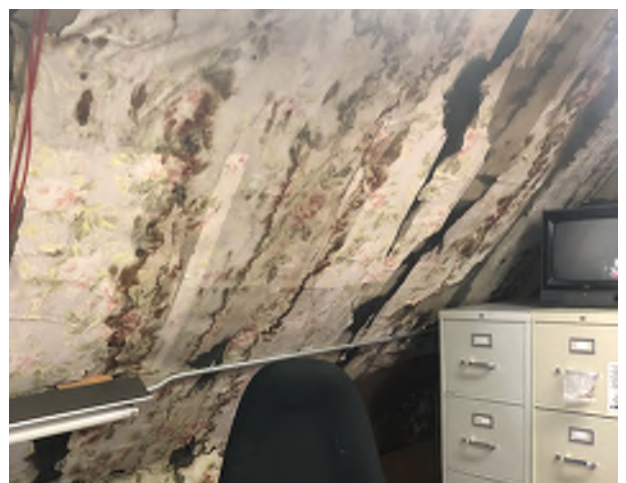
Figure 8.14: Peeling wallpaper in Attic due to elevated levels of humidity and moisture on wood substrate.

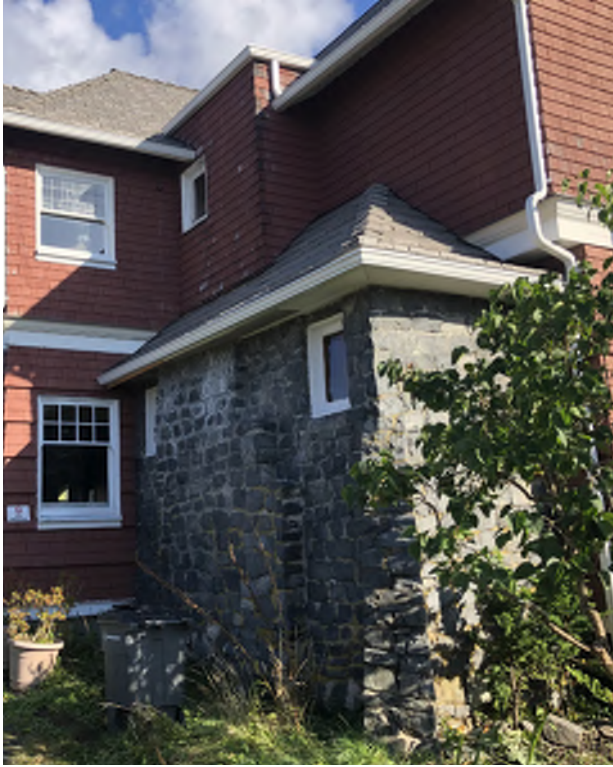
Figure 8.15: Chimney on the west facade above the lower roof was removed.

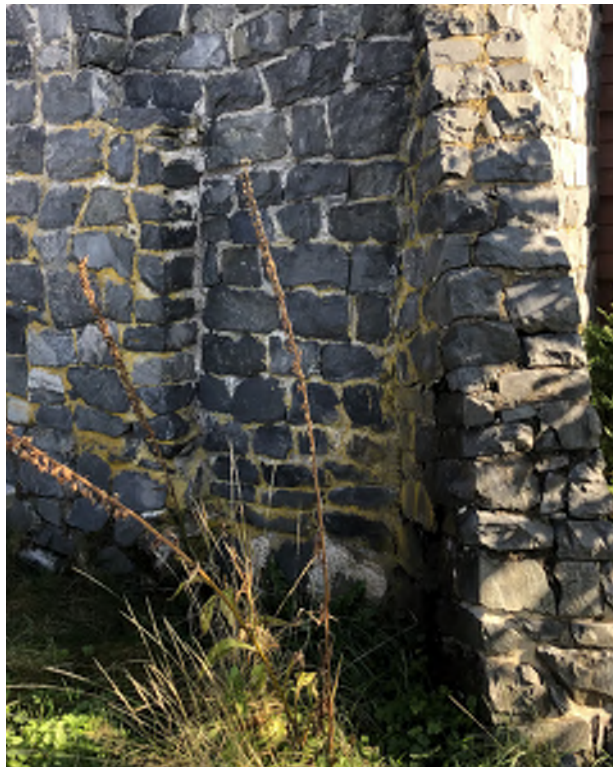
Figure 8.16: Stone masonry buttress is in poor condition and efflorescence and moss growth are visible on masonry.

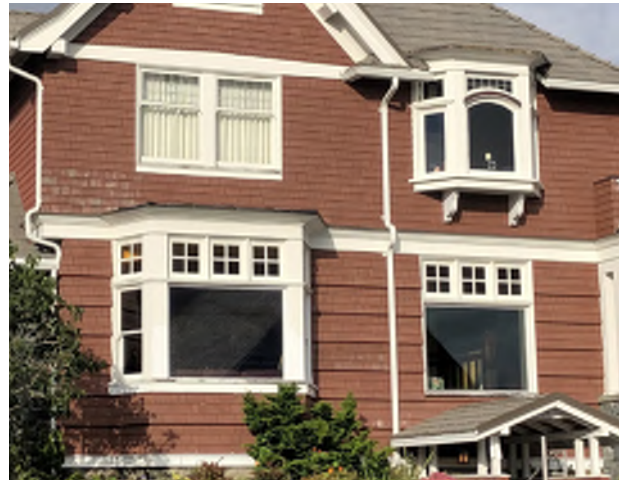
Figure 8.17: Shingle coursing is flared at each third course with the addition of molding trim beneath the shingles.

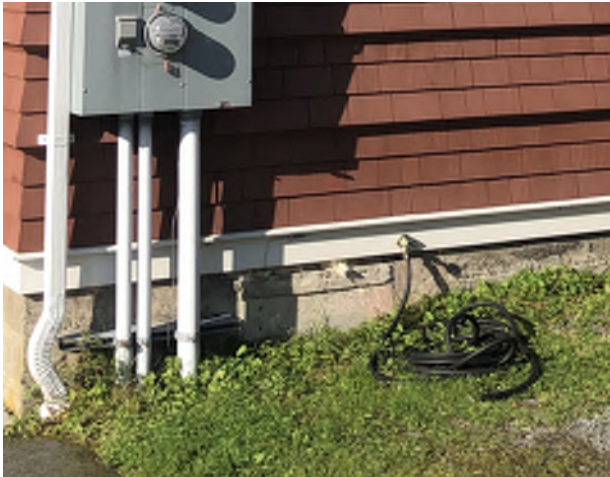
Figure 8.20: Water table on the east facade does not cover the foundation wall, exposing insulation and allowing an ingress path for rodents and pests.

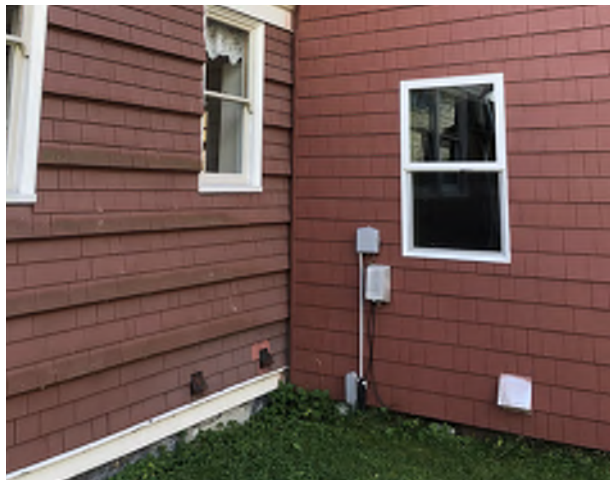
Figure 8.21: Exterior of addition lacks a water table at the base of the shingle siding.

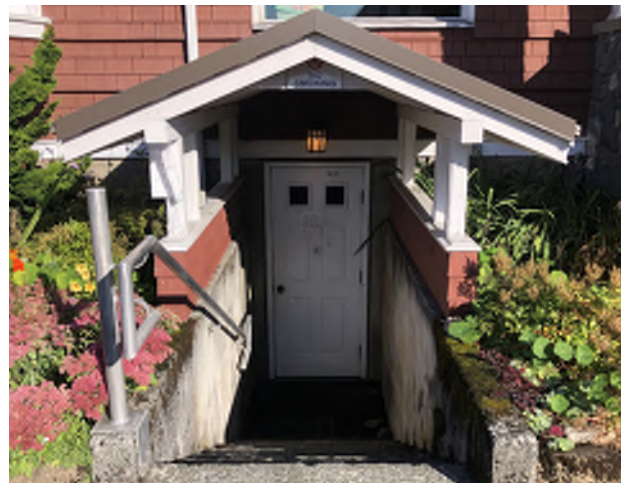
Figure 8.24: Basement entrance (a later addition) cut into concrete foundation walls, accessed from concrete stairs.

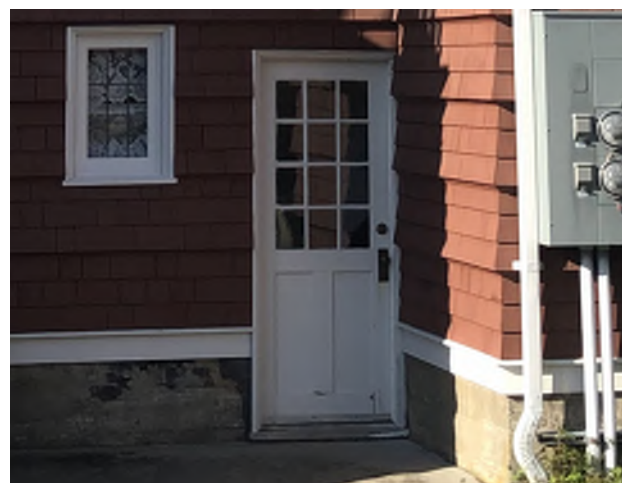
Figure 8.25: East entrance provides access to Kitchen and Basement stairs.

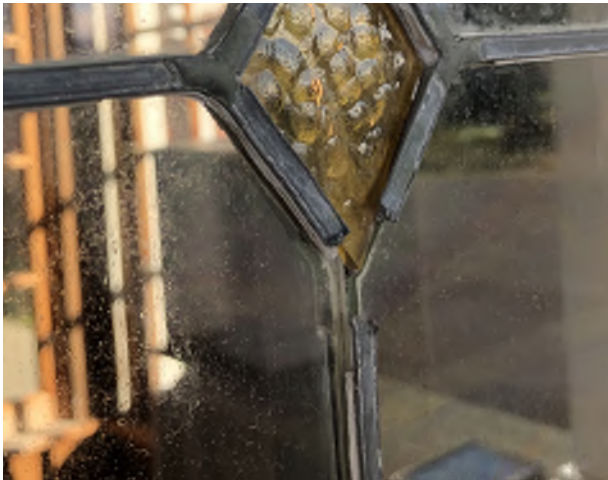
Figure 8.27: Deteriorated lead came at solder joints on the main entrance door leaded glass lite.

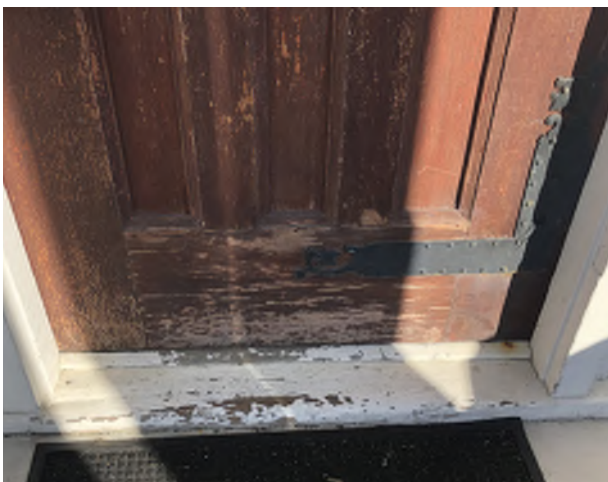
Figure 8.28: Stain finish of main entrance is in poor condition due to general wear and tear and lack of stain maintenance.

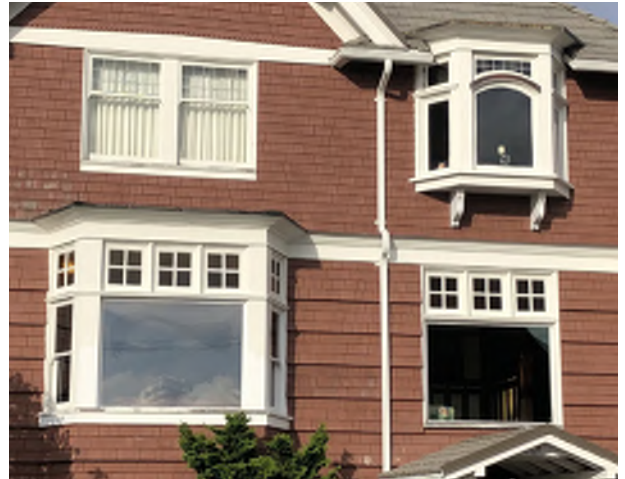
Figure 8.29: Larger first-floor fixed window with upper transom lites at south .

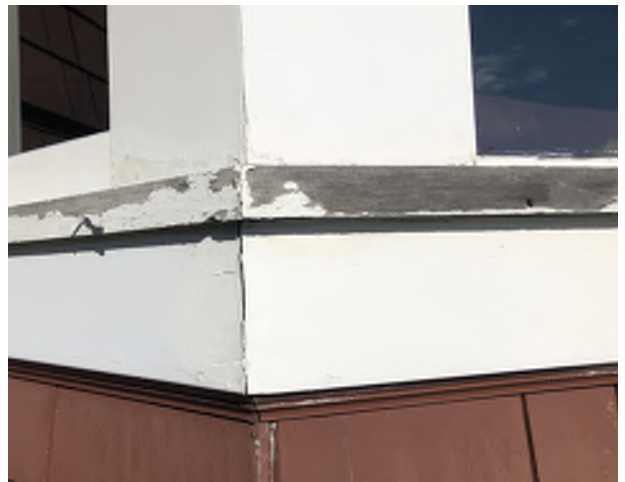
Figure 8.30: Weathered and deteriorated window sill on south bay window.
