Historic Structure Report

Prepared by: FFA Architecture and Interiors, Inc.
architecture + history, llc

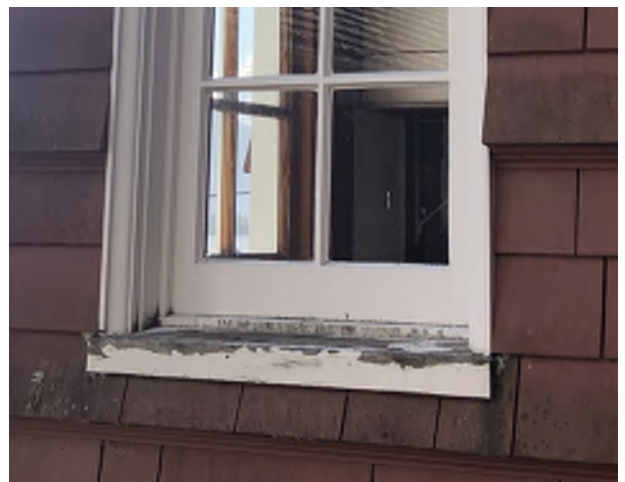
Figure 8.31: Paint failure on east Entry Vestibule window.

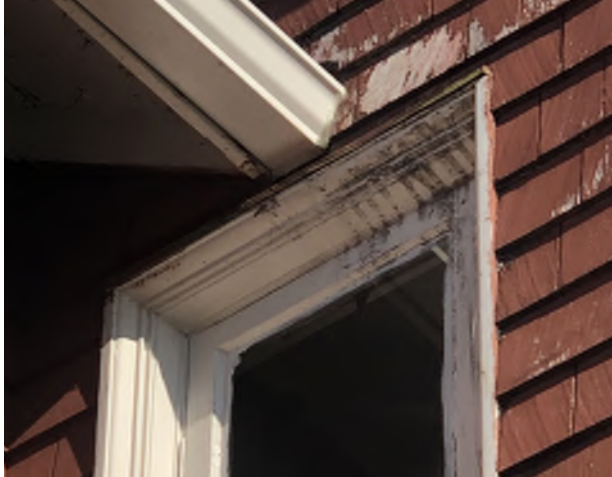
Figure 8.32: Staining on the upper casing and rail, with paint failure visible on the sill at Closet 205 window.

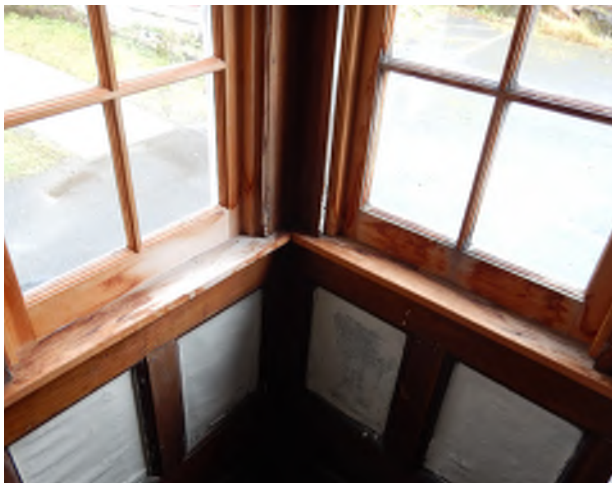
Figure 8.33: Interior moisture damage visible on the interior of sills at southeast Entry Vestibule windows.

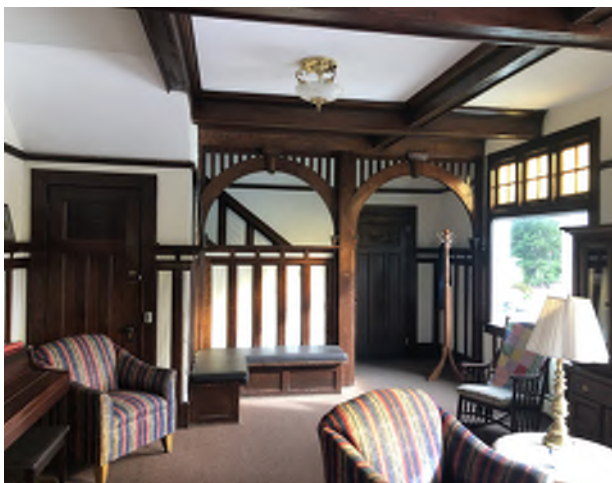
Figure 8.34: Intact plaster wall finish with original wood wainscoting in Living Room.

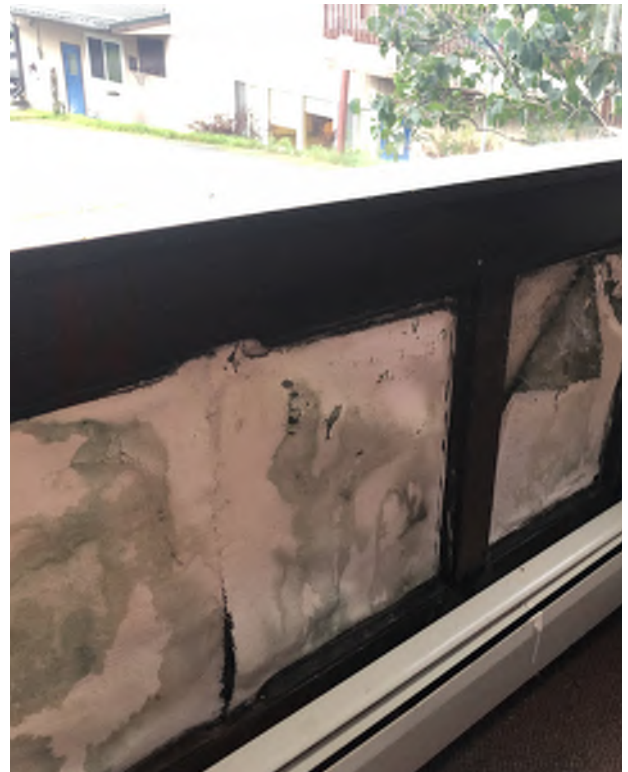
Figure 8.35: Plaster and burlap wall panel coverings in poor condition on the interior wall beneath the bay window in the Living Room.

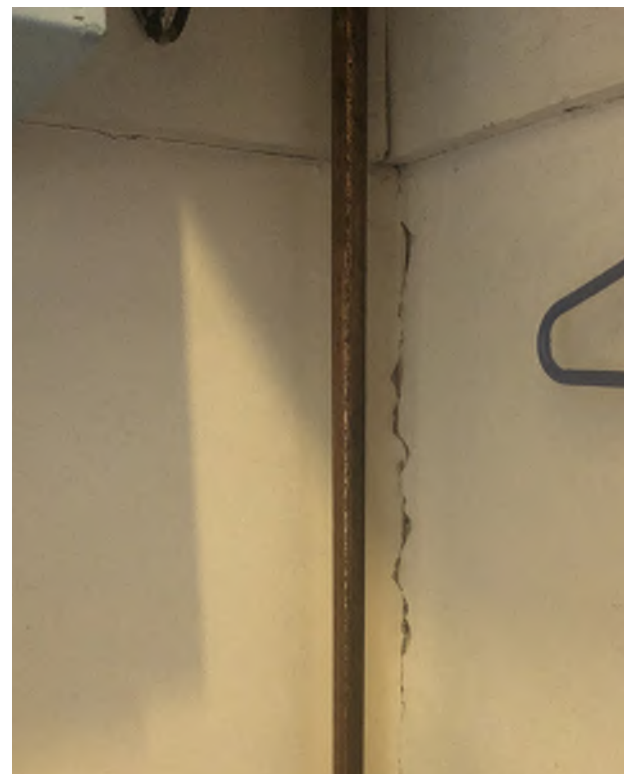
Figure 8.36: Significant crack in plaster wall next to copper pipe in Storage 204.

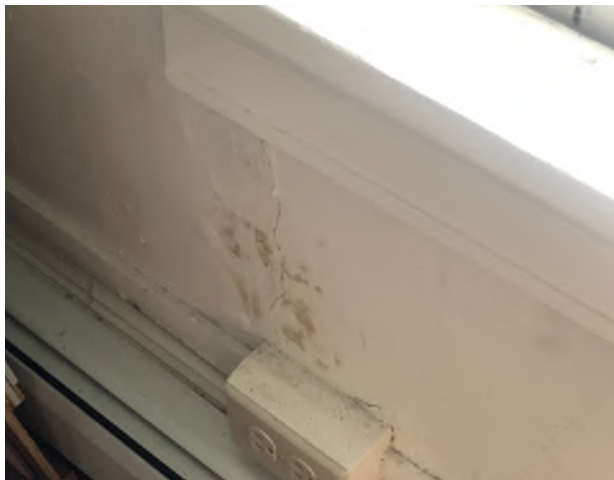
Figure 8.37: Damaged and cracked plaster below south facing window in Office 203 on the second level.

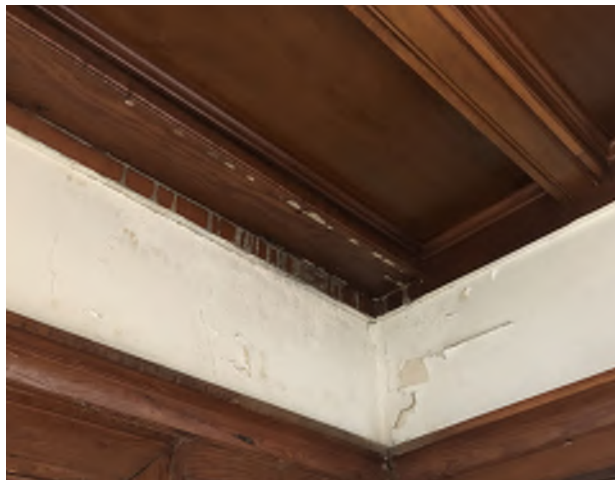
Figure 8.40: Water damage on ceiling and walls in Entry Vestibule.

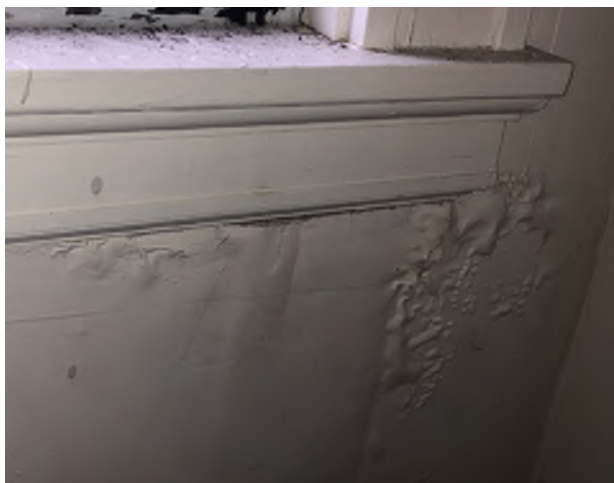
Figure 8.38: Moisture intrusion related to exterior gutters has delaminated and cracked plaster walls below the window sill of Closet 205.

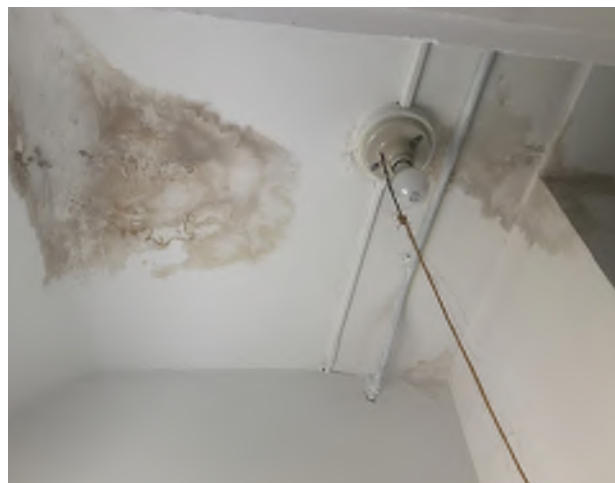
Figure 8.41: Moisture stains on plaster ceiling in Closet 210.

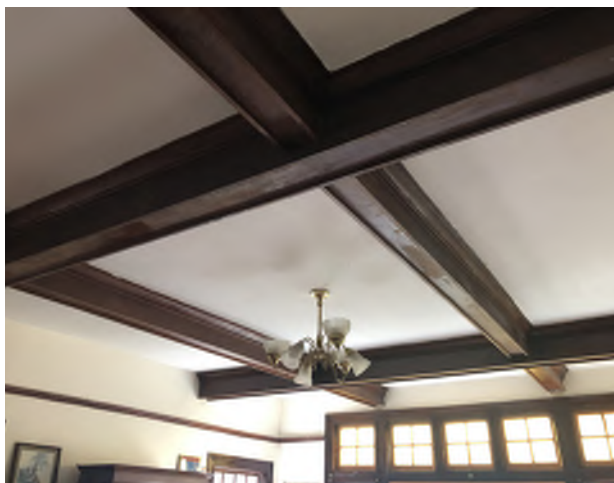
Figure 8.39: Original wood coffered beam and infill panel ceilings in Dining Room.

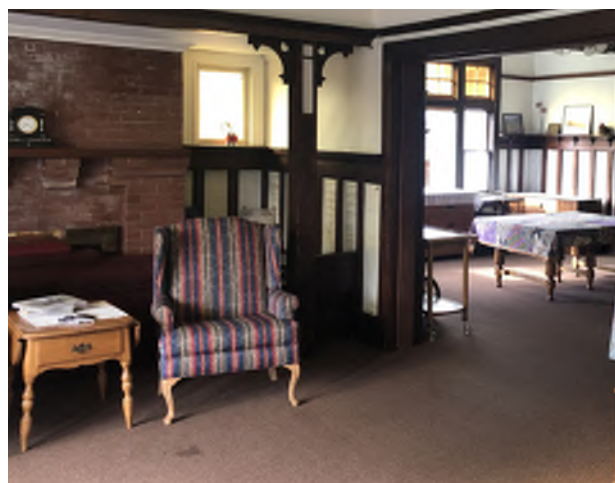
Figure 8.42: Interior floors are typically carpet installed over tongue-and-groove wood flooring.

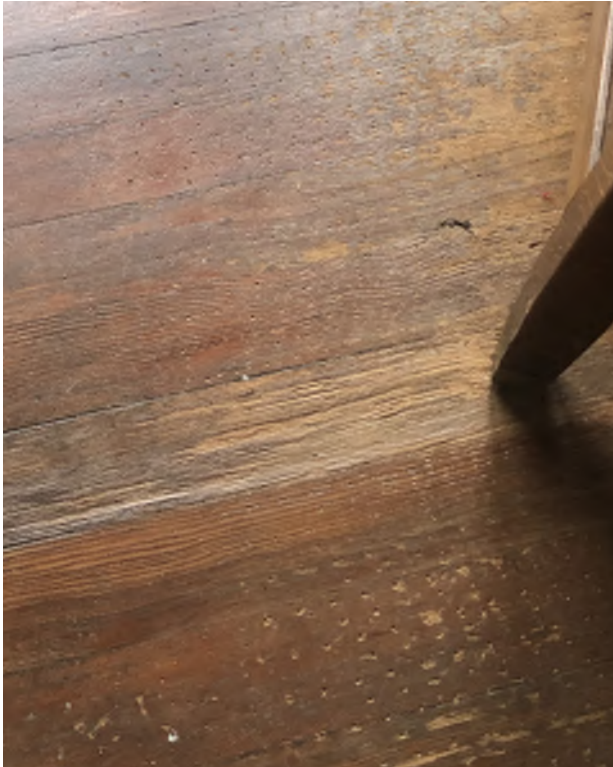
Figure 8.43: Worn and exposed surface of wood flooring in Office 203.

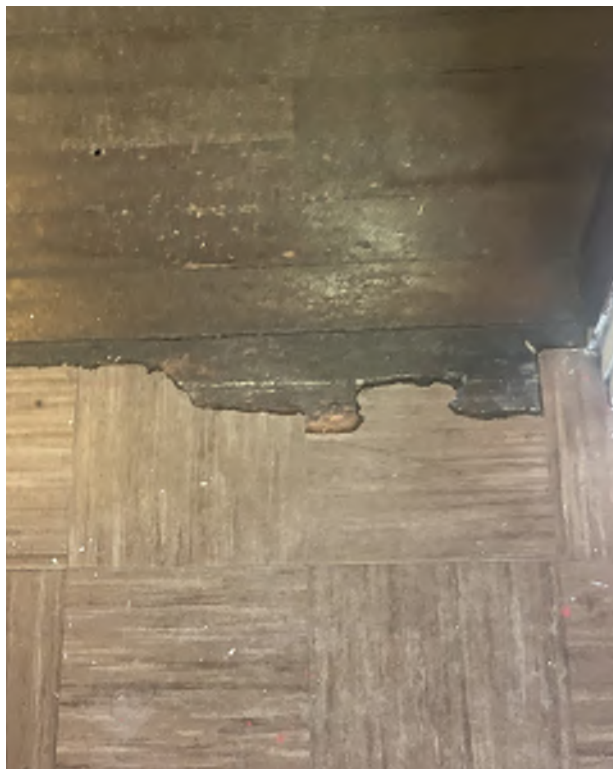
Figure 8.44: Damaged floor tiles at door threshold of Father's Study.

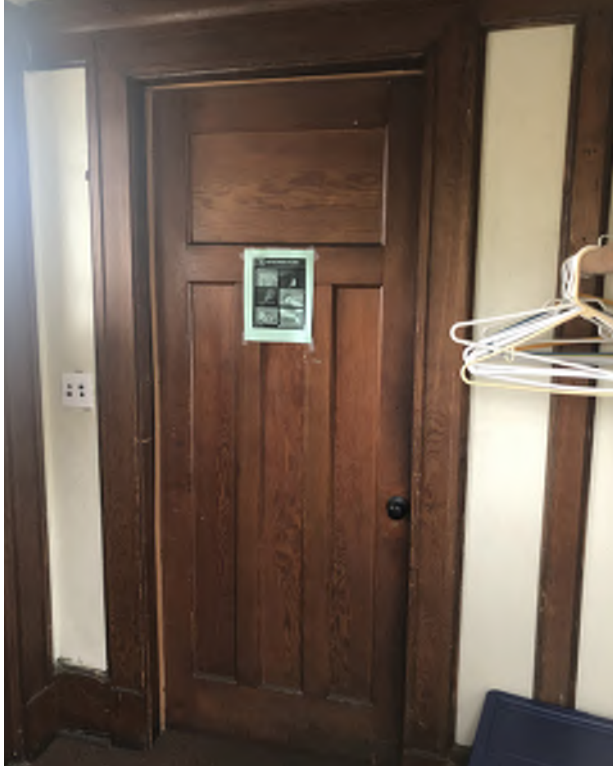
Figure 8.45: Original Vestibule door that leads to the Living Room.

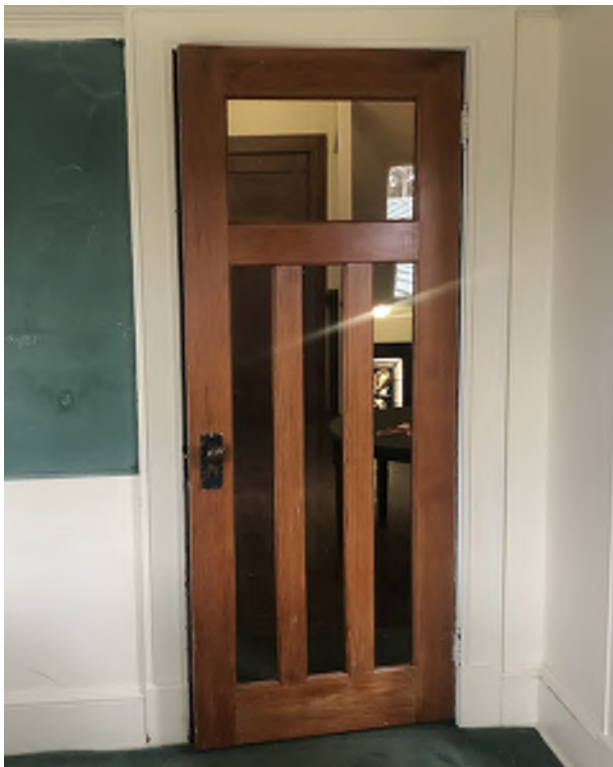
Figure 8.46: Vertical lites have replaced the lower wood panels on a majority of doors on the second floor.

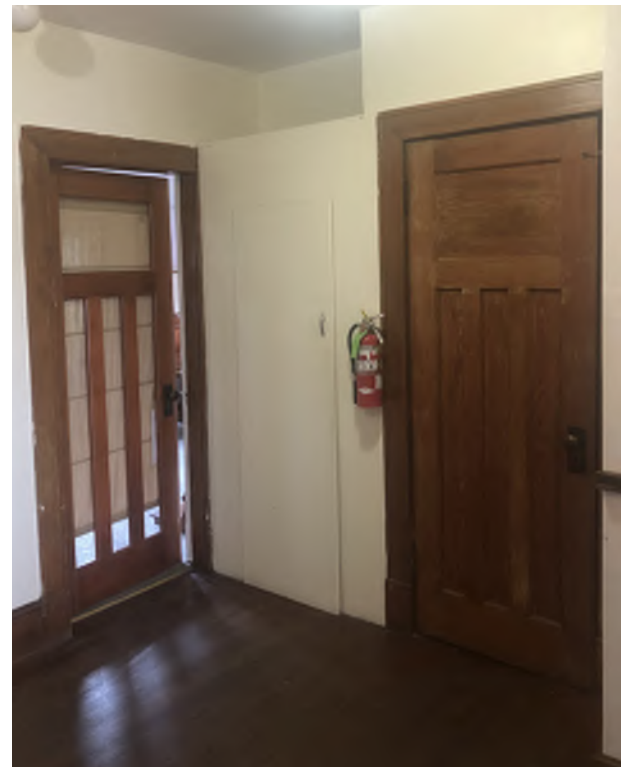
Figure 8.48: Uneven staining and discoloration on Attic door.

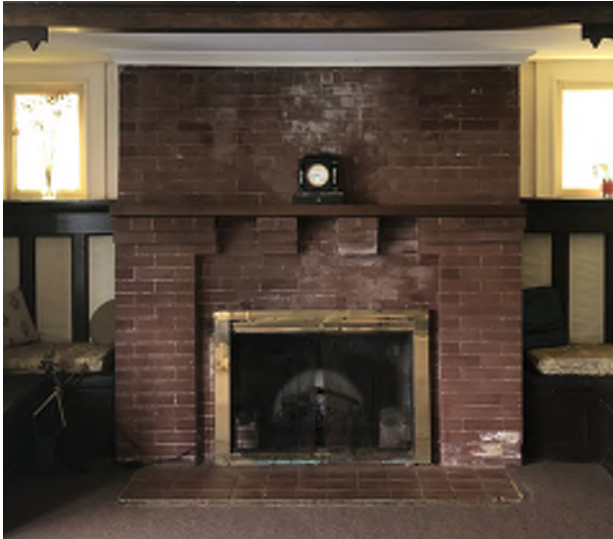
Figure 8.49: The brick fireplace is no longer operable since the removal of the exterior chimney above the roofline.

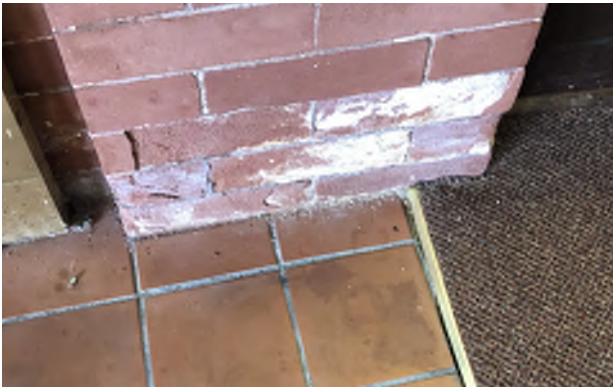
Figure 8.50: Evidence of deterioration and spalling of brick surface, and damaged tile grout.

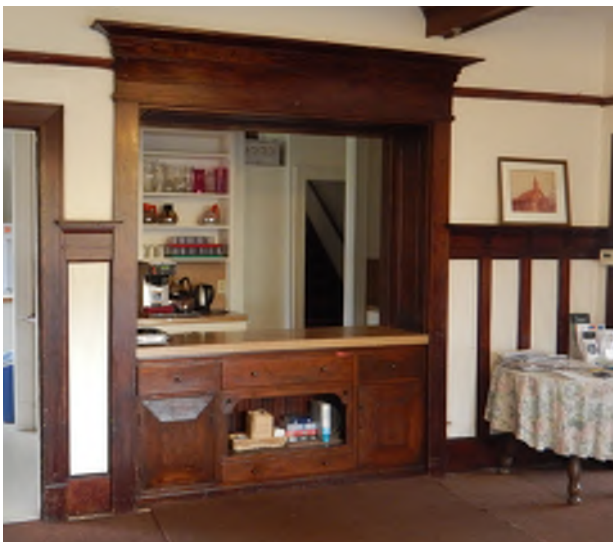
Figure 8.51: The original Dining Room built-in between the Kitchen and Dining Room.

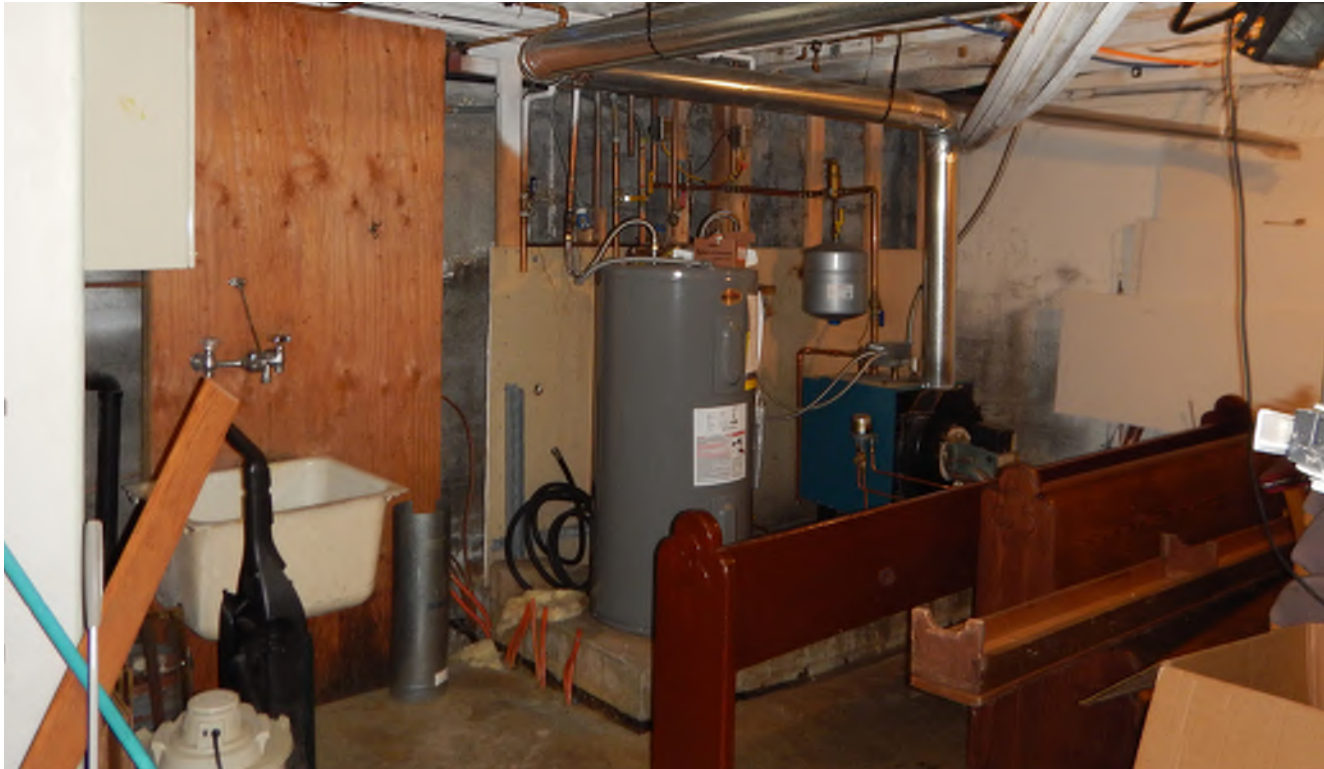
Figure 8.52: Mechanical heating system in the Boiler Room.

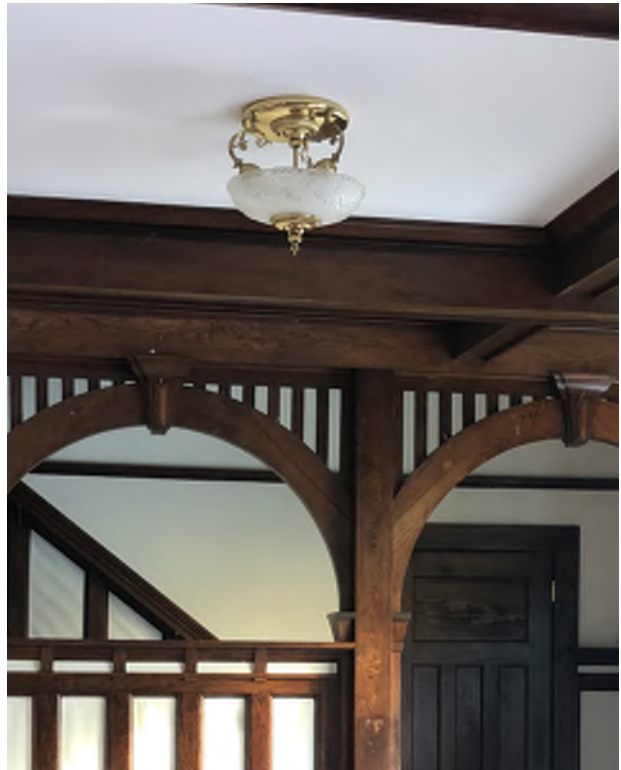
Figure 8.54: Historic lighting has been updated and replaced.

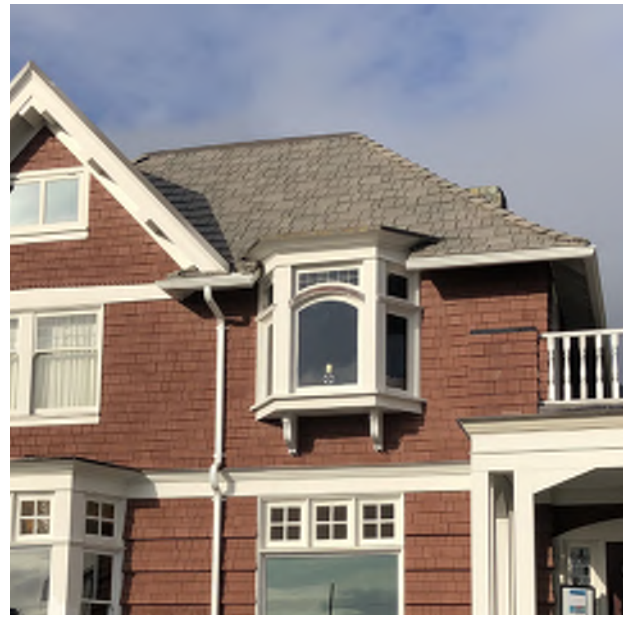
Figure 9.2: Materials are largely intact or replaced in kind, with exception of the synthetic roofing shingles.

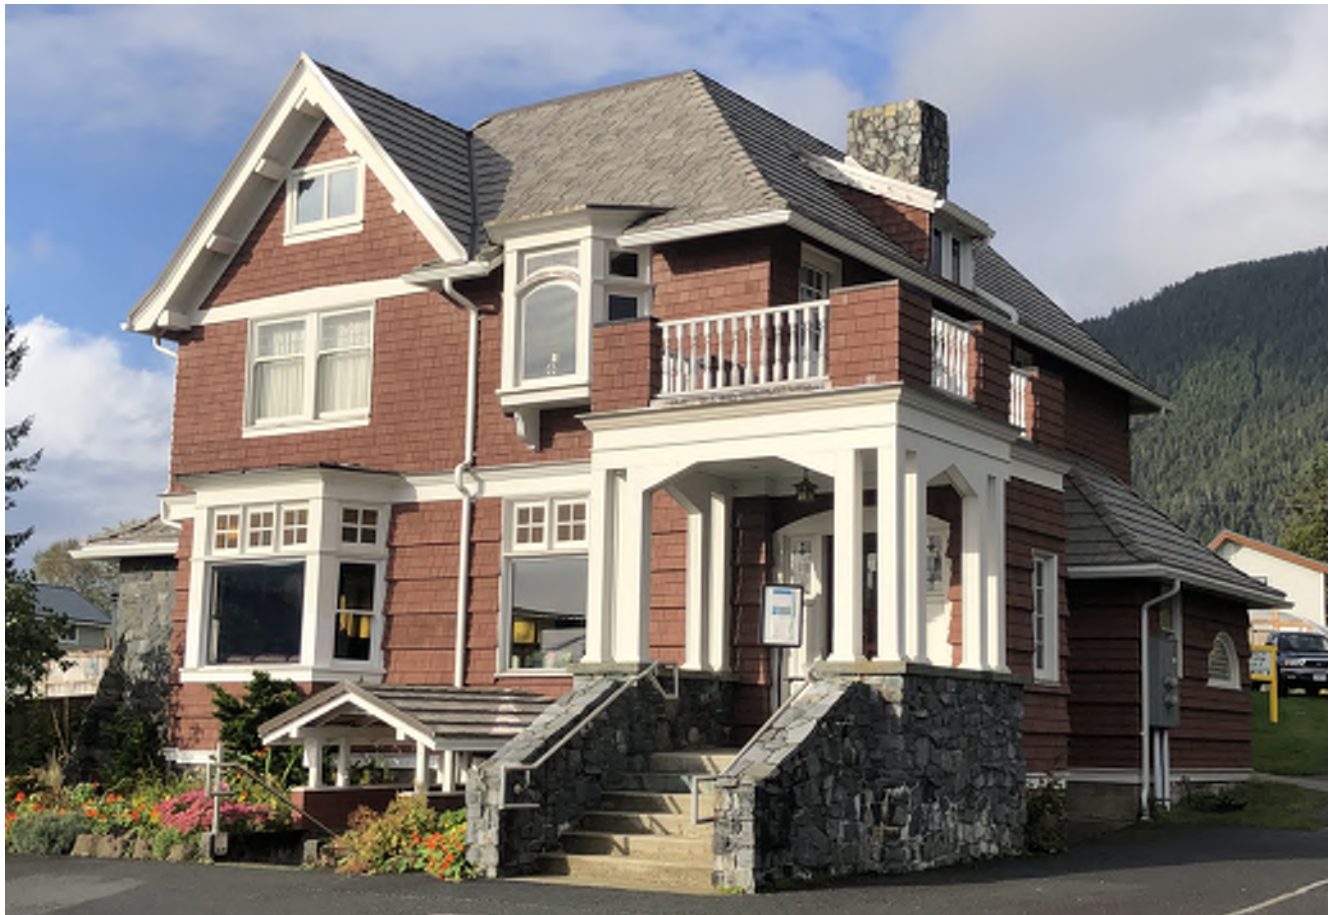
Figure 9.3: The house retains the strong feeling of the Queen Anne and Shingle styles.

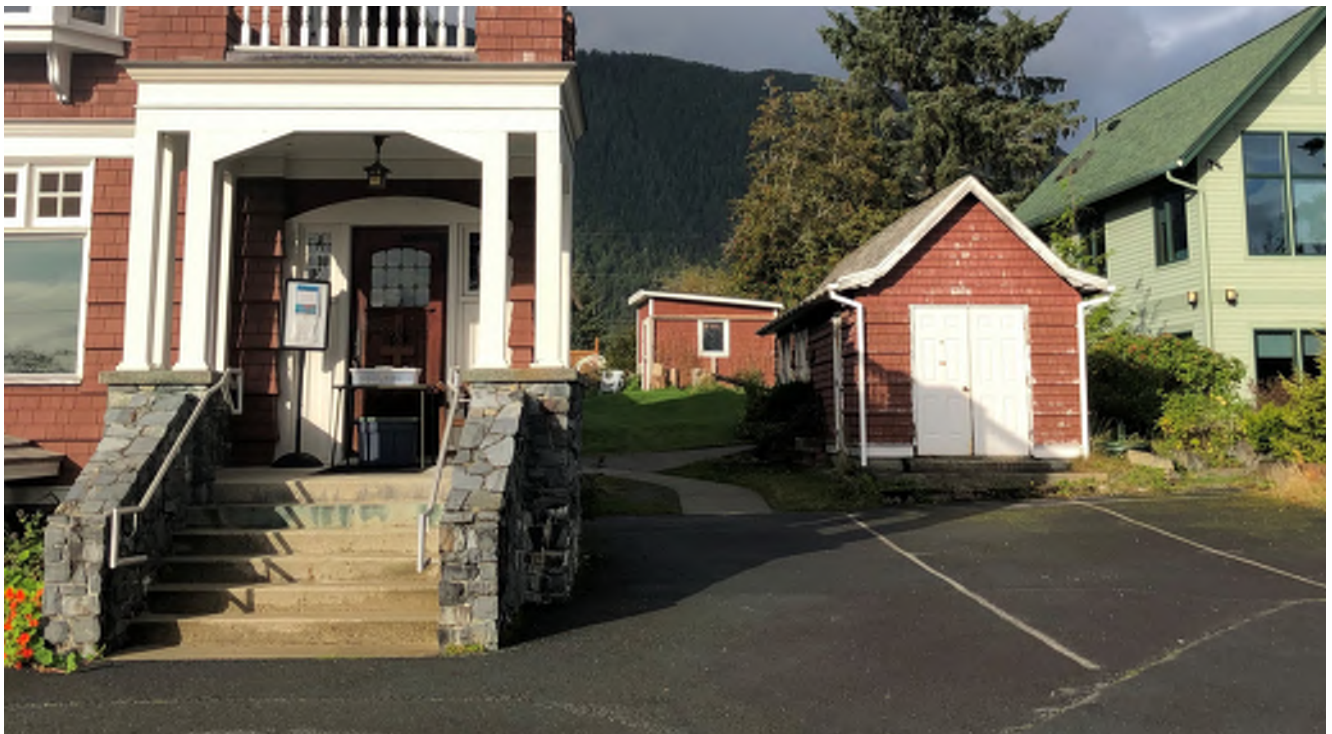
Figure 10.2: Provide a code-compliant accessible parking space including access zone and required signage.

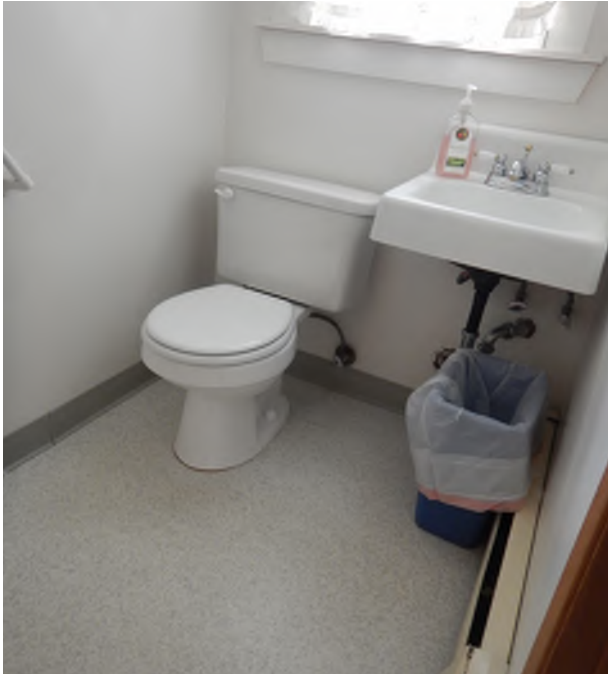
Figure 10.3: Install a code-compliant accessible restroom at Fellowship Hall.

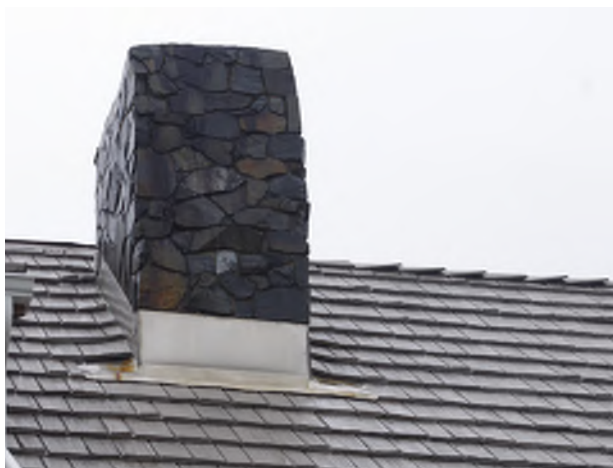
Figure 10.9: Replace synthetic shake roof with cedar shingle material after lifespan has ended.

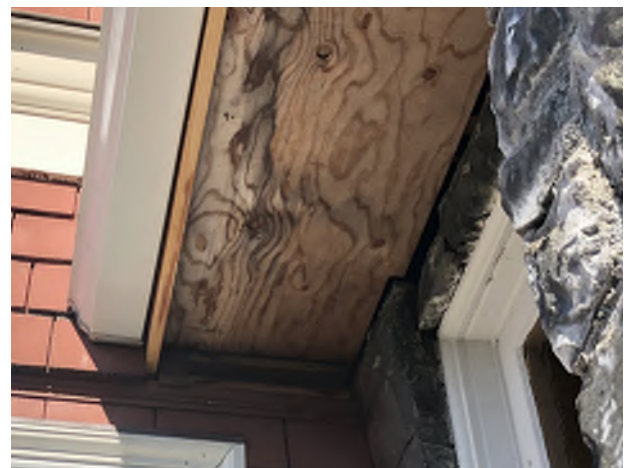
Figure 10.12: Replace plywood with tongue-and-groove beadboard at soffits.

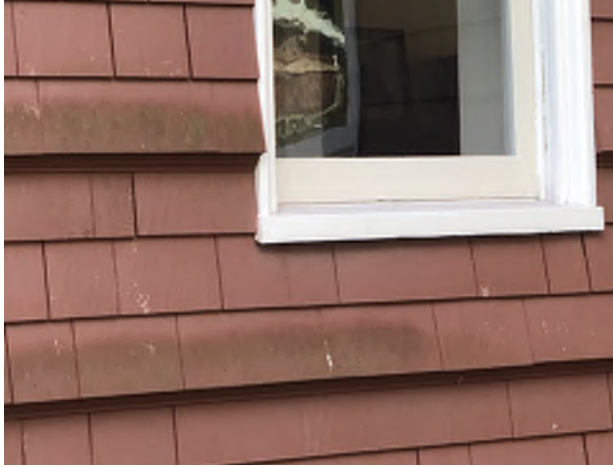
Figure 10.13: Remove biological growth and soiling from shingle surfaces.

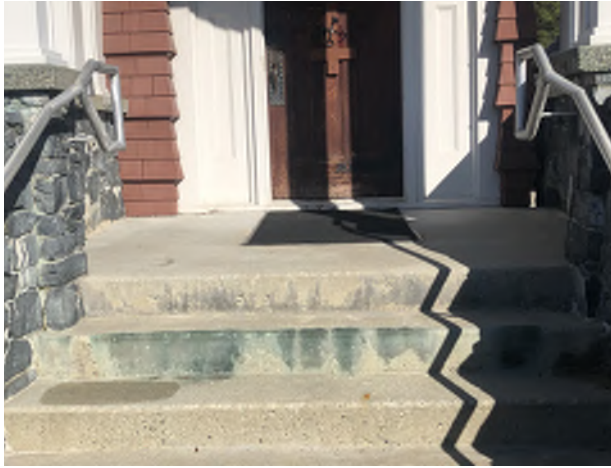
Figure 10.14: Green staining from oxidization and runoff of copper flashing above entry stairs.

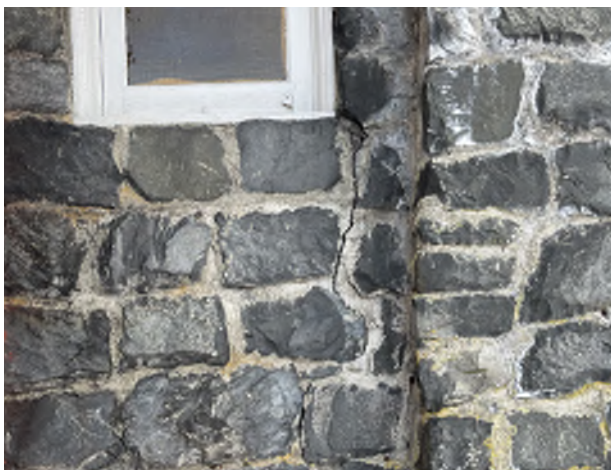
Figure 10.15: Repair vertical mortar joint crack at north side of chimney. Photo credit: Troy Feller

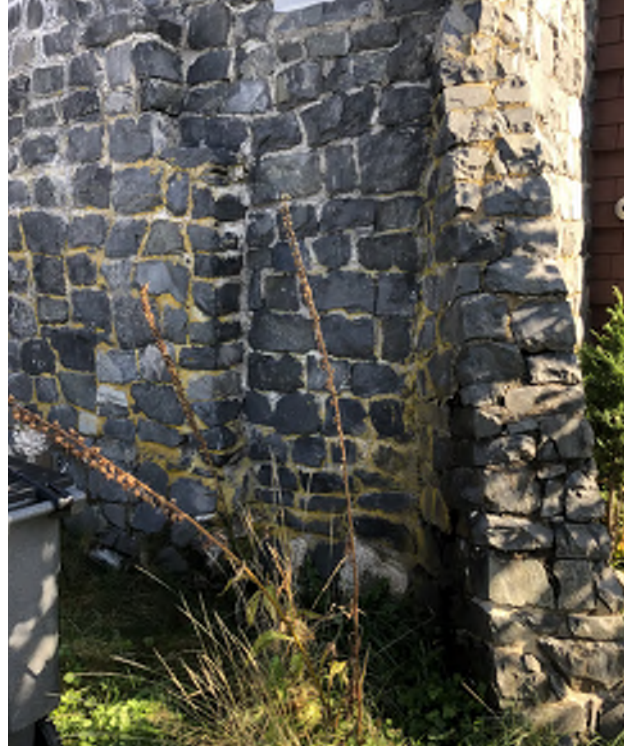
Figure 10.16: Remove biological growth from masonry walls.

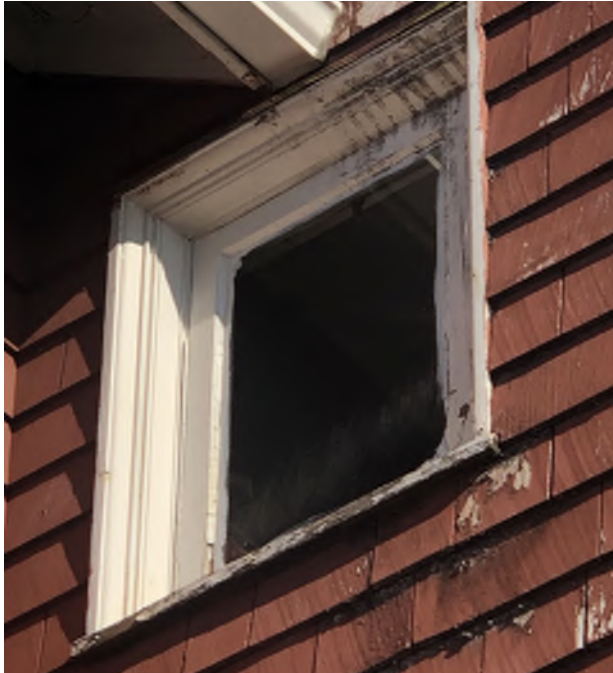
Figure 10.18: Inspect exterior and interior of Closet 205 window for wood decay and deterioration.

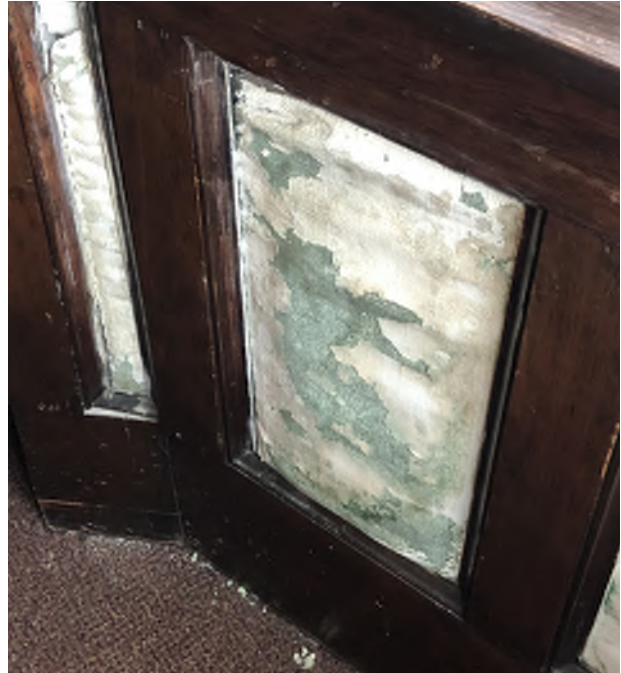
Figure 10.20: Restore damaged plaster and/or burlap wall finishes.

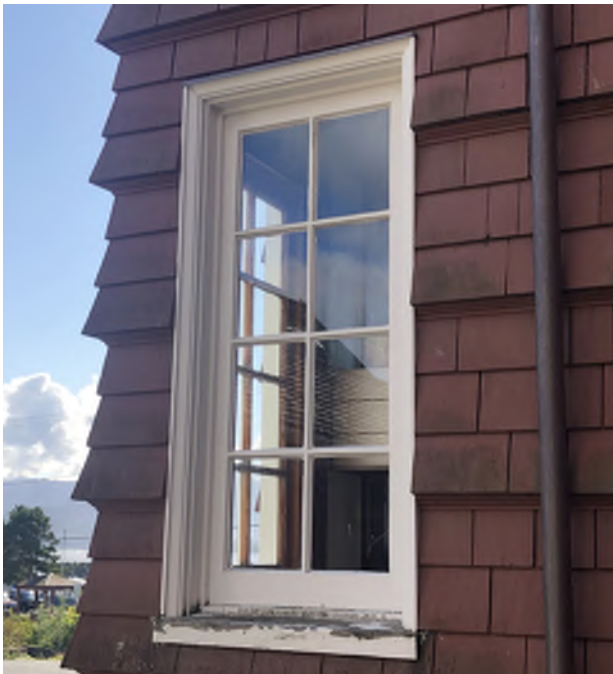
Figure 10.19: Remove failing paint from deteriorated wood sills and repaint to protect wood.

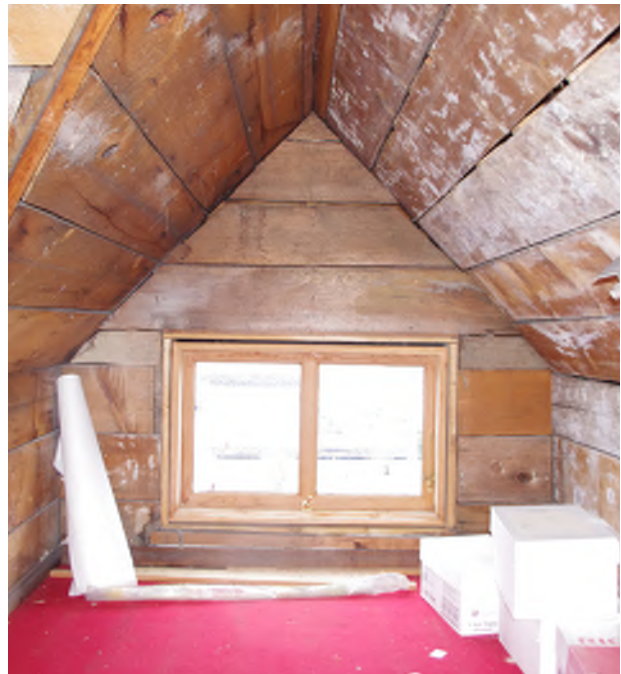
Figure 10.21: Remove mildew from all wood surfaces in Attic. Photo credit: Grant Crosby

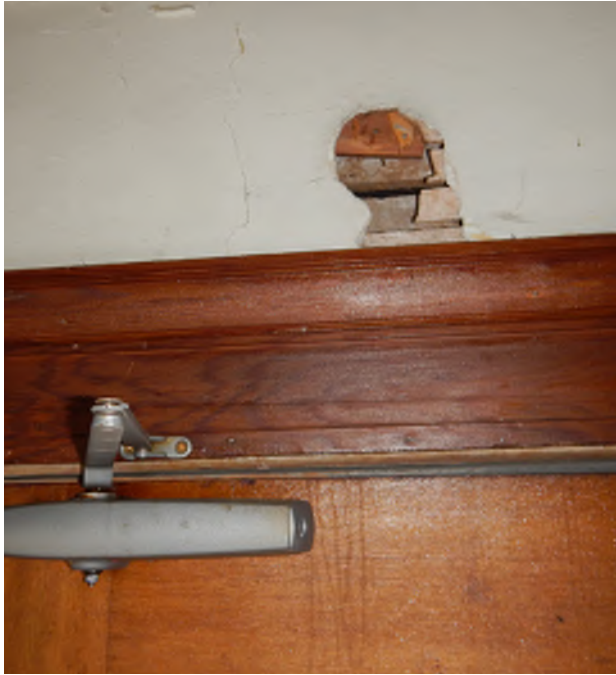
Figure 10.22: Restore deteriorated plaster wall finishes on first and second floors.

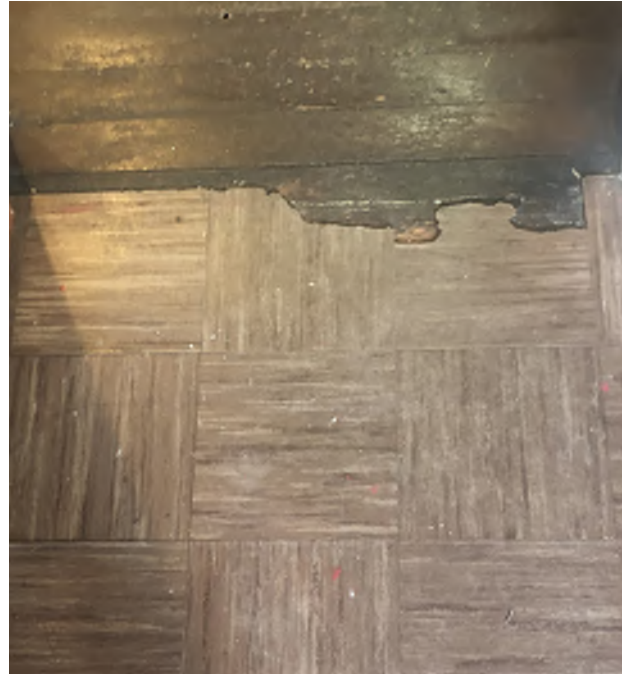
Figure 10.24: Contact certified inspector to have tile flooring in Father's Study tested for asbestos.

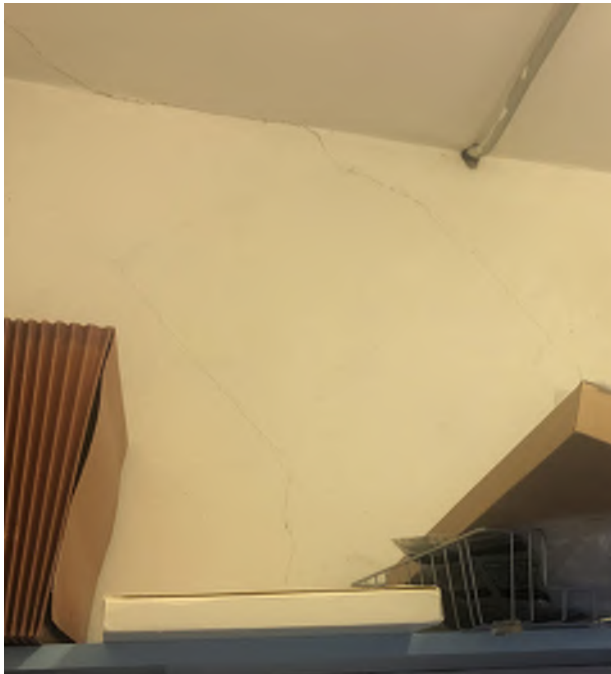
Figure 10.23: Repair hairline cracks and repaint ceiling finishes in storage closets on second floor.

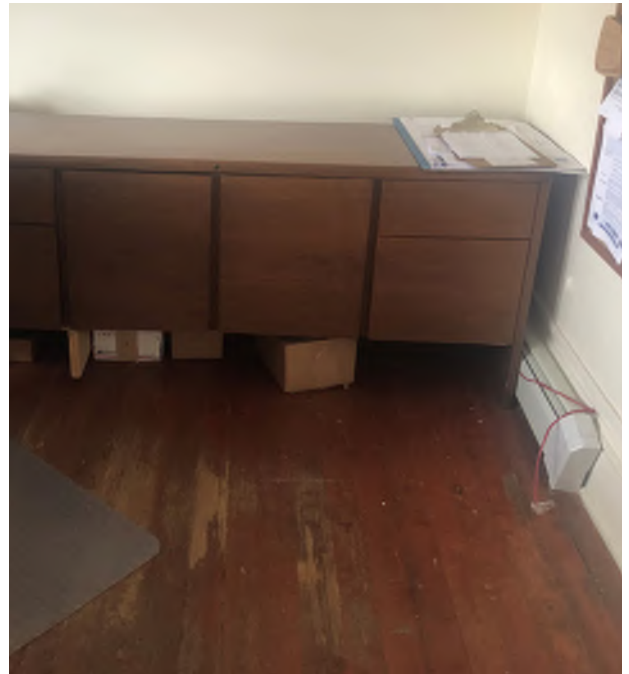
Figure 10.25: Restore existing original wood floors on second floor.

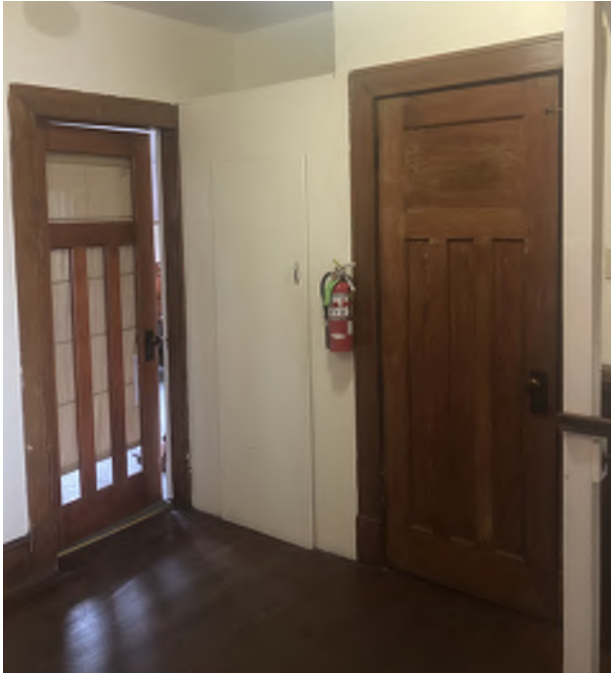
Figure 10.26: Restore original interior doors on first and second floors.

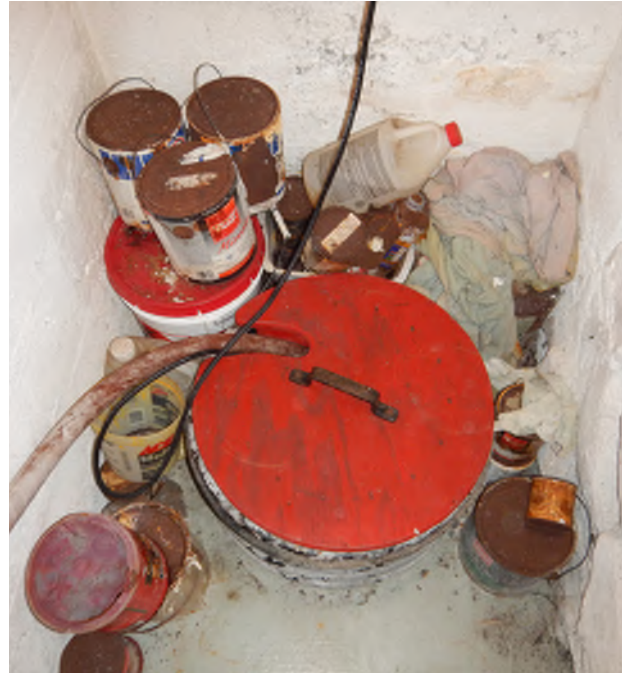
Figure 10.28: Remove hazardous materials stored in basement or install fire lockers for safe containment.

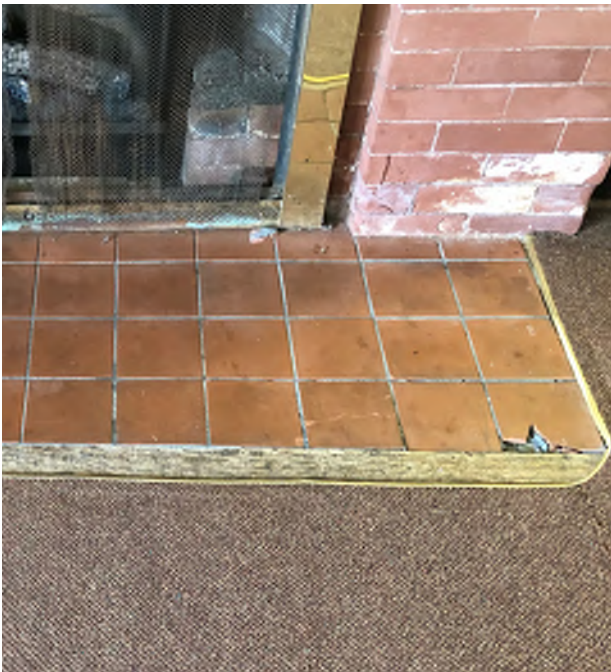
Figure 10.27: Remove existing non-original tiles that are in poor condition from the fireplace hearth.

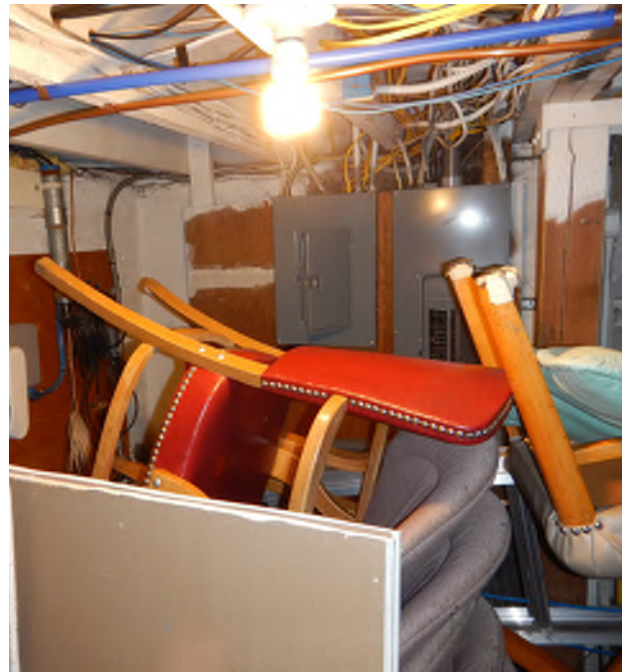
Figure 10.29: Remove material stored in Boiler Room to provide a clear pathway and code required access to mechanical equipment and electrical panels.

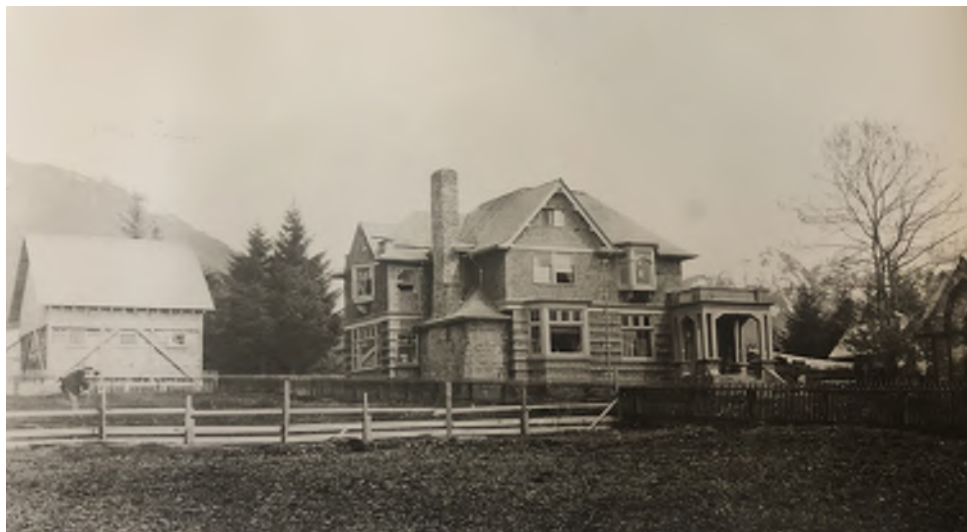
An early view of the See House. This may be the earliest view dated c.1905-1910. Note that the shingle siding does not appear to be weathered or stained. Source: St. Peter's by-the-Sea Archives.

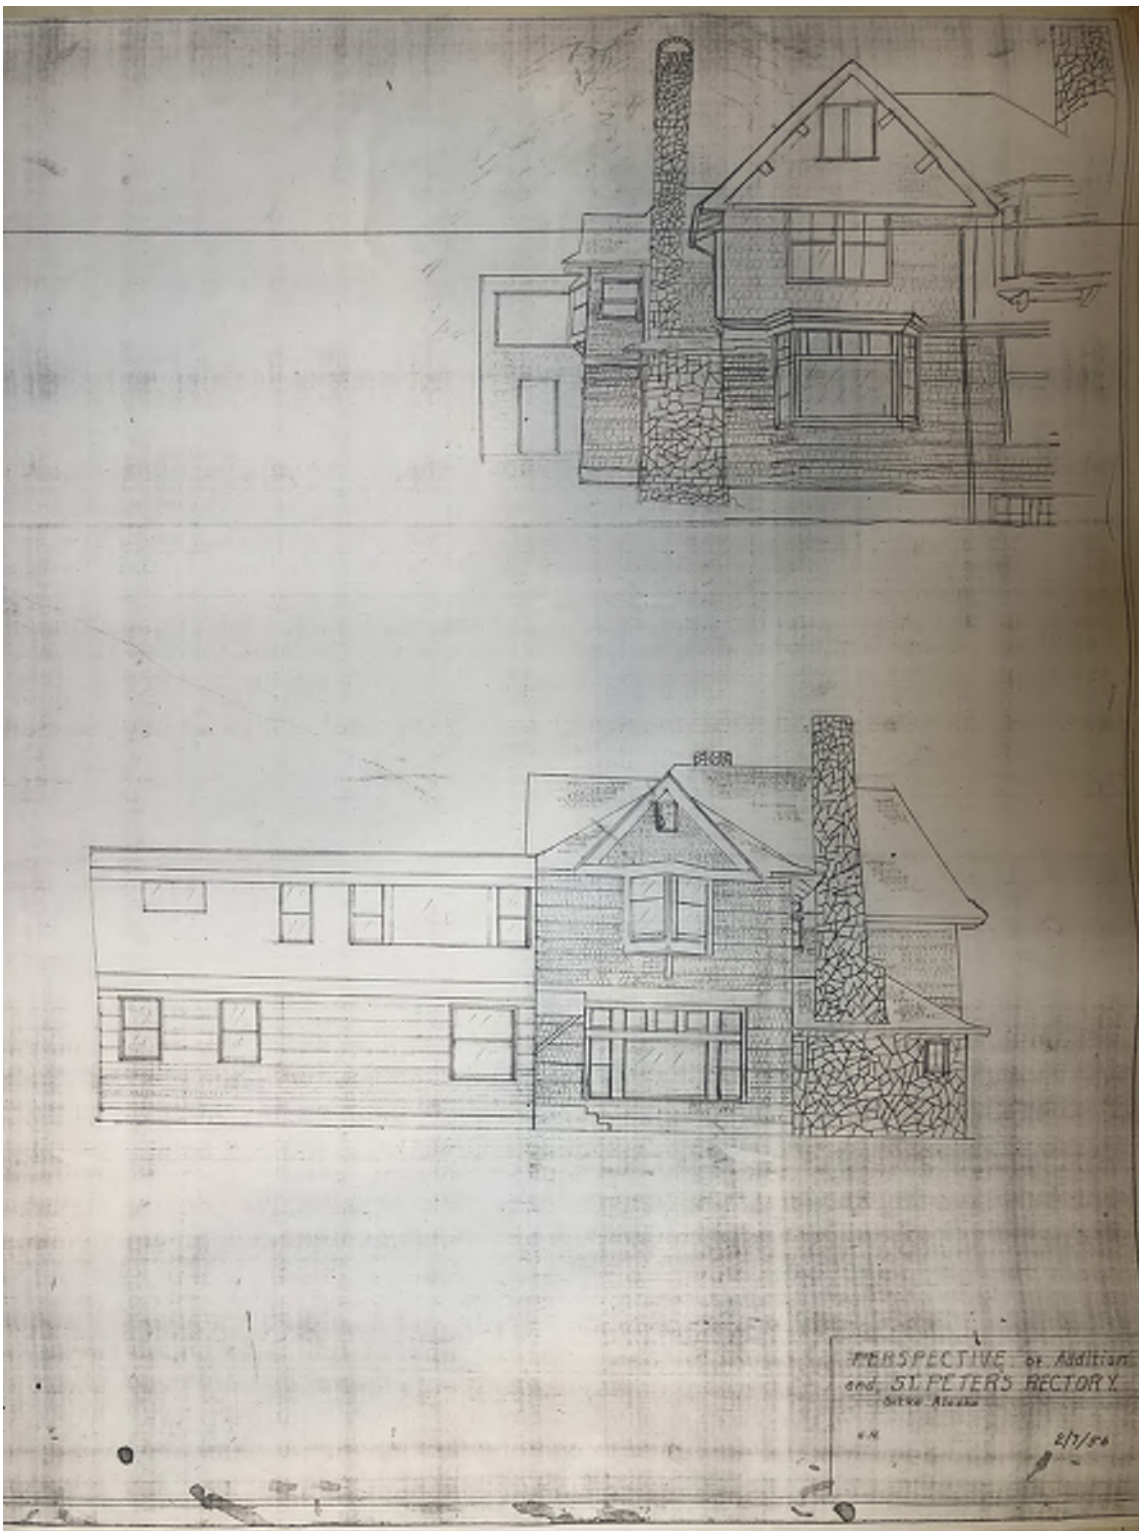
Drawing sheet by George Nelson for the 1956 addition to the See House illustrating the west and south elevations, including the entry to the upstairs apartment Source: St. Peter's by-the-Sea Archives.
