St. Peter's by-the-Sea Episcopal Church Historic Structure Report

Prepared by: FFA Architecture and Interiors, Inc.

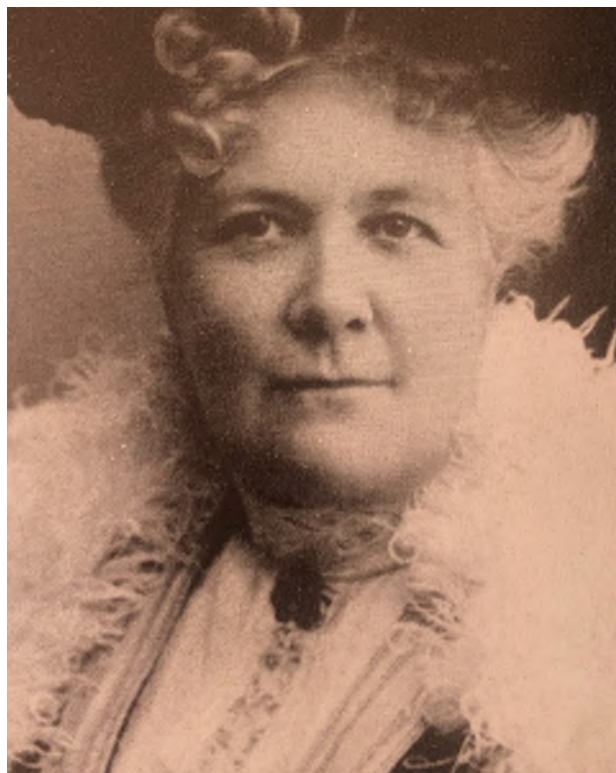
Figure 4.3: Dora Henriette Carry Rowe. Source: *Man of Alaska*.

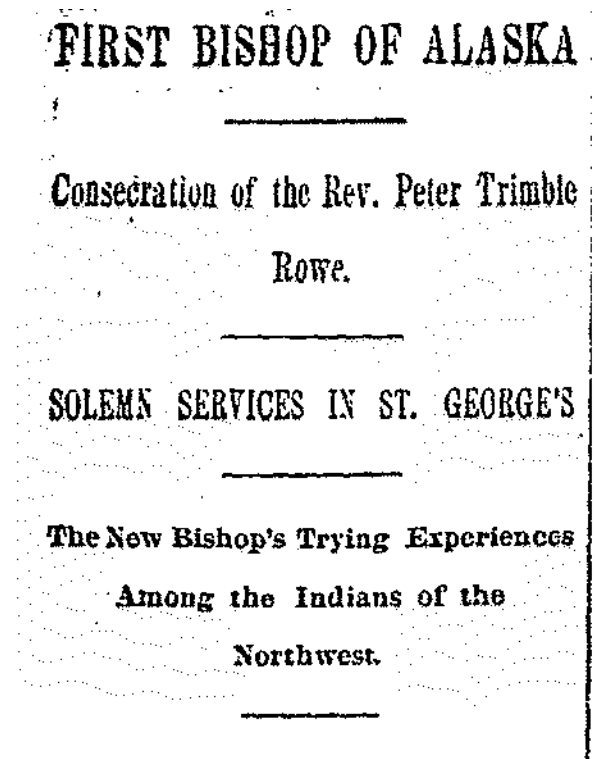
Figure 4.4: *New York Times* article 1895.

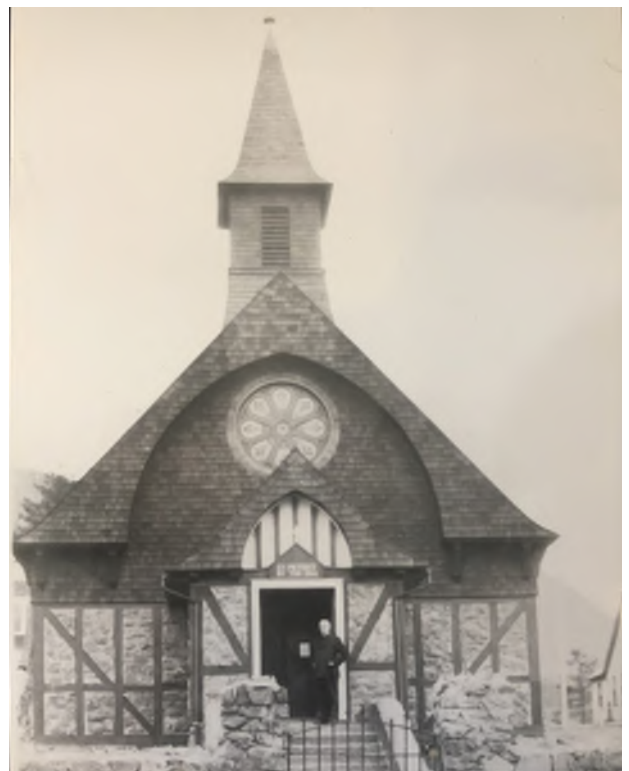
Figure 4.5: Bishop Rowe pictured on the steps of St. Peter's, date unknown, but after the bell tower had been enclosed.

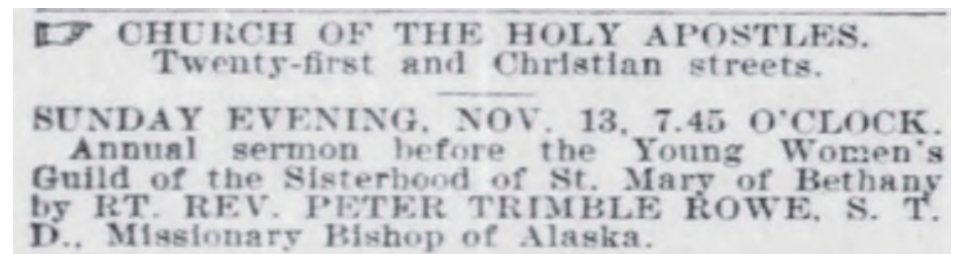
Figure 4.11: *The Philadelphia Inquirer* November 12, 1898. Source: *Philadelphia Inquirer* indexed in Newspapers.com.

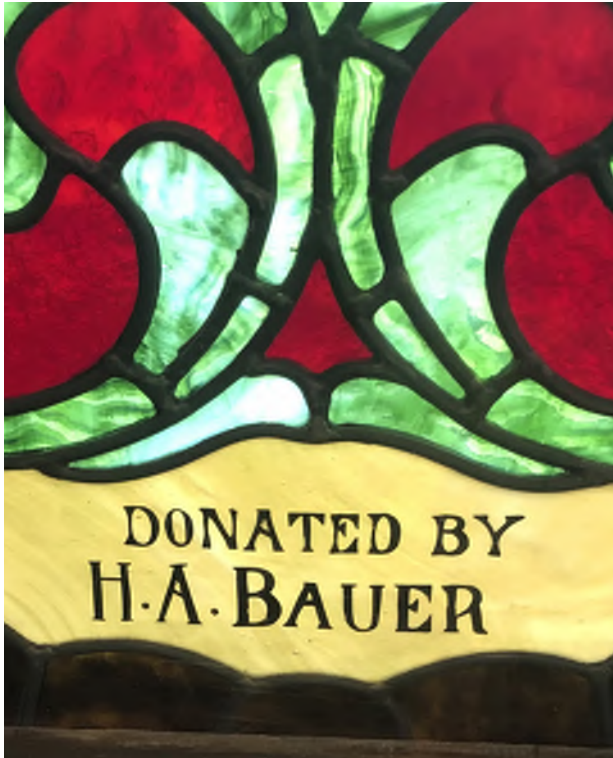
Figure 4.12: A current detail photograph of the stained glass window with inscription "Donated by H. A. Bauer."

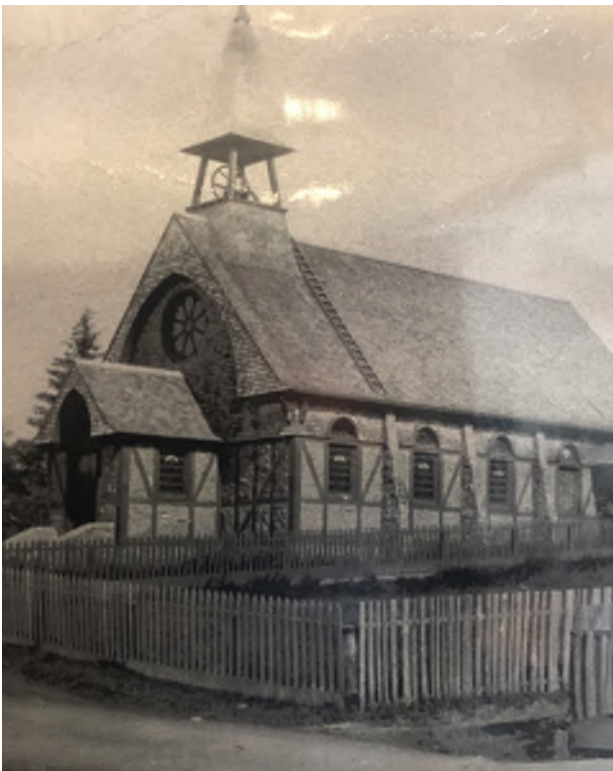
Figure 4.13: An early view of St. Peter's, but after the 1905 construction of the See House. Source: St. Peter's by-the-Sea Archives.

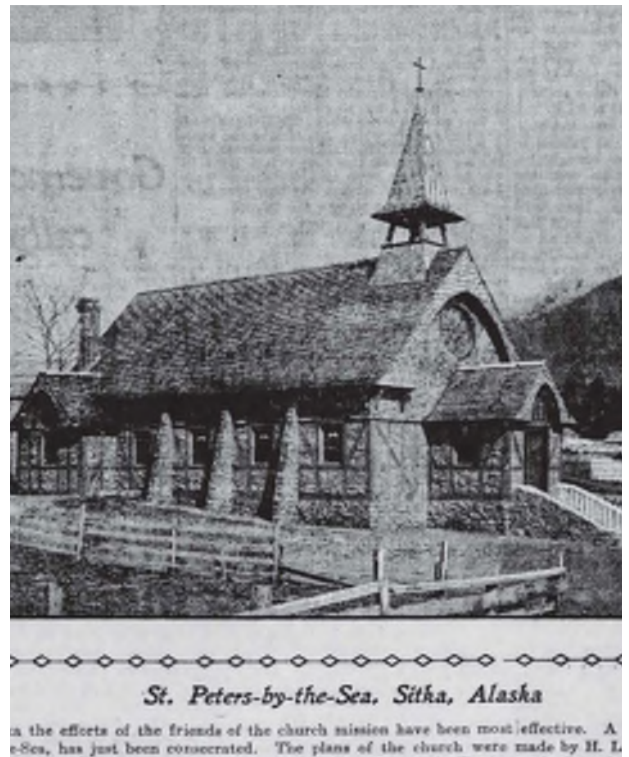
Figure 4.14: From the *Philadelphia Enquirer* August 5, 1900. Source: Newspapers.com.

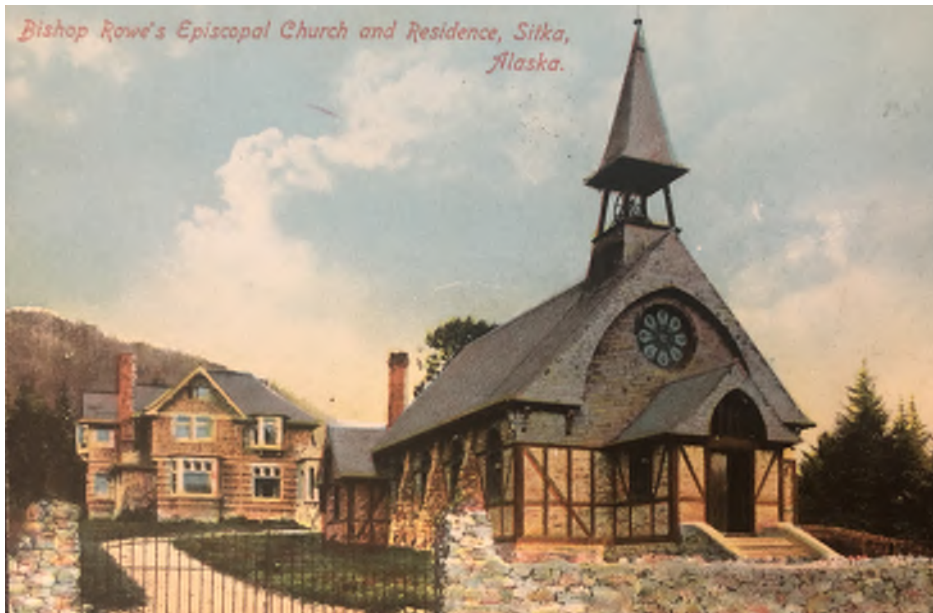
Figure 4.18: An colorized postcard view of St. Peter's. Source: St. Peter's by-the-Sea Archives.

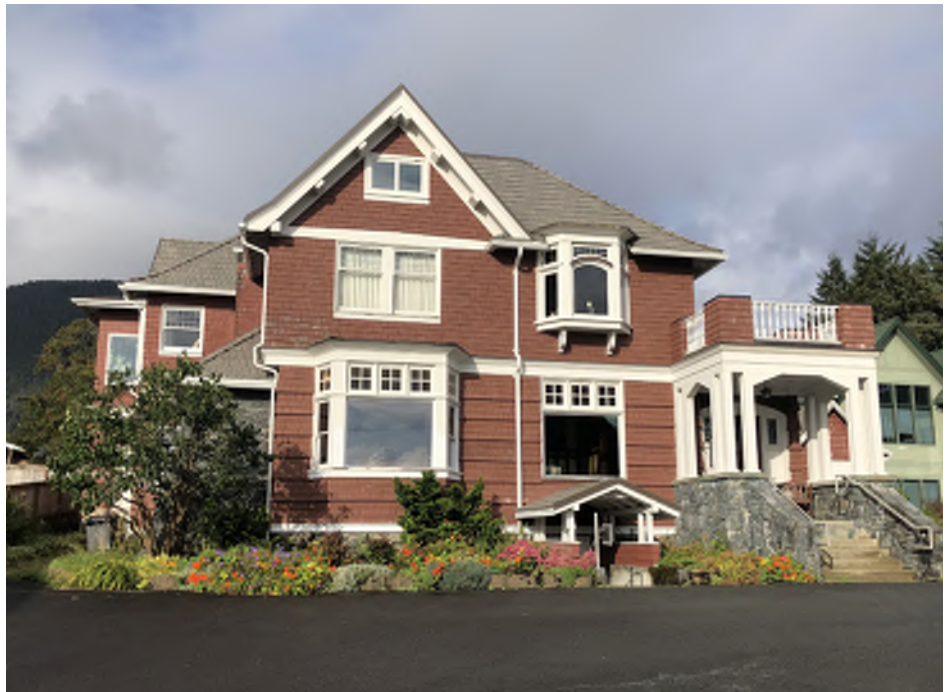
Figure 5.6: Paved parking area and drive that separates the church and See House, looking north.

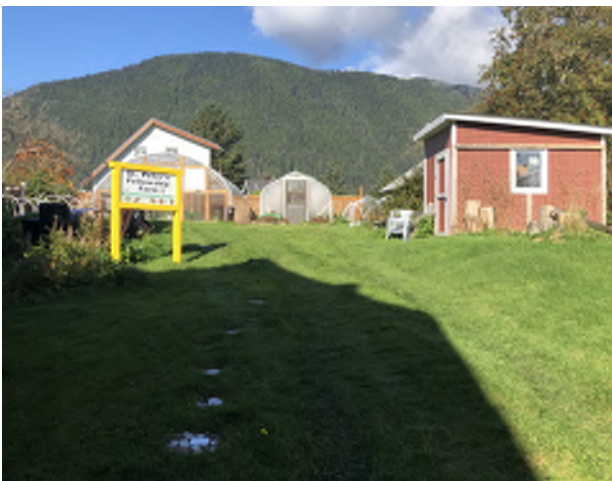
Figure 5.9: Church garden at the north end of the parcel behind the See House, looking north.

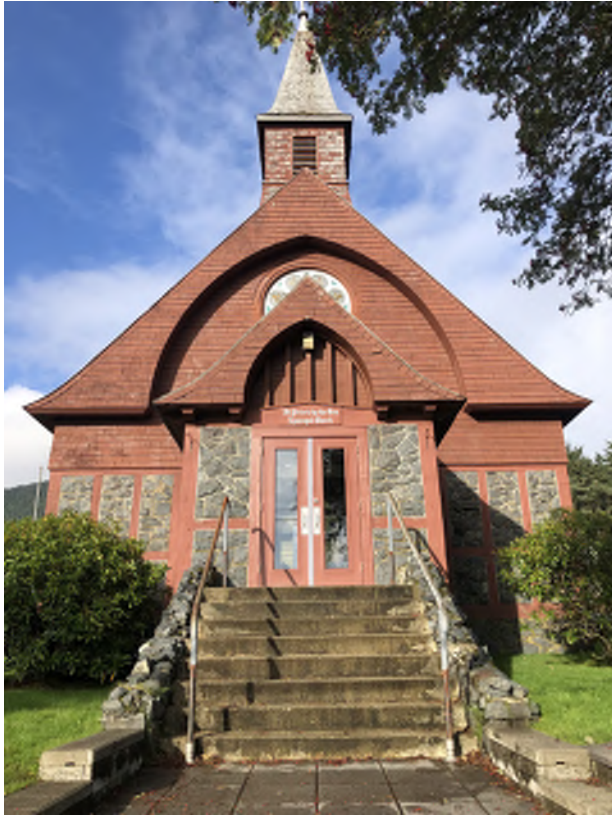
Figure 5.10: St. Peter's is an amalgam of the Shingle, Tudor Revival and Gothic Revival styles, south (front) facade of church.

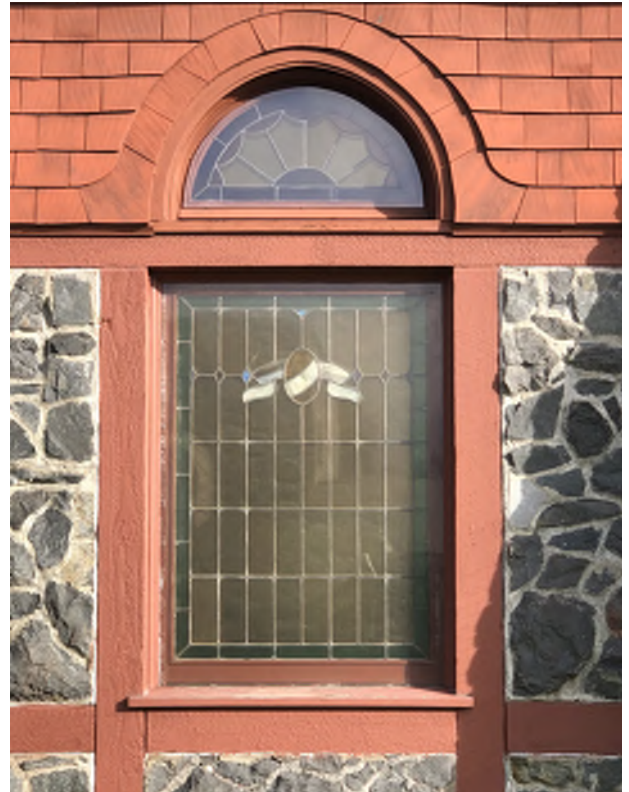
Figure 5.17: Typical windows are wood frame with leaded stained glass of a simple design.

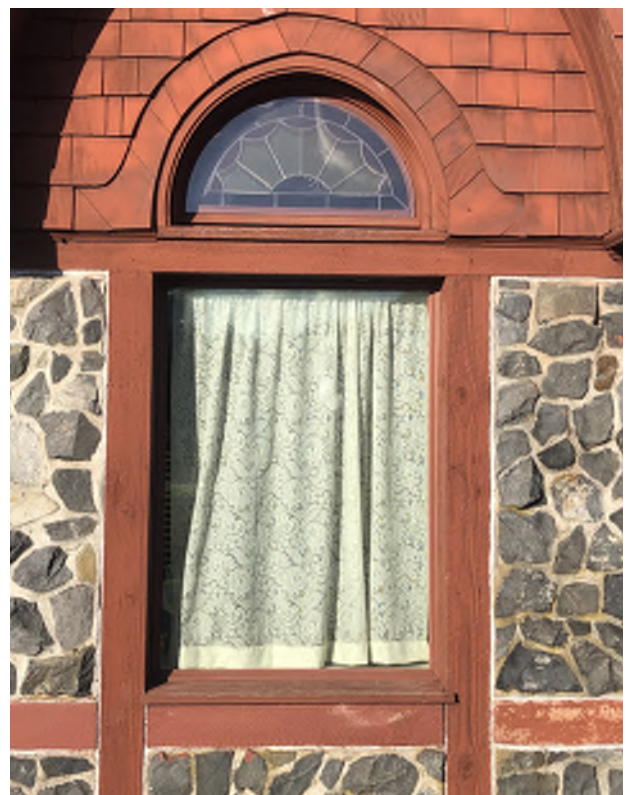
Figure 5.18: The east transept window at the sacristy has been replaced with clear glass.

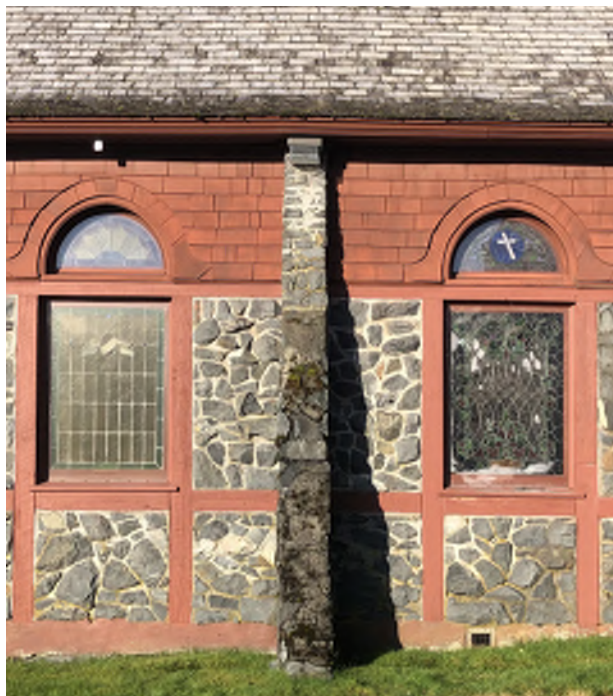
Figure 5.19: Two northern-most windows on the east and west facades contain more decorative stained glass, with the same configuration as the typical window.

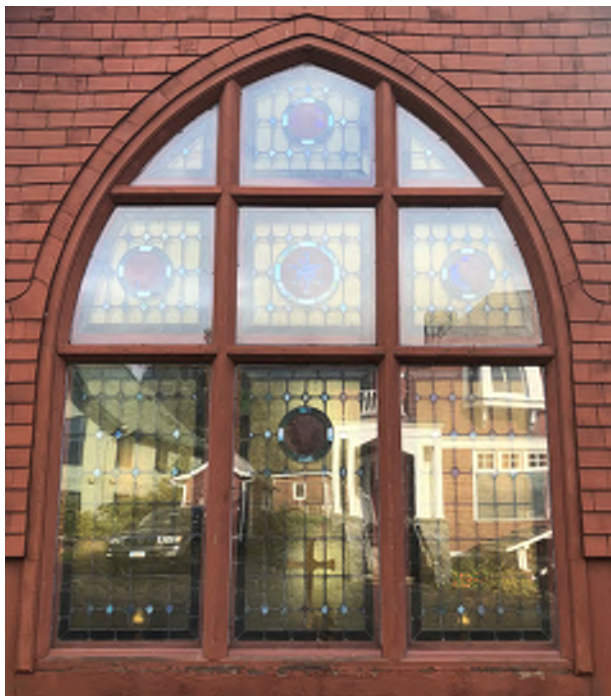
Figure 5.21: The most elaborate window at St. Peter's is a large, divided, arched window at the north facade behind the altar.

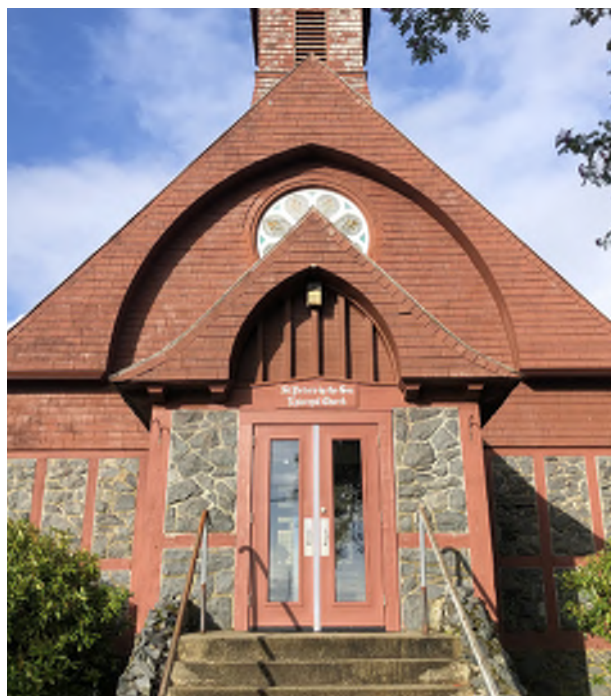
Figure 5.22: Similar to the walls of the main church, the walls of the entrance vestibule are timber framing infilled with fieldstone.

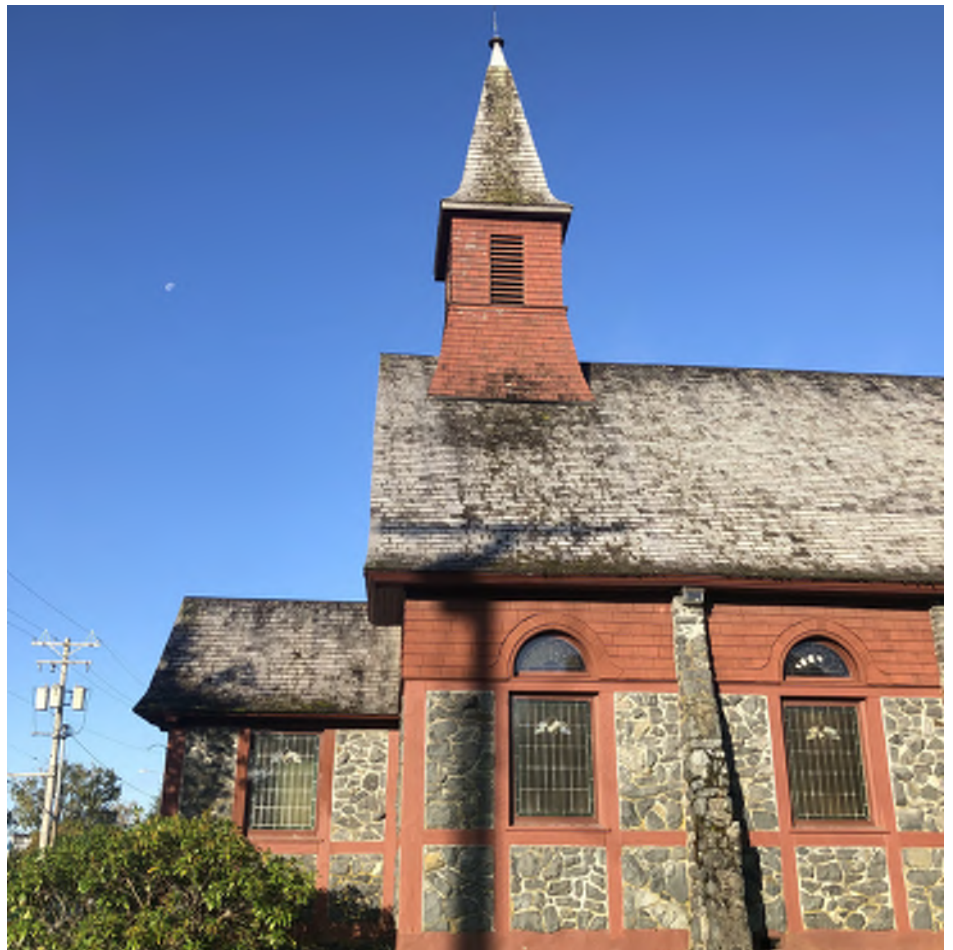
Figure 5.23: The gabled roof of the entrance vestibule has flared eaves, a hooded arch, and is covered with wood shingles.

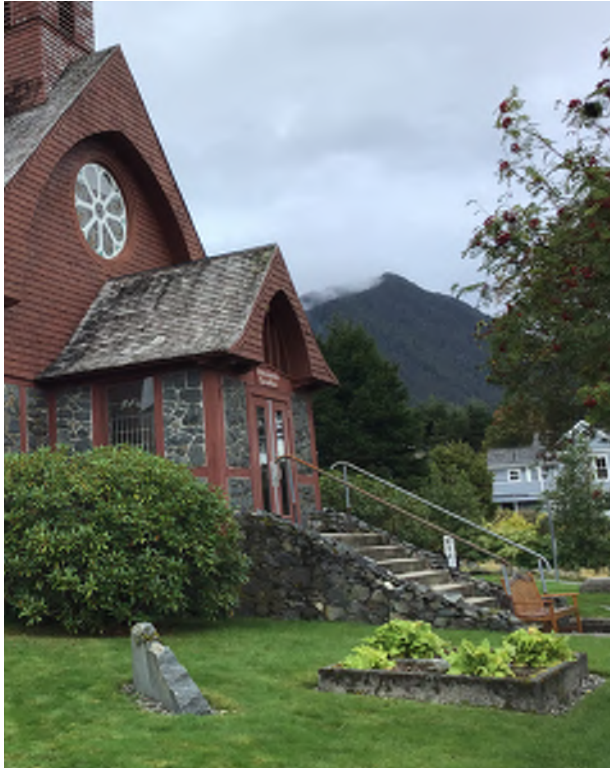
Figure 5.26: A concrete stairway with closed fieldstone balustrades leads to the entrance. Modern round metal pipe handrails have been added to the stairs.

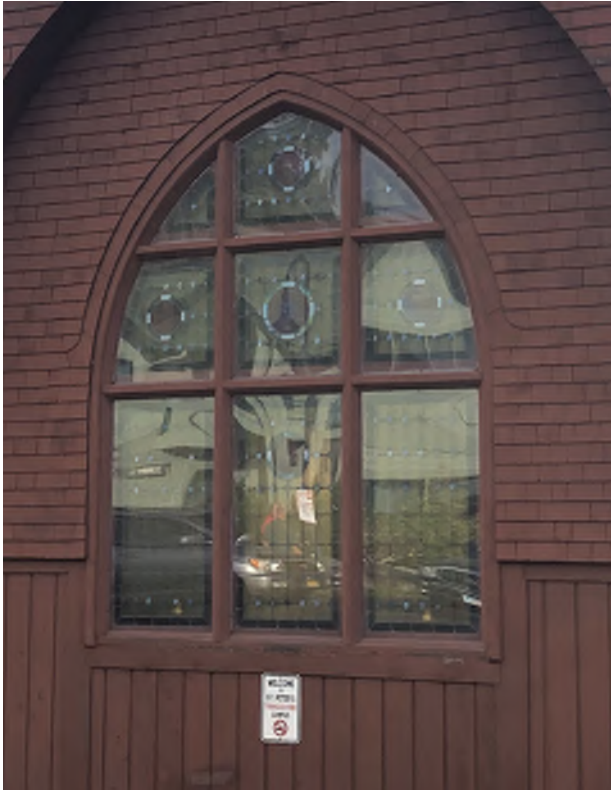
Figure 5.29: A large, nine-panel stained-glass, pointed arch window dominates the north facade.

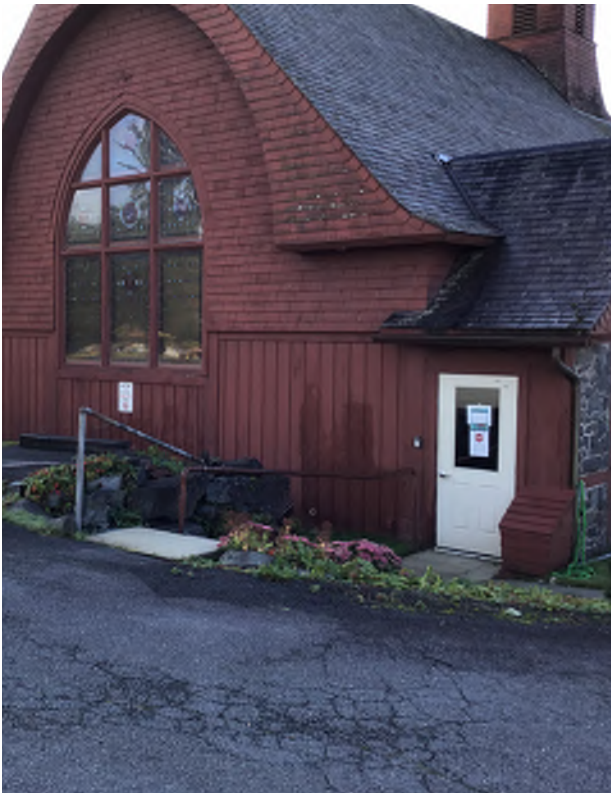
Figure 5.30: A secondary entrance at the north facade provides access to the vestry and nave, looking southeast.

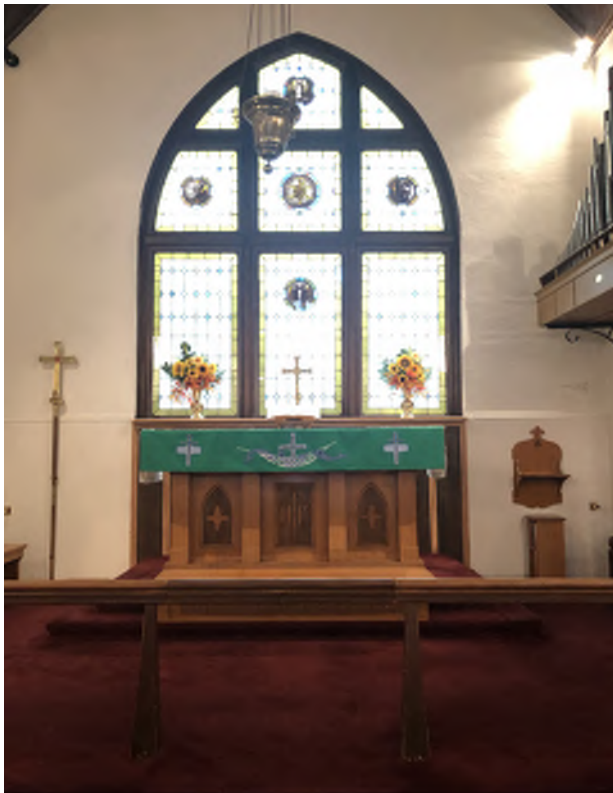
Figure 5.32: The alter, chancel and north wall stained glass window, looking north.

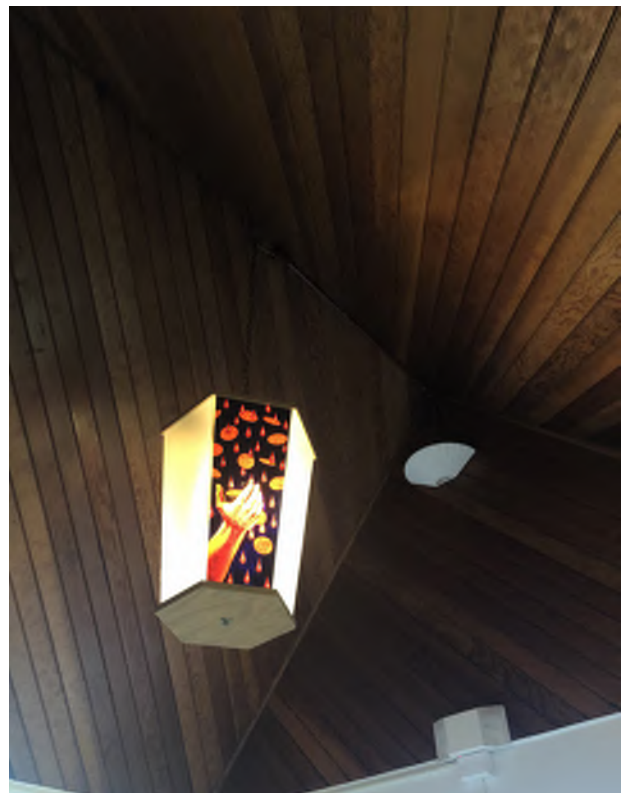
Figure 5.34: Detail of the entry vestibule ceiling and decorative light fixture.

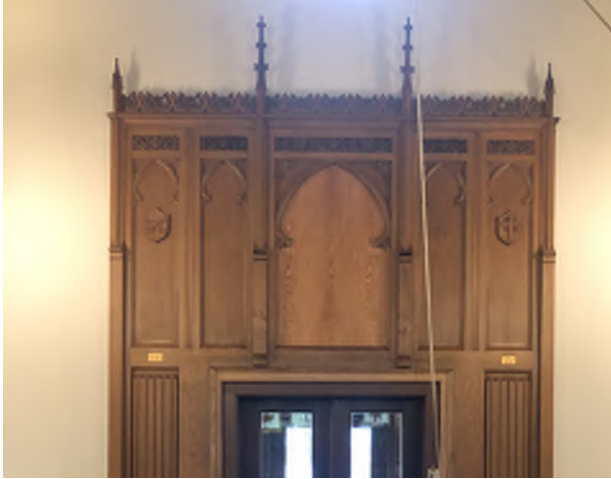
Figure 5.47: The reredos was relocated from behind the altar to the south wall of the church, looking south.

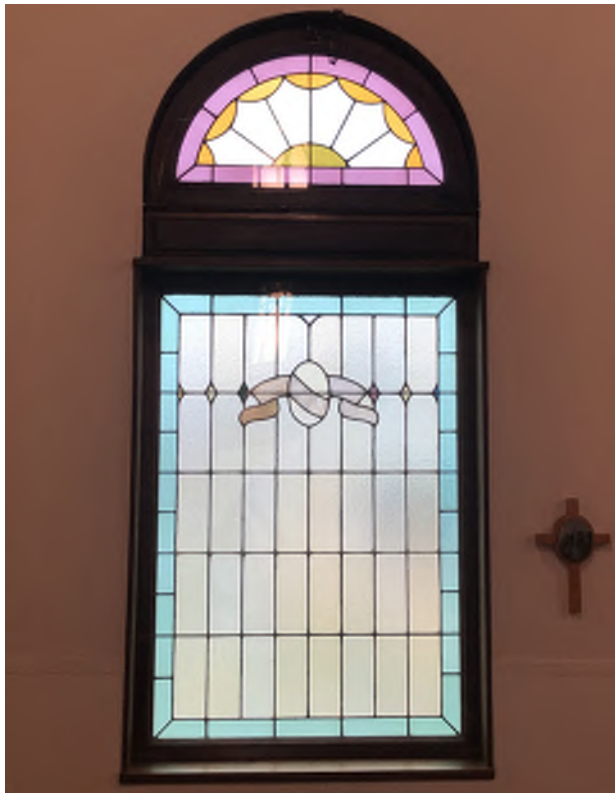
Figure 5.54: Detail of a typical stained glass window with the fan lite transom above.

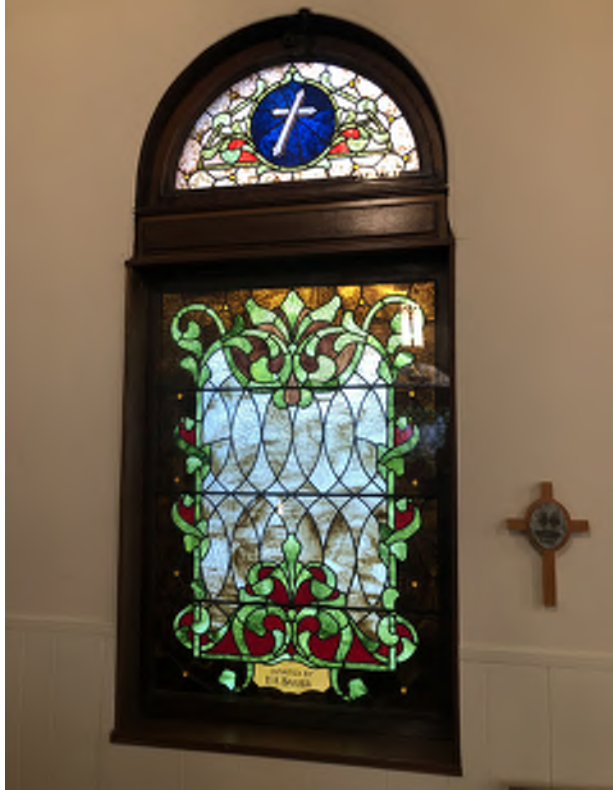
Figure 5.55: The stained glass window at the northern-most bay at the east wall of the church.

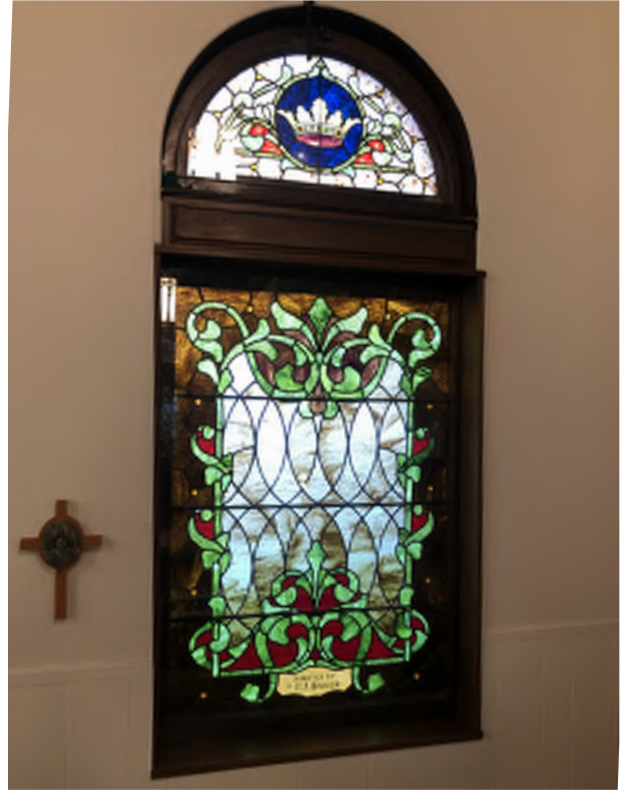
Figure 5.56: The stained glass window at the northern-most bay at the west wall of the church.

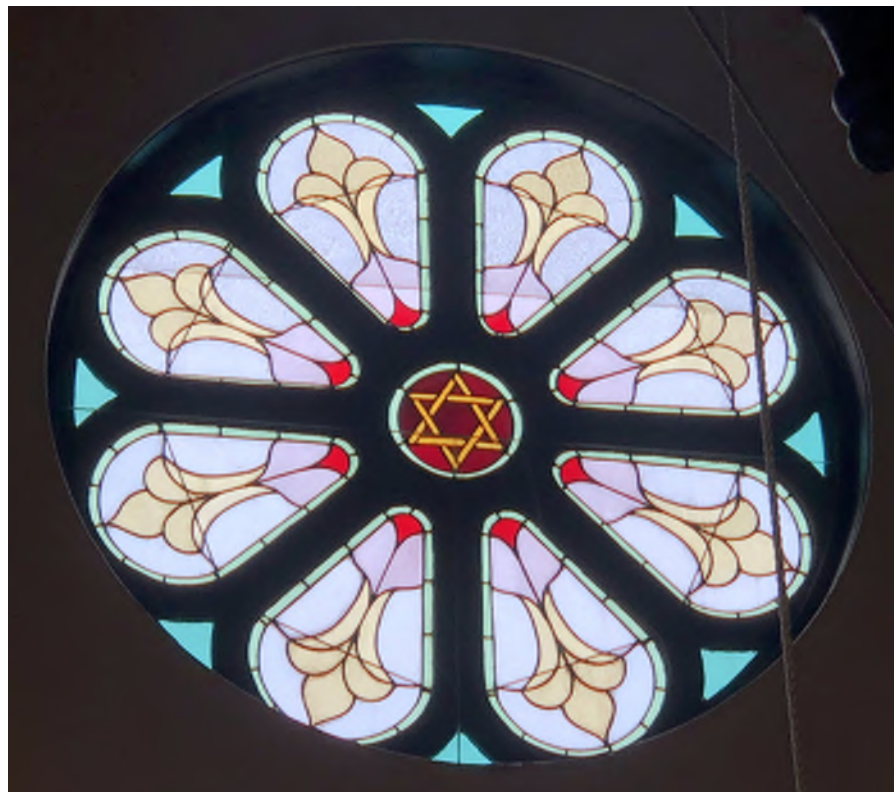
Figure 5.57: Detail of the rose window at the south gable of the church.

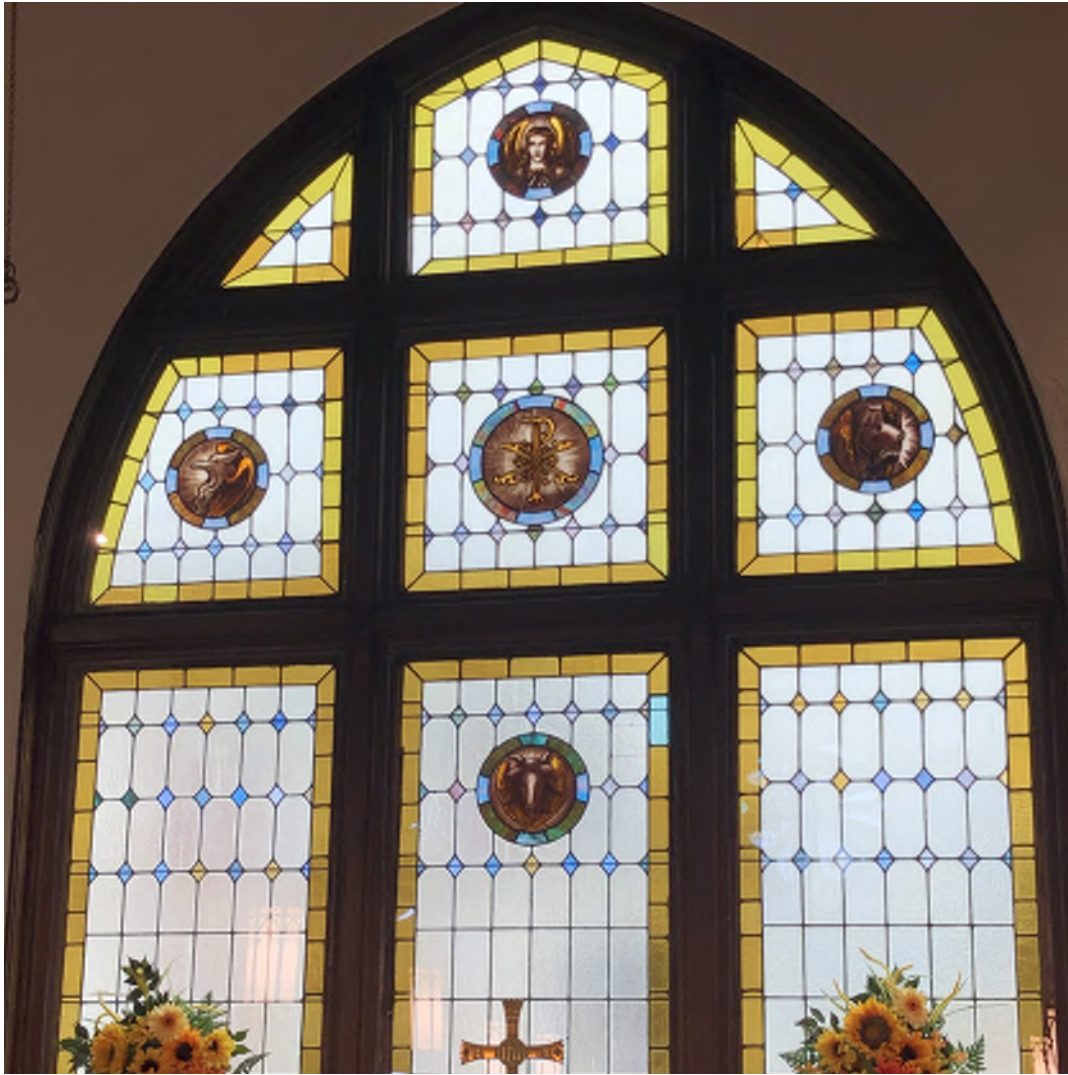
Figure 5.58: Detail of the north wall stained glass window assembly.

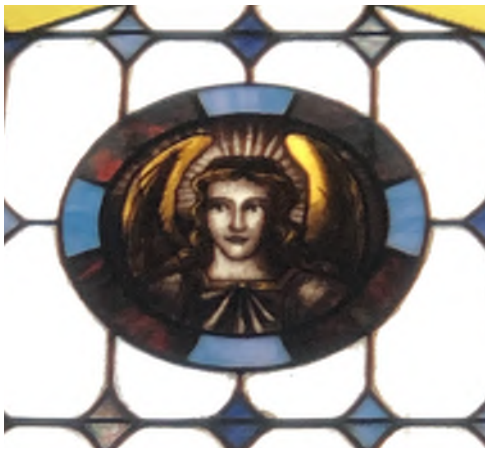
Figure 5.59: The center window of the upper most grouping of windows has a modillion with an angel, the symbol of Matthew.

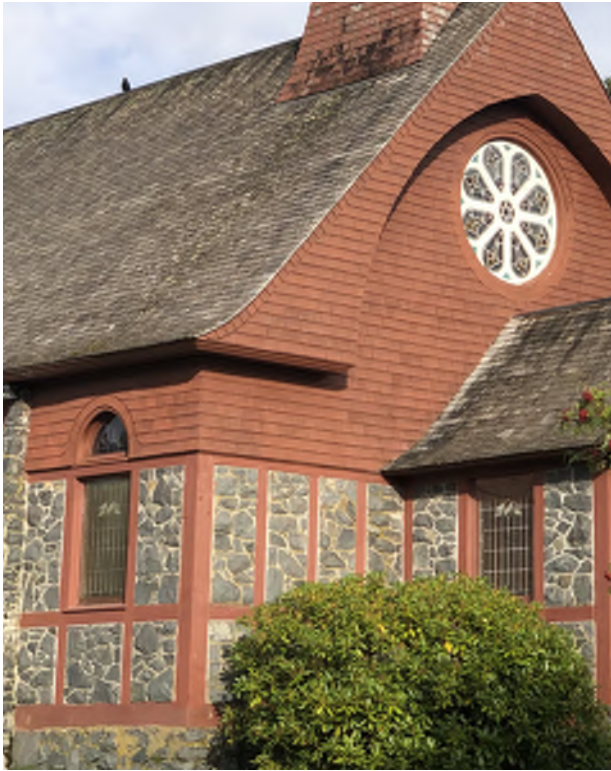
Figure 7.1: Half-timber framing and fieldstone wall infill at lower half of walls with painted wood shingles at upper half.

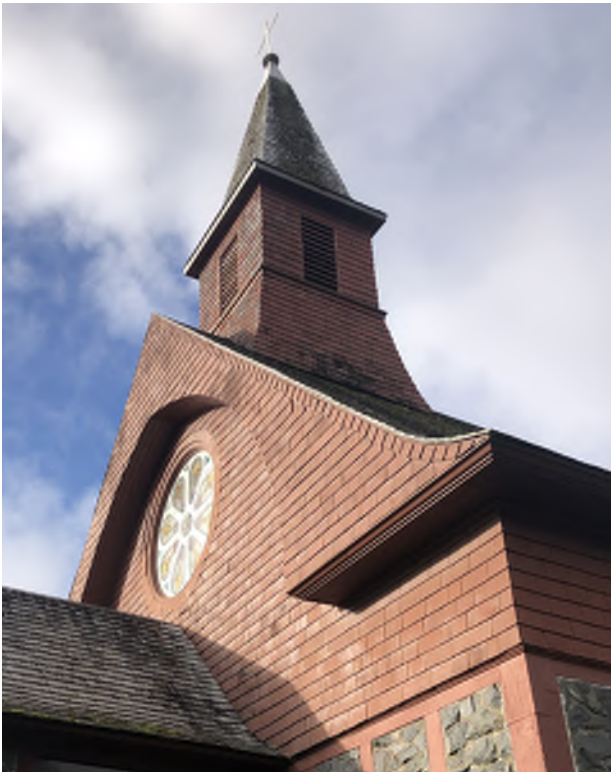
Figure 7.2: Steeply pitched roof with eaves, hooded arches at gable ends, belfry with pyramidal metal spires.

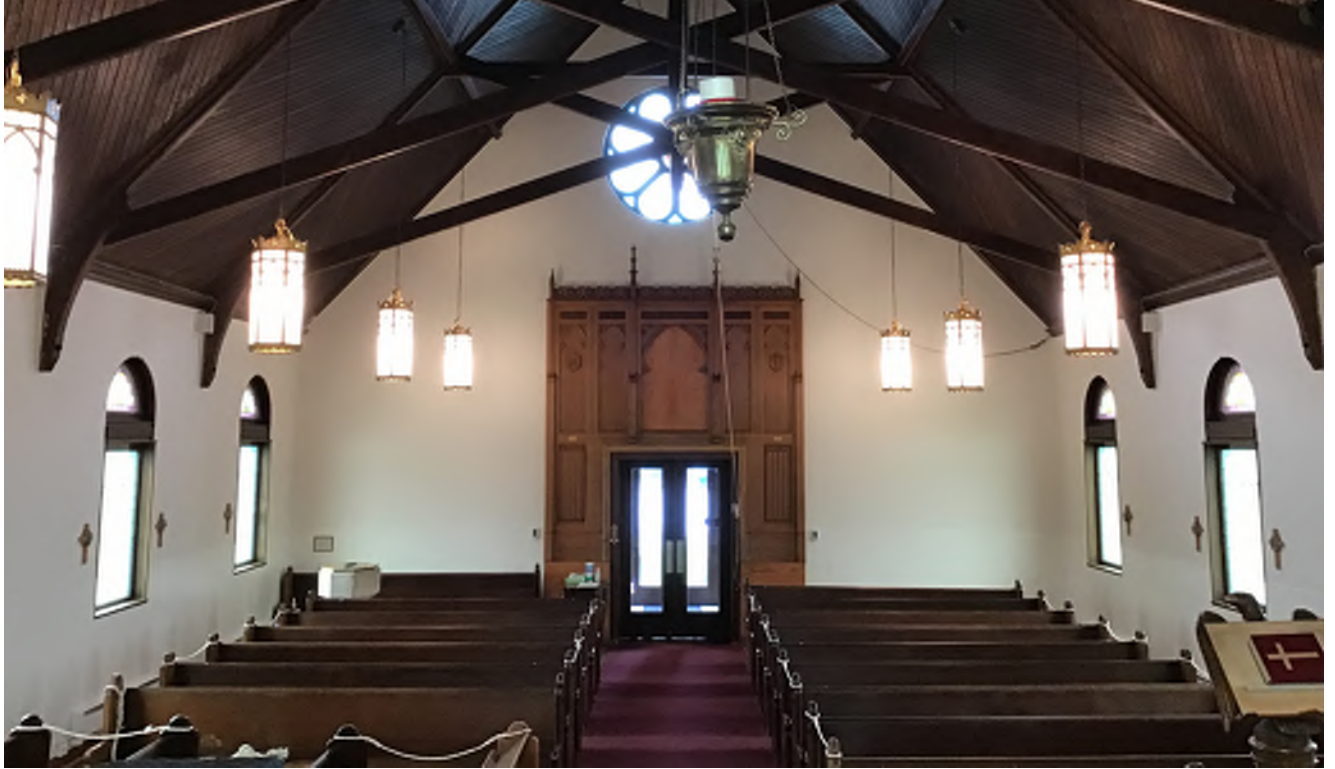
Figure 7.3: Nave, central aisle, side aisles, and pew configuration.

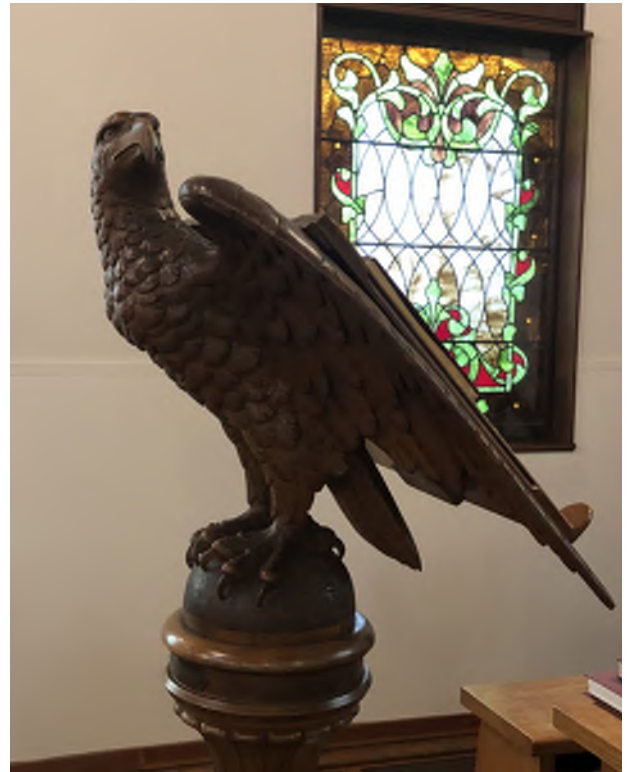
Figure 7.5: Carved wood eagle lectern in sanctuary.

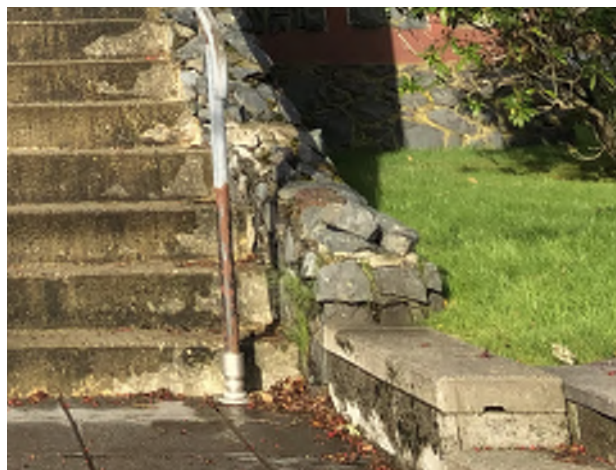
Figure 8.10: Loose stones and crumbling mortar caps on entrance stair walls are a falling hazard and potential tripping hazard.

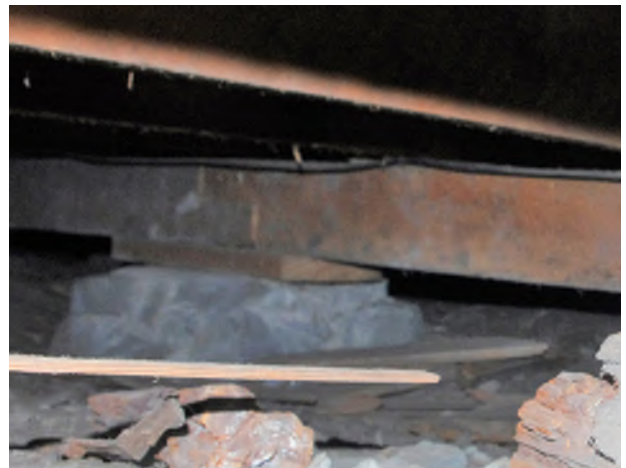
Figure 8.12: Flooring is supported by narrow beams at intermediate masonry foundation piers. Photo credit: Grant Crosby

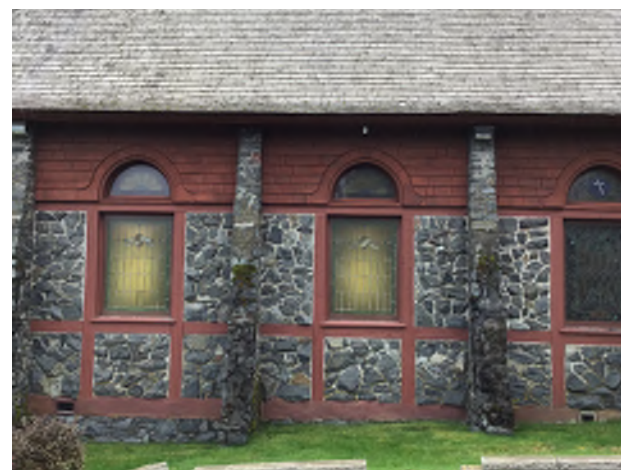
Figure 8.13: Typical half-timber framing positioned around windows centered in wall bays.

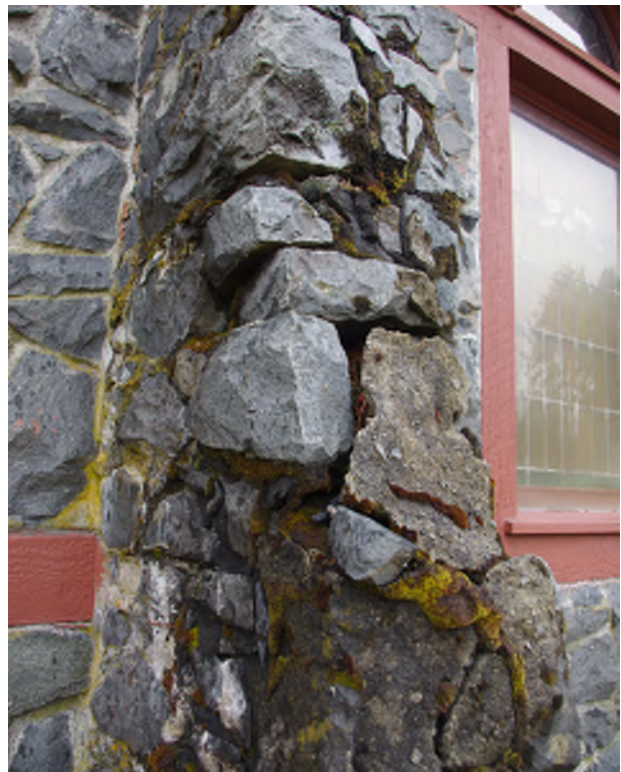
Figure 8.17: Cracks on the masonry mortar joints at the buttresses.

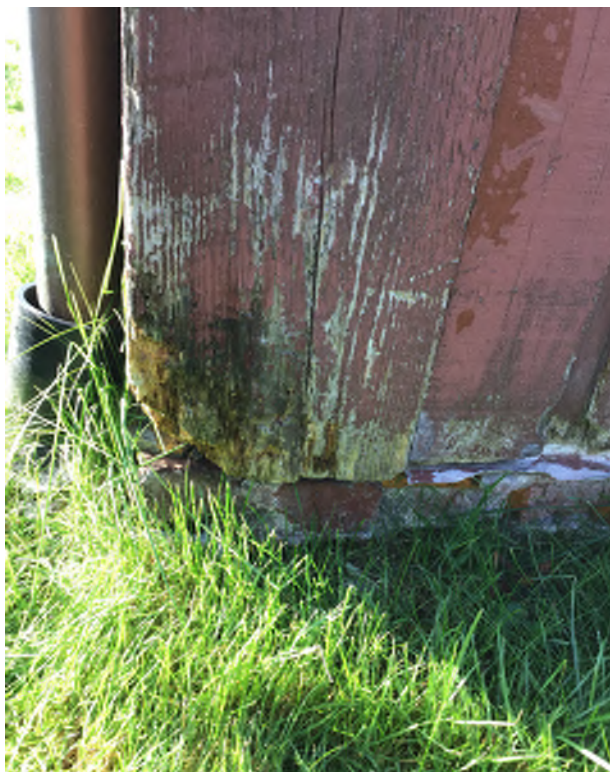
Figure 8.20: Rot deterioration and checking on half-timber framing column.

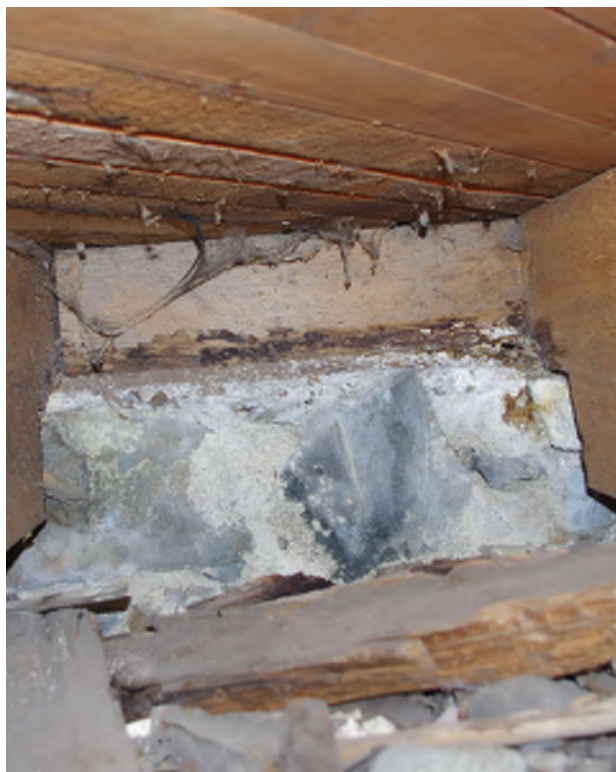
Figure 8.19: Visible debris between floor joists, minimal separation from soil, and decay at joist blocking. Photo credit: Grant Crosby

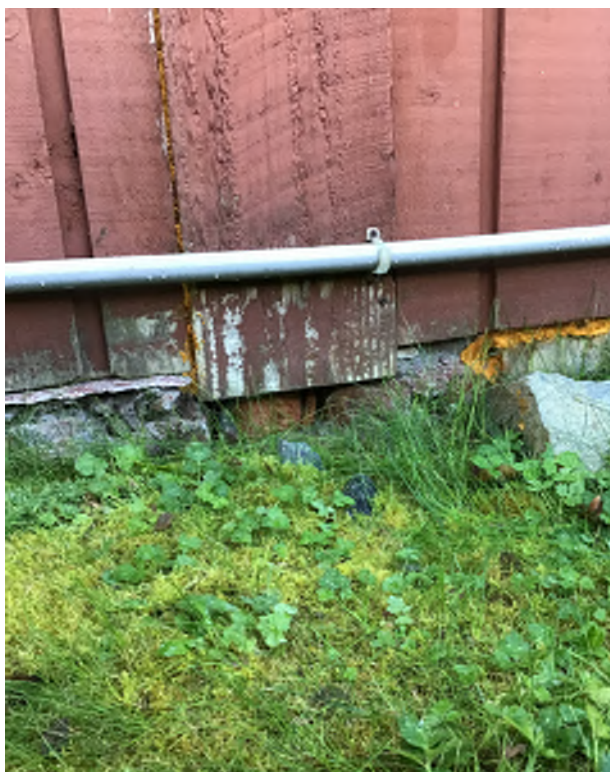
Figure 8.21: Spalling on parge coat, exposing mortar.

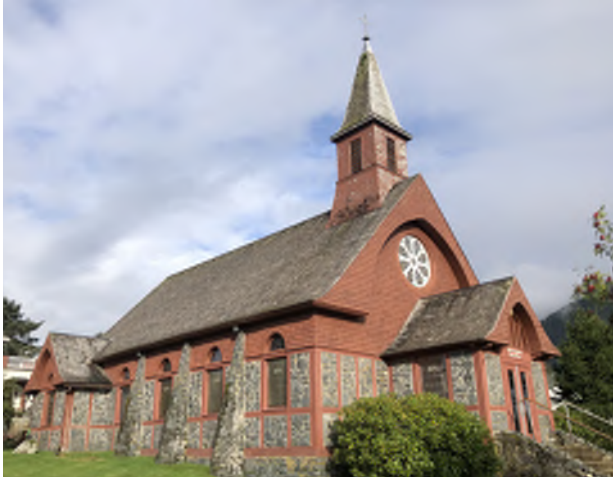
Figure 8.22: All roofs are sloped approximately 12:12 with flared eaves at lower ends.

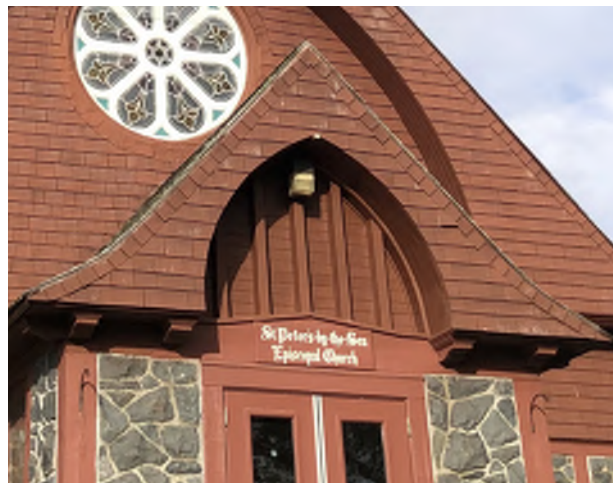
Figure 8.23: Soffits at the vestibule roof are supported by flat decorative corbels with an ogee profile not found elsewhere on the building.

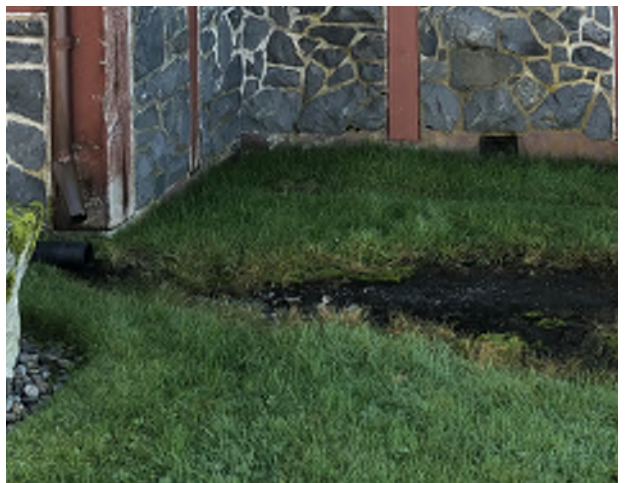
Figure 8.26: The downspout is disconnected at the northeast corner of the church, causing water to flow onto building walls.

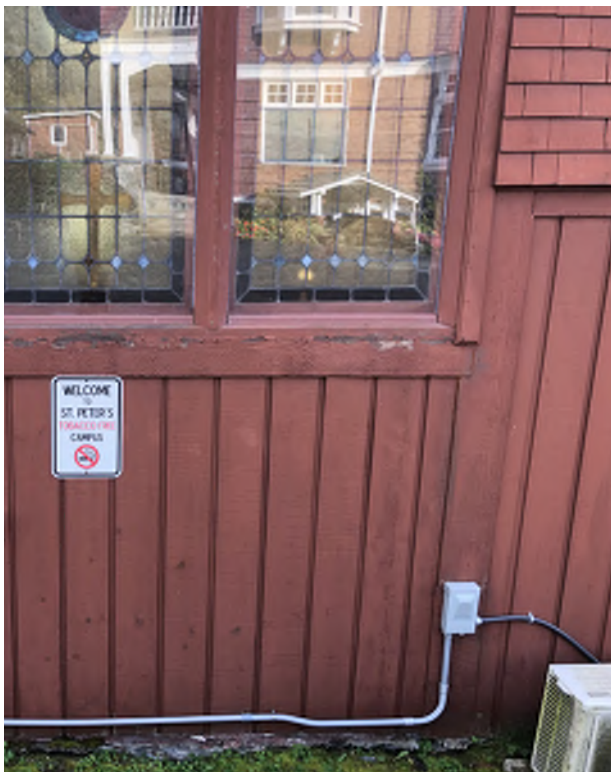
Figure 8.30: Original wall cladding below the timber datum has been replaced with T1-11 plywood siding.

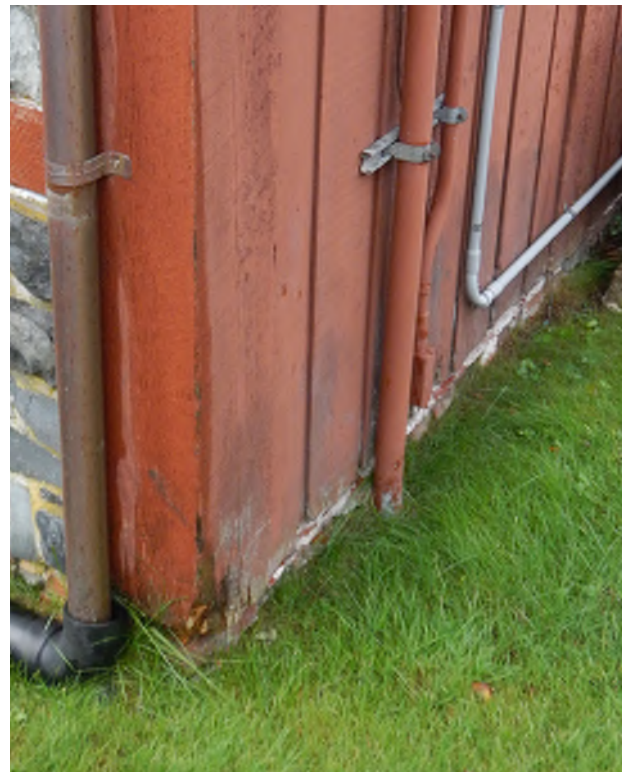
Figure 8.32: Evidence of wood decay at bottom edge of plywood siding on northeast corner of building.

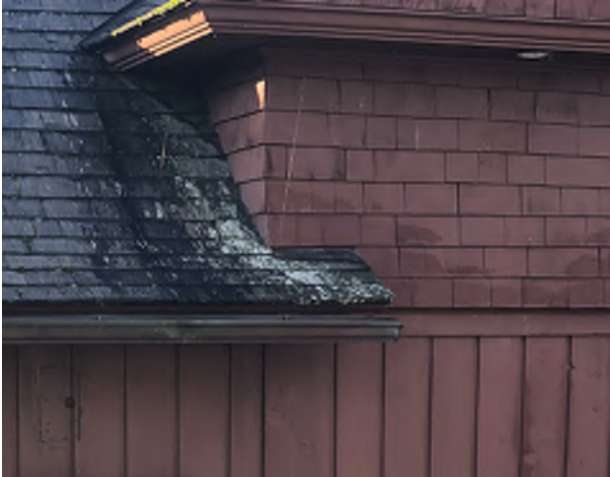
Figure 8.33: Shingles and plywood siding contain elevated moisture levels and evidence of biological growth.
