St. Peter's by-the-Sea Episcopal Church Historic Structure Report

Prepared by: FFA Architecture and Interiors, Inc.

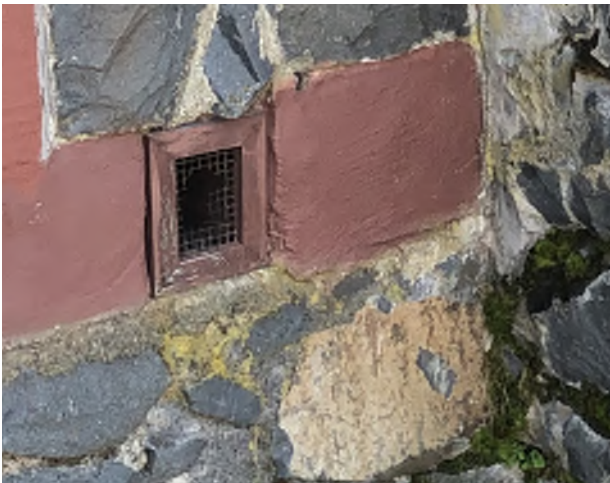
Figure 8.34: Damaged wire mesh on crawl space vent at the east facade.

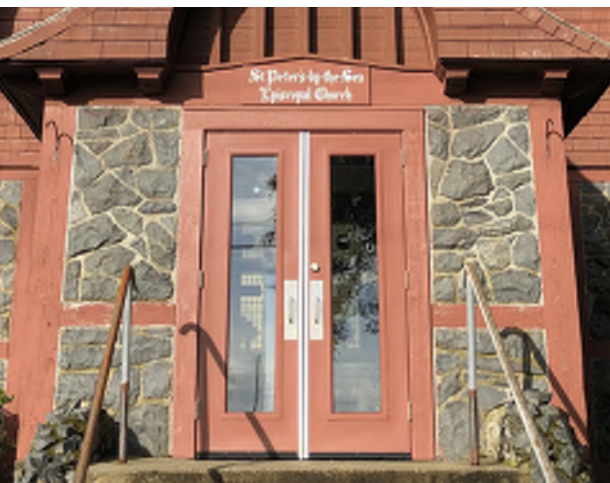
Figure 8.35: Main entry doors on the south facade with carved wood sign above entitled "St. Peter's-by-the-Sea Episcopal Church".

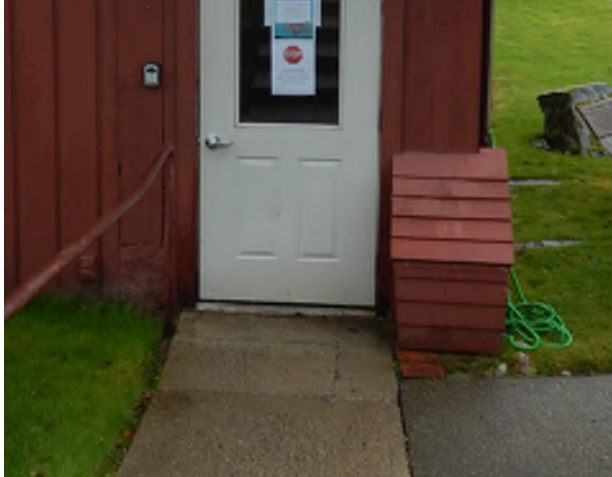
Figure 8.39: The north entrance door threshold exceeds the 1/2" maximum height and is not accessible.

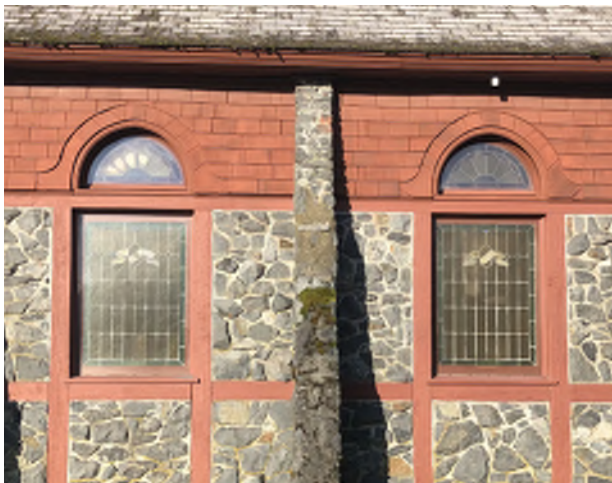
Figure 8.40: Typical windows of lower sash rectangular leaded stained glass windows with an upper semicircular leaded glass transom on the east and west facades.

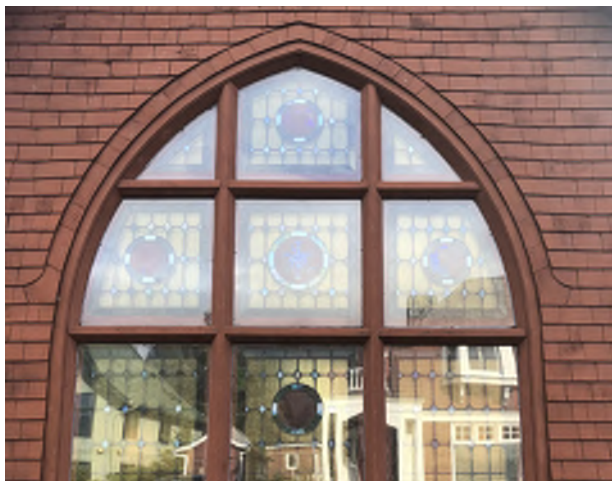
Figure 8.41: Divided stained-glass window on the north facade configured to match the hooded arches throughout the building.

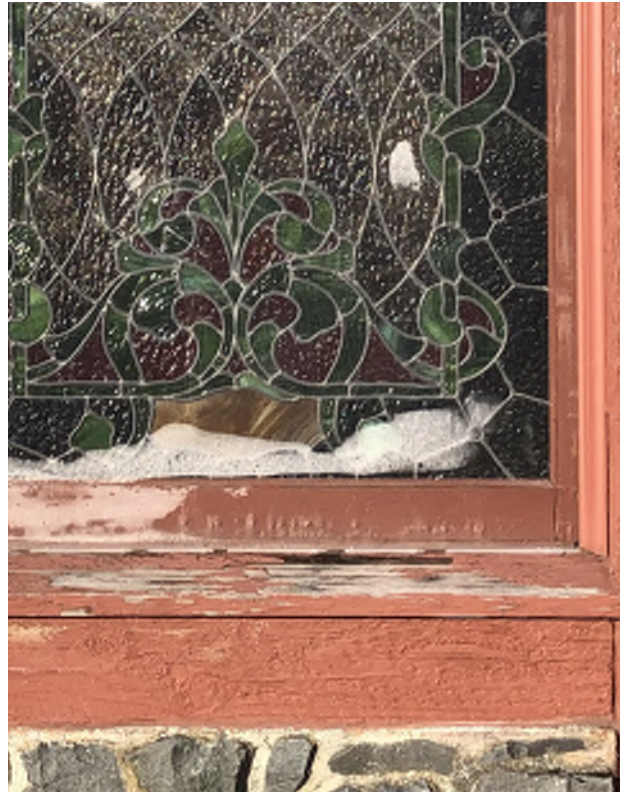
Figure 8.42: Visible deterioration on wood sill of windows on the east and north facades. Paint failure has caused wood to weather and be susceptible to moisture intrusion.

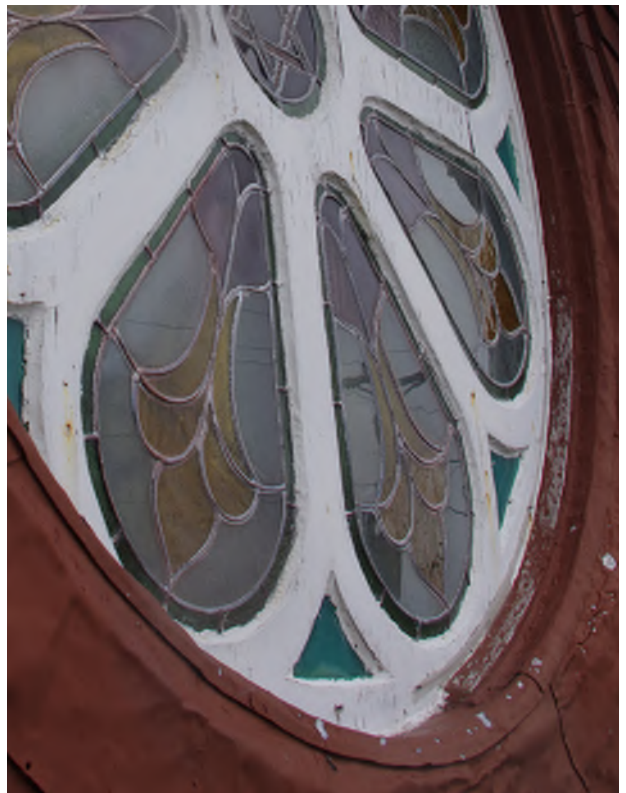
Figure 8.43: Weathered frame and muntins, and rust stains on the rose window located on the south facade.

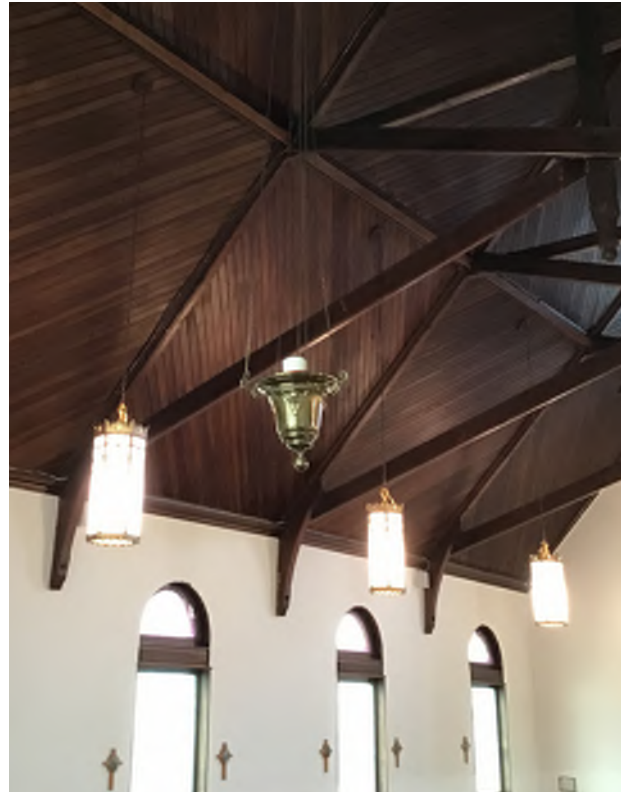
Figure 8.44: Ceiling panel sections in sanctuary bound with diagonal tongue-and-groove beadboard that converges at intersections.

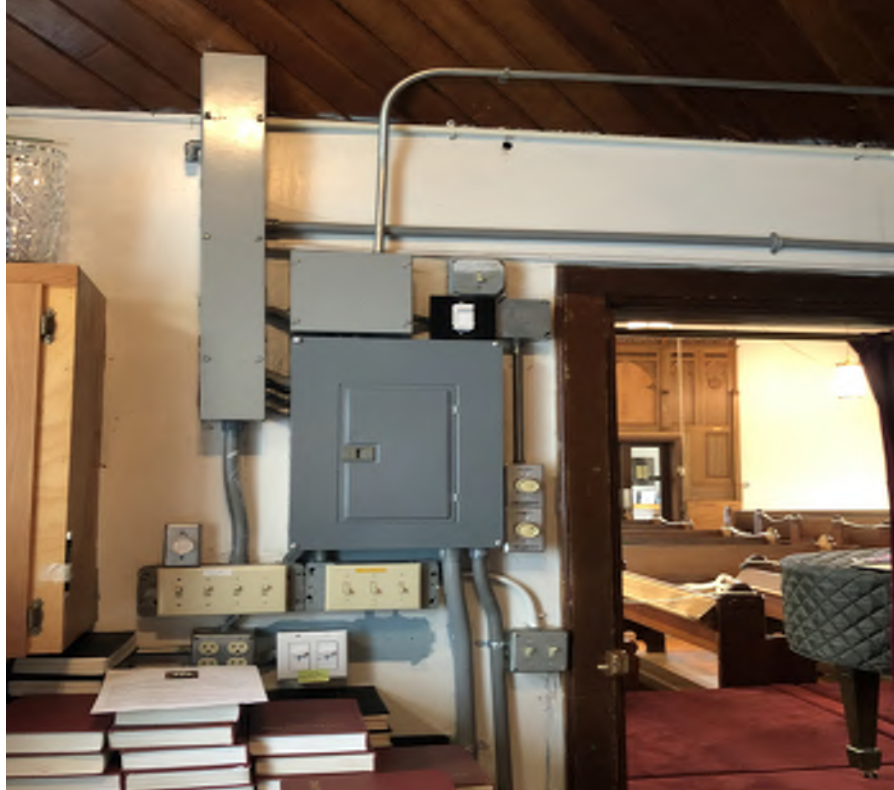
Figure 8.46: Electrical main distribution panel on kitchen wall.

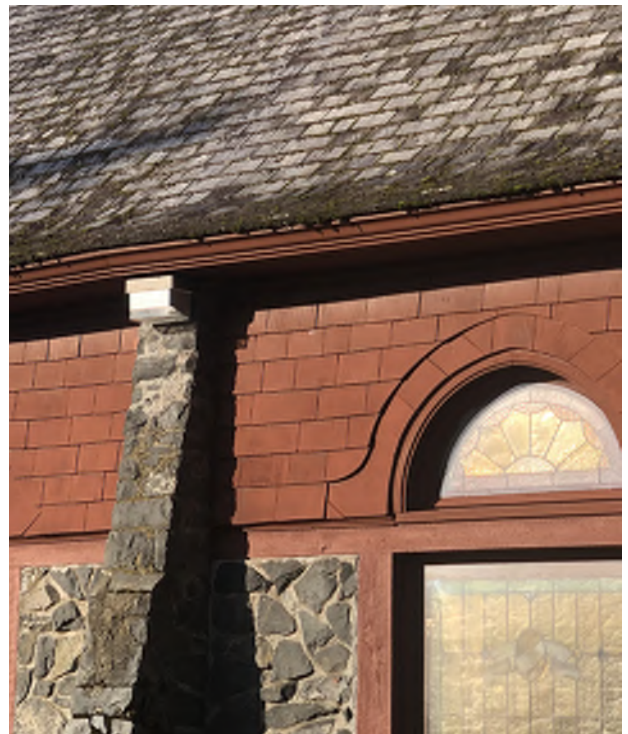
Figure 9.3: Materials are largely intact or replaced in kind, including the wood shingles at the upper portion of exterior walls and the roof.

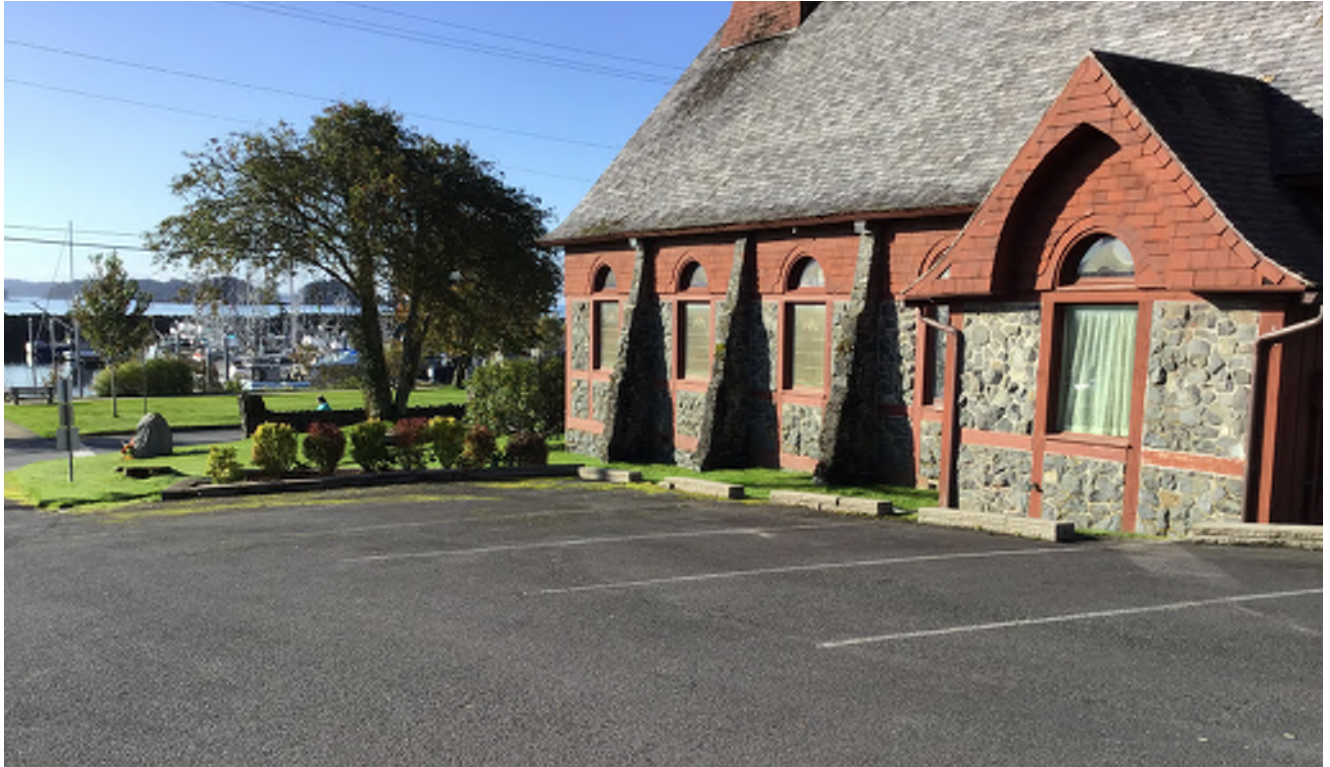
Figure 10.1: Conduct a topographic survey to provide basis for addressing accessibility, drainage, parking, and circulation.

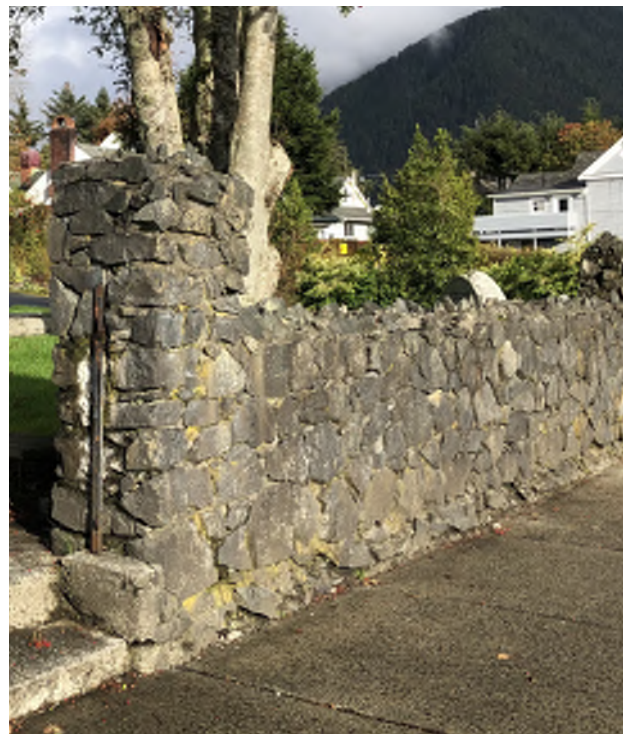
Figure 10.3: Hire qualified mason to repair loose and crumbling masonry walls.

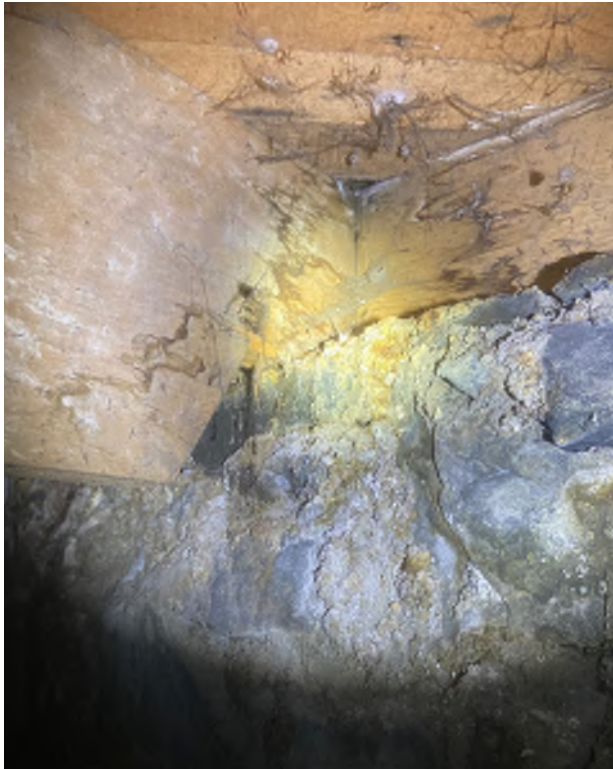
Figure 10.4: Wood rot visible at notch in floor joist. Photo credit: Sterling Holdorf

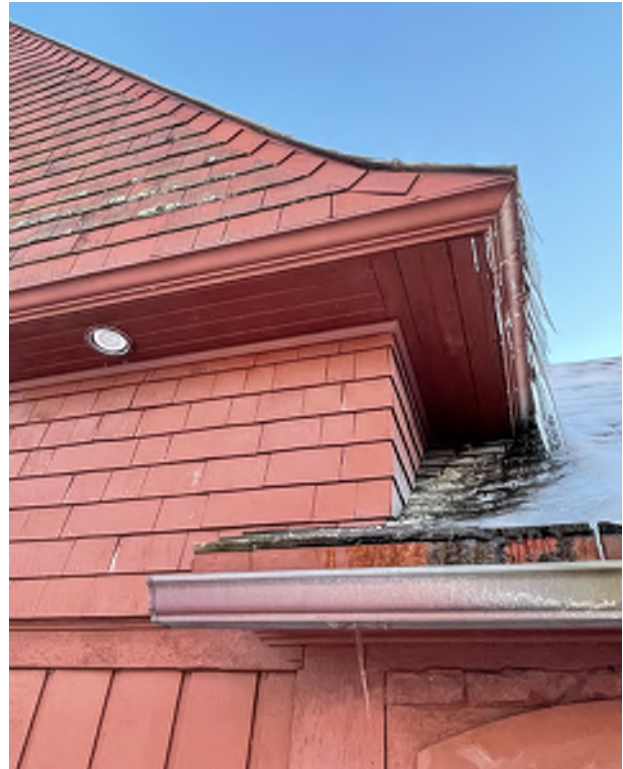
Figure 10.6: Install gutters on all roof sections. Photo credit: Troy Feller

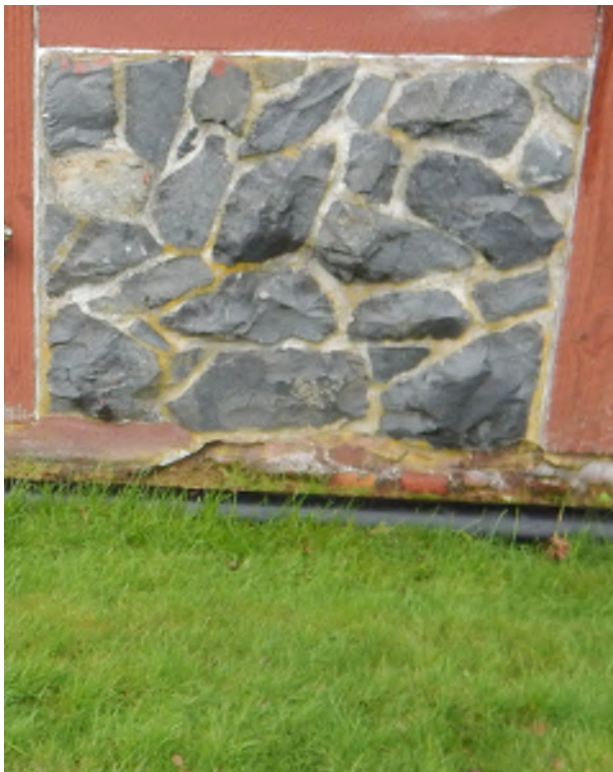
Figure 10.5: Patch and repair mortar parge coat on brick foundation walls.

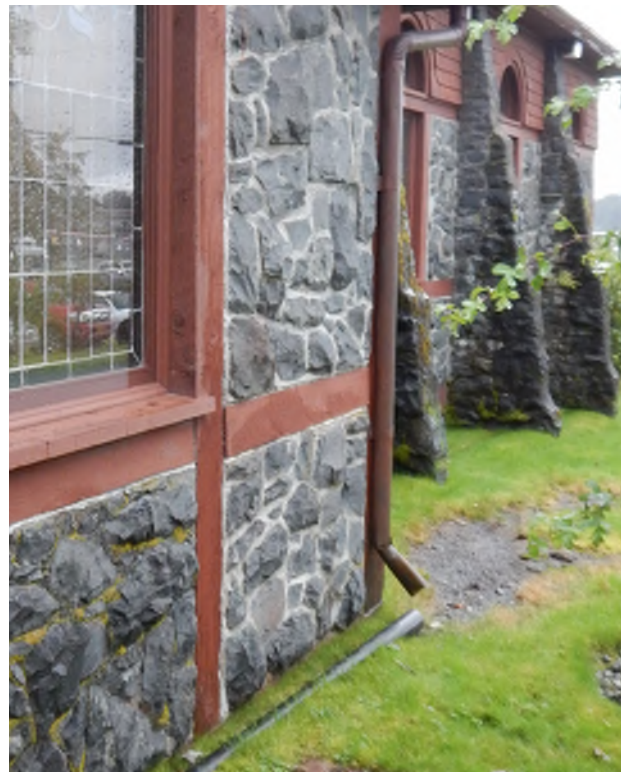
Figure 10.7: Reconnect joints in downspout at northeast corner.

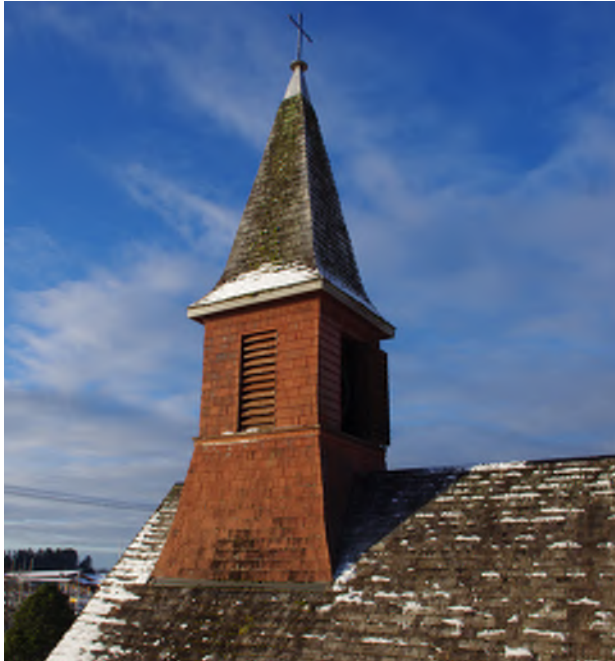
Figure 10.8: Provide cleaning, repair, and maintenance of belfry tower during next scheduled roofing campaign. Photo credit: Grant Crosby

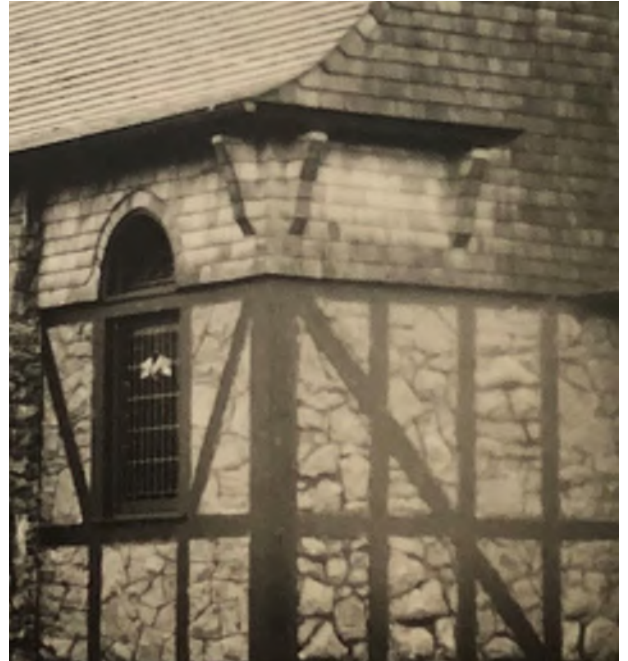
Figure 10.9: Restore the original character-defining shingle covered corbels. Source: St. Peter's by-the-Sea Archives.

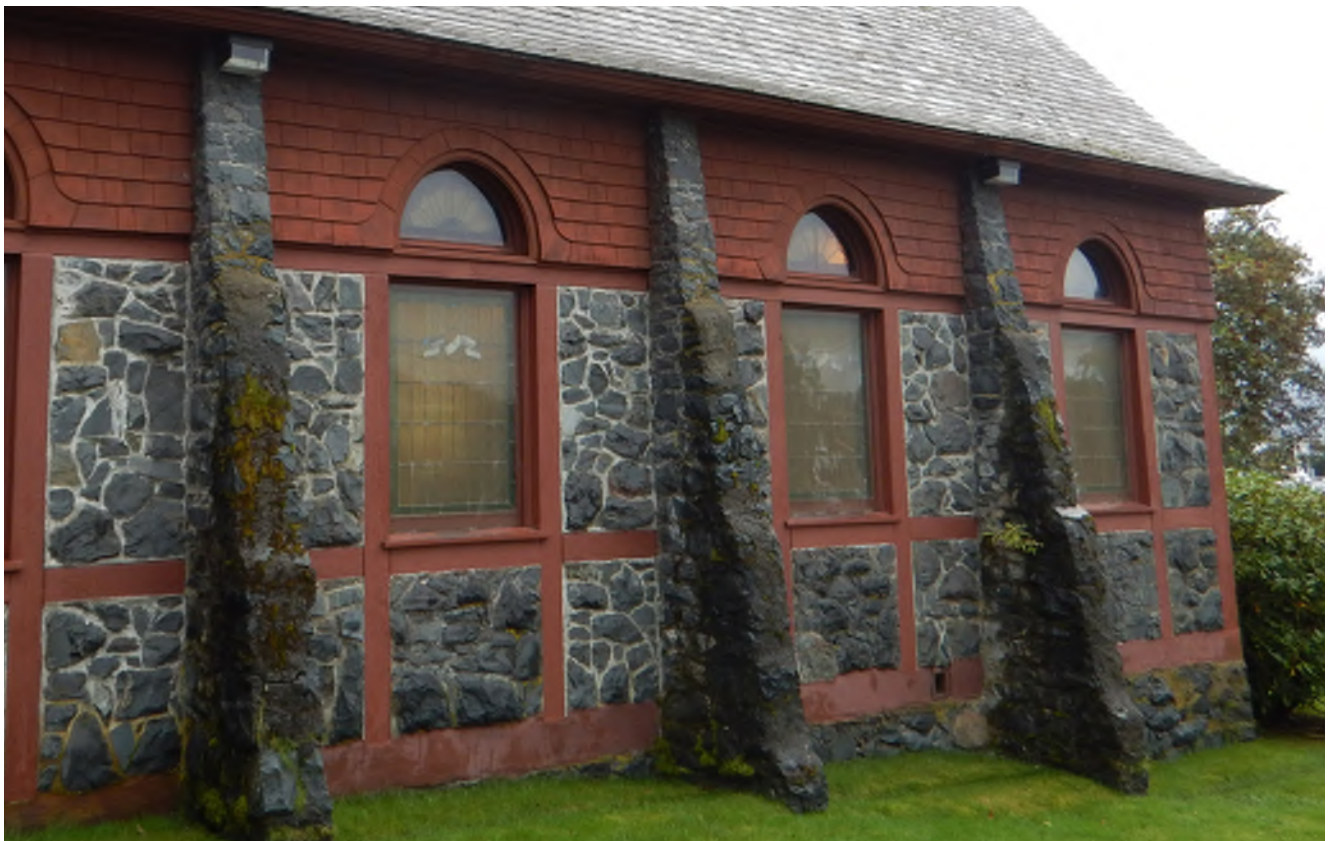
Figure 10.10: The repair and repointing of masonry buttresses is required due to prolonged water infiltration from roof runoff and repeated freeze-thaw cycles.

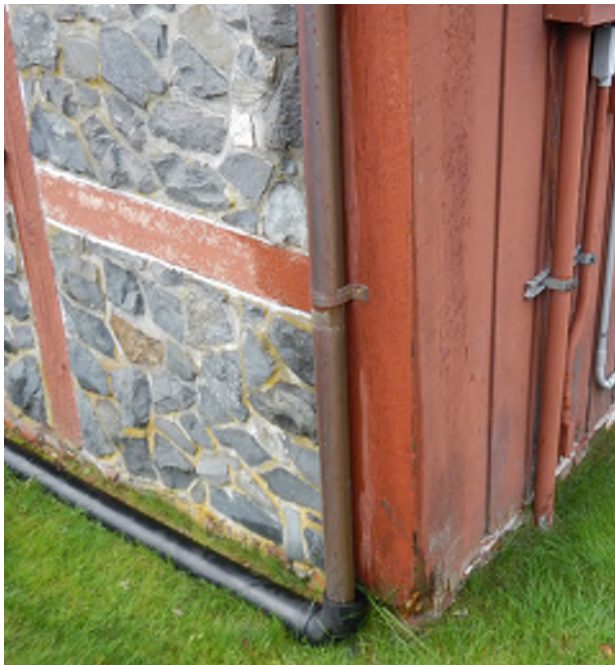
Figure 10.11: Reduce soil levels around building to provide clearance between bottom of parge coat and top of soil

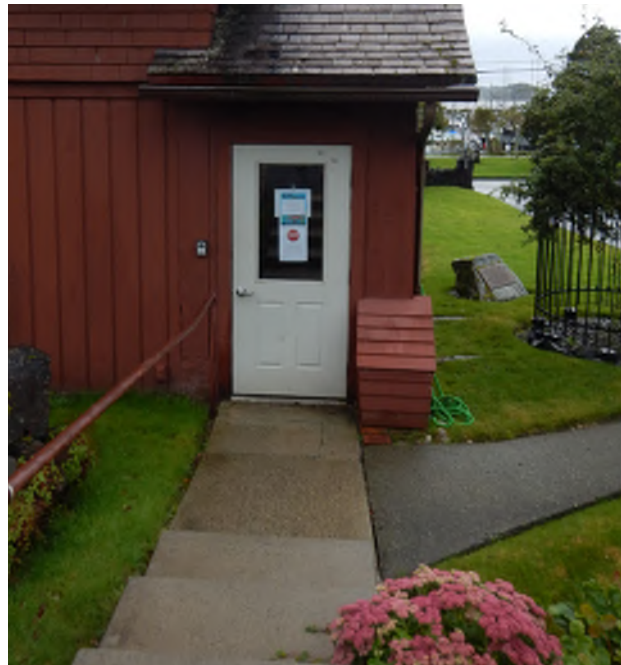
Figure 10.13: Review egress conditions with local fire marshal.

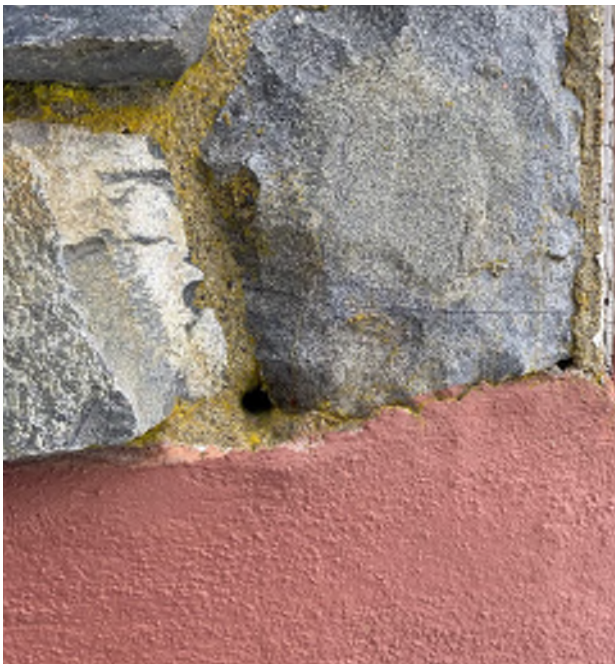
Figure 10.12: Inspect weep holes in masonry during regularly scheduled intervals.

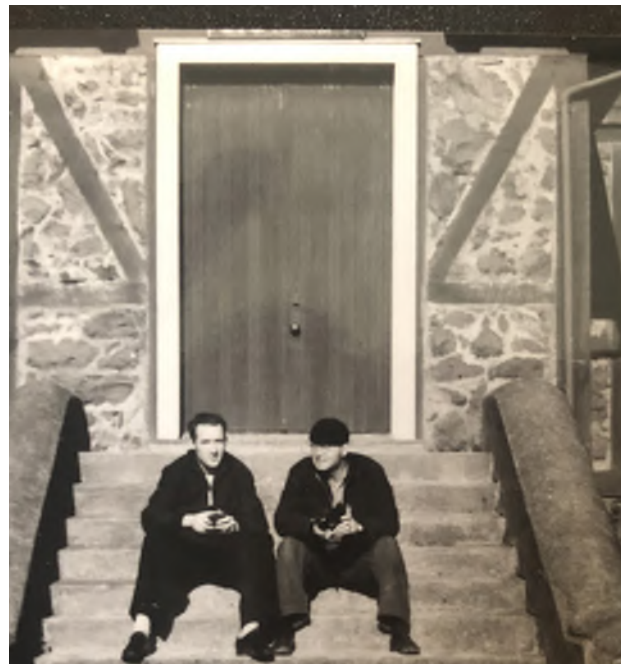
Figure 10.14: Replace non-original entry doors with replica wood doors based on historic documentation. Source: St. Peter's by-the-Sea Archives.

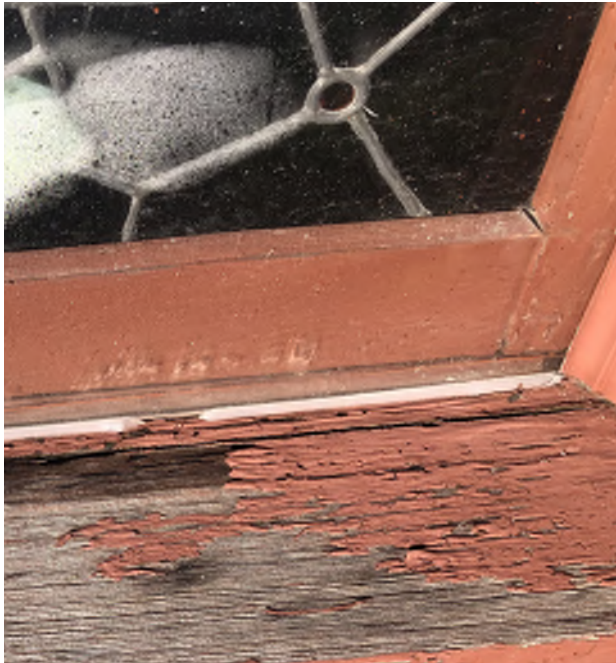
Figure 10.15: Remove clear sealant/caulking from the bottom of acrylic plastic coverings.

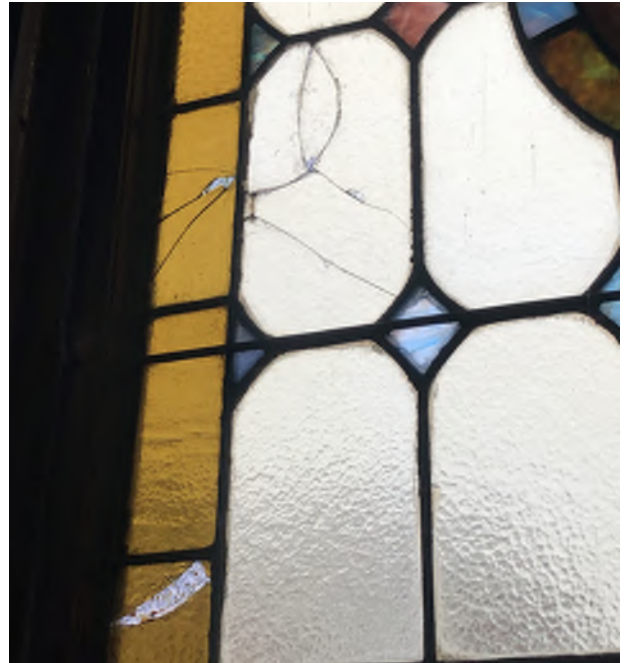
Figure 10.17: Monitor chipped and cracked glass panes on stained-glass windows.

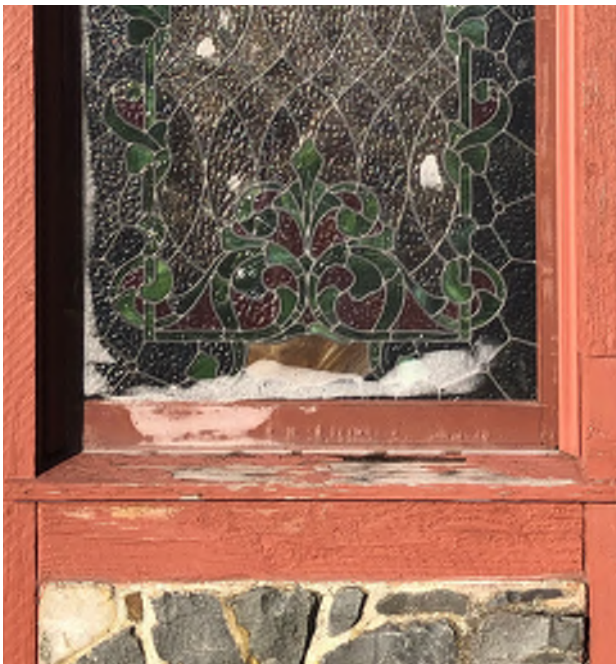
Figure 10.16: Remove failing paint and treat wood deterioration on wood sills on east facade.

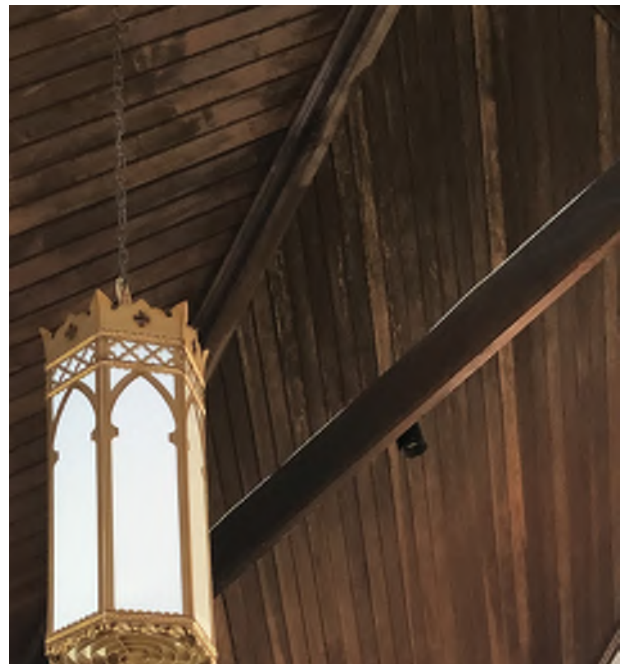
Figure 10.18: Follow manufacture's guidelines for the reapplication of stain finish on ceilings, trusses, and corbels.

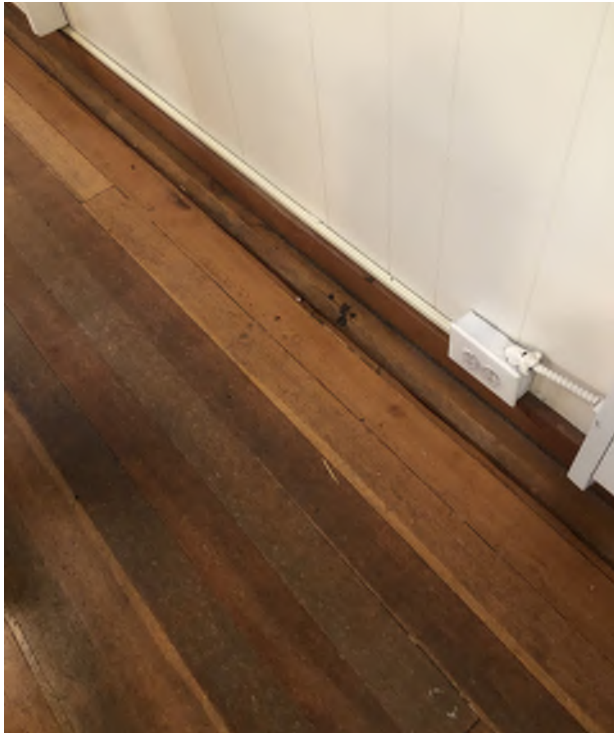
Figure 10.19: Restore existing original Douglas-fir floors in the sanctuary and sacristy.

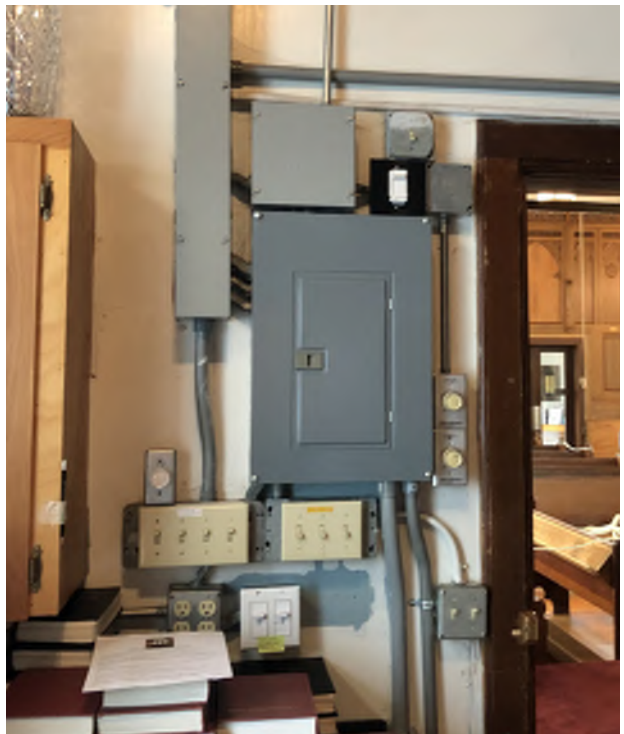
Figure 10.22: Hire qualified electrician to inspect electrical main distribution panel.

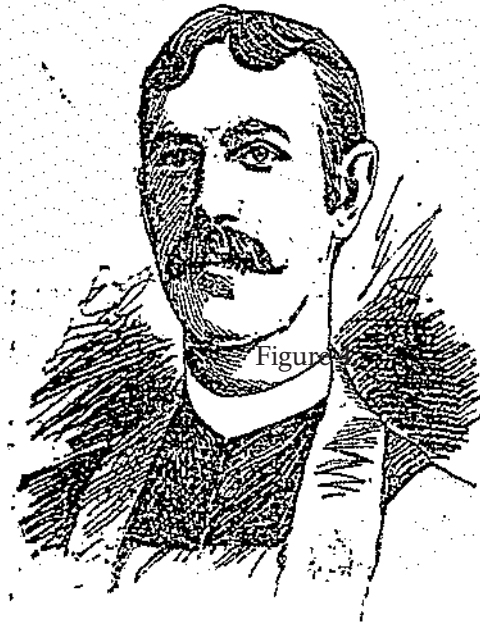
The Rev. Peter Trimble Rowe,
Consecrated Yesterday in St. George's Church.
