March 22, 2024 - Article in the Sitka Sentinel

## [St. Peter's Seeks Support for Historic Building](#)

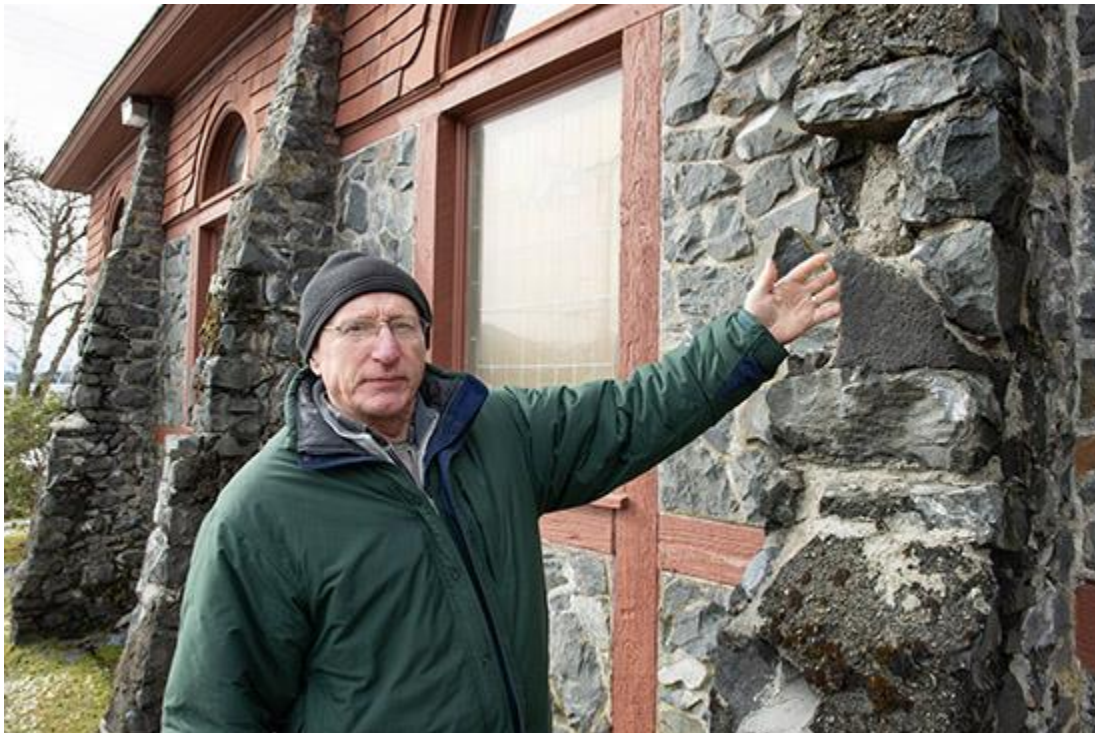
Loyd Platson, St. Peter's junior warden, recently points to stones in the church buttresses that are in need of re-pointing. (Sentinel Photo)

Along with the aging roof and total lack of insulation in the building, Platson pointed out the crumbling buttresses that line the side walls. When he and Julie arrived in town in 2015, that stonework was in fine condition, but a century and a quarter of freezing and thawing has finally taken a serious toll. The stonework and floor joist problems are linked.

“You can see the condition of the buttresses. So the water’s coming off the roof and dripping on the buttresses, and so then it’s getting in the cracks and breaking those apart. And then it’s coming down to the ground, and then it’s seeping through the rock underneath the church. That’s what rotted,” he said. The issue overall comes down to poor drainage, as the building has no gutter system. As part of the repair of the sacristy floor, Platson said, contractors dug a trench beside the church and installed the beginnings of a gutter pipe. When the roof is redone in 2025, he continued, the plan is to add gutters.

“We’re going to take the roof, we’re actually going to put four inches of solid foam insulation up there. Because that’s where most of the heat is going out — the roof. And that will allow us to have fascia on there so that we can actually put gutters on the church,” Platson said.

But before the roof repairs, which are planned for the first half of 2025, Platson said a stonemason is flying in from Pennsylvania to work on the buttresses, along with some other parts of the building.
